Northview Pond Remediation

Project Overview

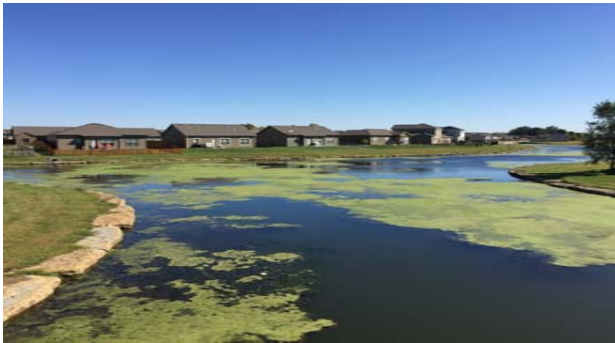
The Northview Homeowners Association (HOA) oversees the maintenance of the pond in the Northview neighborhood and has noted a decrease in water quality and clarity over the years. In the summer, there are a large number fish kills and what appears to be algae on the surface of the pond. The objective of this project was to identify the material floating on the pond and give the HOA suggestions on how to improve the water quality of Northview pond.

Image 1: The state of the pond in October, 2017.

- The Northview HOA would benefit from implementing Stormwater Control Methods (SCMs) such as increasing the number of plants present in and around the inlets feeding into the pond. It may also be beneficial to increase circulation of the lower pond to allow the plants to sequester nutrients and other harmful material in the pond.
- Fertilizers and lawn clippings from the surrounding neighborhood can contribute to the high levels of nitrogen and phosphorus in the pond. Measures should be put in place to keep runoff from lawns from getting into the pond such as requiring residents to dispose of lawn clippings and other waste in the garbage.
- It is also recommended that the HOA invests in a manual pond skimmer. One can be seen in Image 6 below. It will help remove duckweed from the water.

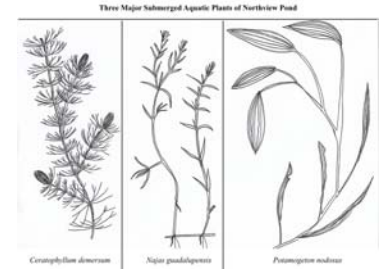
Three major plant species were identified at the Northview pond. These native plants are very beneficial to their environmental because they filter out sediment and nutrients such as nitrogen and phosphorus.

Image 4: Native plants in the pond

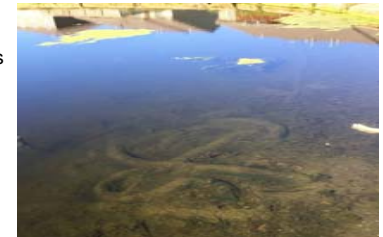
Additionally, site visits showed the poor erosion control practices in place at the pond. Erosion socks are used around the banks, however they slip into the water and do not do enough to control runoff into the pond. Image 5 shows the failure of erosion control at the site.

Image 5: Erosion control at the pond
