Road Cuts in the Flint Hills: An Overview of Ecological Health
and Structural Integrity

NRES Capstone

May 5, 2017

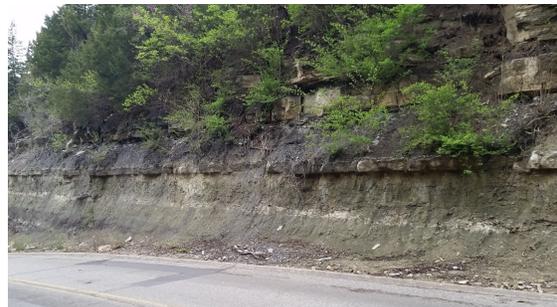
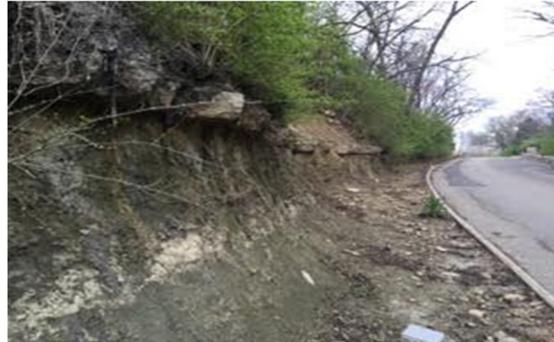
Juliette Road Cut

The outcrop at Juliette is a west facing but shows much more age. It is the most residential outcrop that we observed and has a lot of vegetation surrounding the top of the

outcrop. Although there is a lot of vegetation the shale had the steepest gradient showing that erosion has taken a decent toll on this outcrop. The vegetation's root structures have also penetrated the surface of the outcrop contributing to the break-up of shale and limestone. Given this there is a decent amount of undercutting from the top layer of limestone with the combined rooting structures and shale and soil erosion from underneath. It also appears that the shale has a more fine loamy clay composition that seemed to retain a lot of moisture. The west facing outcrops in the rest of the observations did not show as much evident moisture retention as

Juliette did. This is most likely due to the fact that it is heavily shaded with less sunlight. As seen from the picture the erosion that has taken place could be somewhat scaled by the amount of limestone and shale along the roadside. Compared to Scenic Drive there is a drastic difference in the amount of sediment and limestone at the base

of Juliette. There is also a large rill that runs along the roadside that is filled with sediment from the outcrop suspectedly. Juliette has a relatively decent amount of erosion from years of weathering and will continue to erode as the

smaller shale and soil particles are washed away and the limestone is thus broken off by gravity.

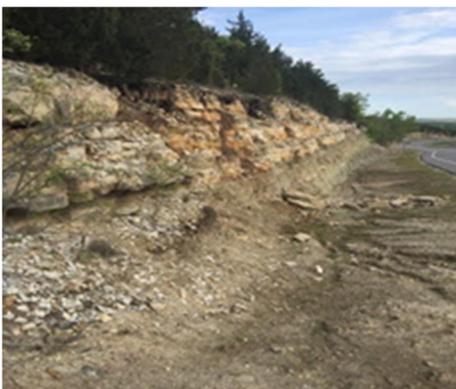
Scenic Drive Road Cut

When observing this West facing outcrop it is evident that it is the youngest and most structurally intact outcrop that has been observed in the duration of this project. Some background on this outcrop is that around half of the exposed surface is limestone with more shale and soil composing the bottom half.

This could potentially lead to large chunks of limestone being undercut in the future as seen in some older outcrops. But due to its age it has not had enough time to weather to a point where enough shale and soil has been lost to see any significant loss of limestone. Naturally with all the other factors discussed above there is minimal rill erosion or sheet erosion evident to the naked eye or deposited on the roadside. This outcrop also has a steep gradient or slope compared to all the others which is also a factor of being next to a recently

constructed road. On top of the outcrop there is a large amount of vegetation that seems to help with retaining moisture and keeping some of the effects of water from eroding the outcrop. The topsoil is eroding from the edge of the limestone which could have an ecological impact on soil erosion and the vegetation on top of the outcrop in the future. Overall due to the age of this outcrop it would take a lengthy period of observations to get a gauge on the annual erosion as a function of time. Compared to the outcrops in this study, Scenic Drive shows that the structural integrity of this outcrop is still good and shows minimal indications of erosion.

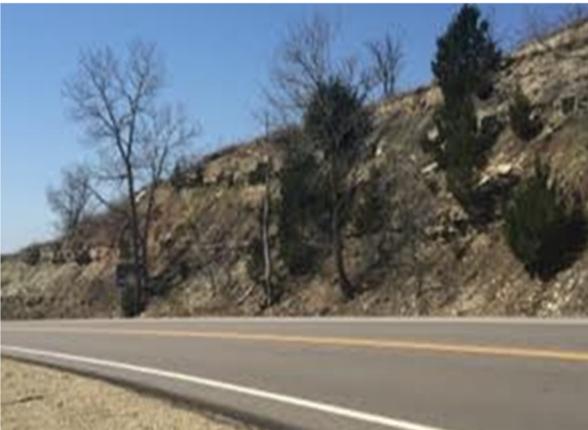
Tuttle Creek Outcrop: East Facing

The outcrops at Tuttle Creek were the largest outcrops that we observed and appear to have a large amount of erosion in places and less in others. Part of this has to do with some variances in the rock composition along the whole side of the outcrops.

There was some vegetation along the outcrop but not enough to make a difference in erosion or a large effect from the rooting structures. From the pictures some of the outcrop has more limestone erosion from having more erodible soil and shale below the limestone layers. At the base on this side, there was a decent amount of limestone and shale deposits at the base and rills on both sides of the road. Compared to the west facing slope, there was more moisture observed on the face of this side. This could be a correlation to how moisture affects each side of the outcrops, which would thus be in relation to the aspect and weathering. From general observations it is hard to tell which side has truly eroded more per unit area, but given the average gradient amongst the other outcrops and the

slope length and open face to weathering that this outcrop may be the most severely eroded out of the list of outcrops observed.

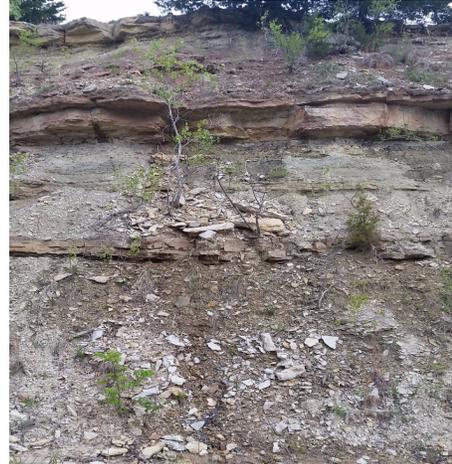
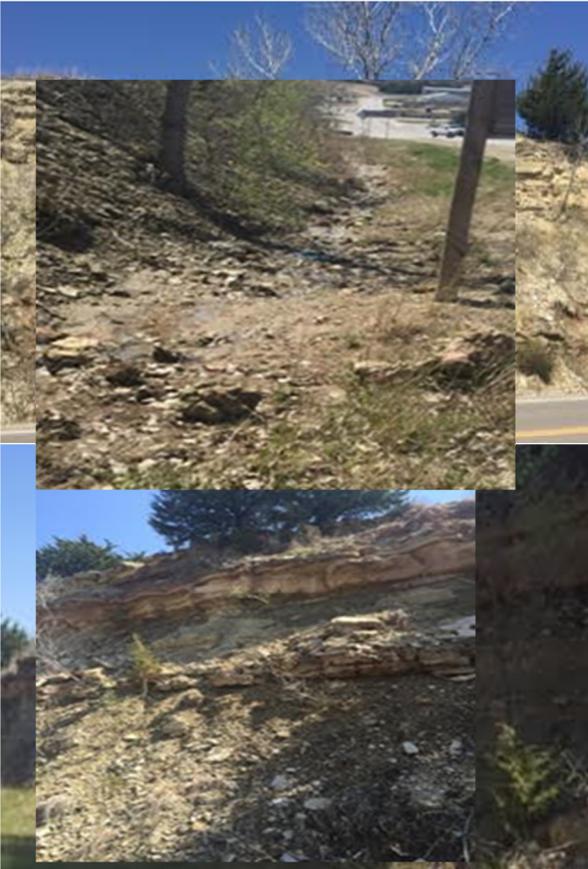
Tuttle Creek Outcrop: West Facing

There were a lot of similarities between the east side and this side. There was a good amount of variation

length. There was also some variation in the undercutting of limestone from smaller sediment erosion depending on the slight variations of layers along the outcrop. There was also a good amount of water at the base of this outcrop that created a rill that carried sediment downhill. From this outcrop it was deducted that the gradient could change over time depending on the layers of limestone and shale because of the different erosion rates from larger

sections of more erodible material such as shale or soil particles. So from this outcrop, some of the differences seen in gradient and erosion rates depend upon the inherent layers exposed in outcrops.

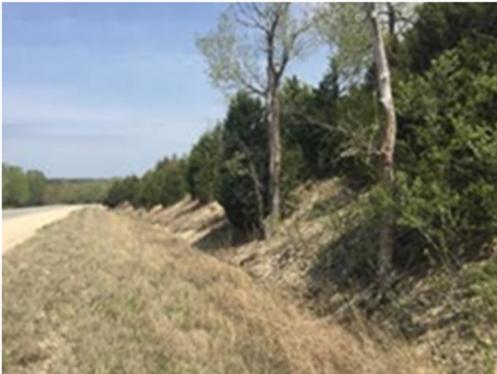
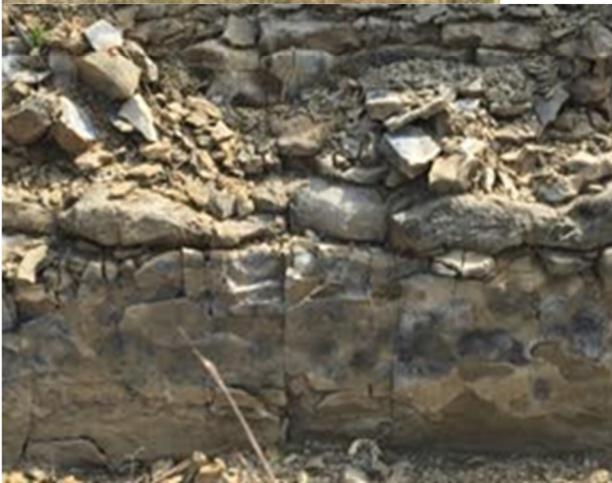
Seth Childs Outcrop: East Facing

Both of these outcrops have the most gentle gradient and are the shortest outcrops that

were observed during this study. Both sides had the most amount of vegetation actually on the outcrop since it had a more gentle gradient. As you can see there is a moderate amount of limestone undercutting and fracturing amongst the limestone. Another interesting factor is that the

outcrop has two different levels or steps that are based on top of limestone. One conclusion that is made from this difference in structure is that the gentle gradient erodes the outcrop in a different manner than compared to a higher gradient outcrop such as Scenic Drive.

Compared to the west facing side this side had less limestone and sediment at the base of the

outcrop. The rill erosion at the base of the outcrop was also less evident and there was less retained moisture around the outcrop compared to the west facing side. Overall both sides seemed to be similar but based on the observations the east facing outcrop had less erosion than the west facing slope.

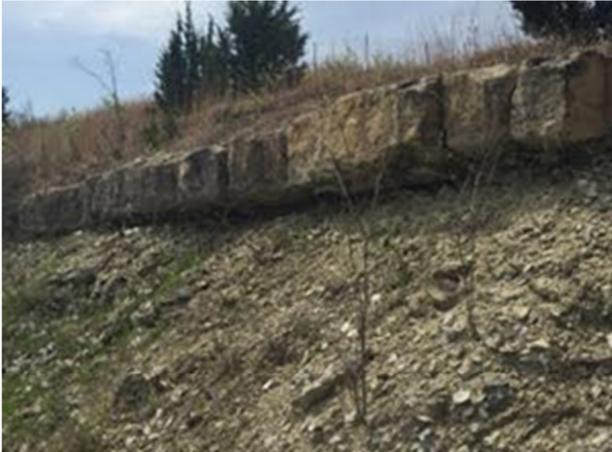
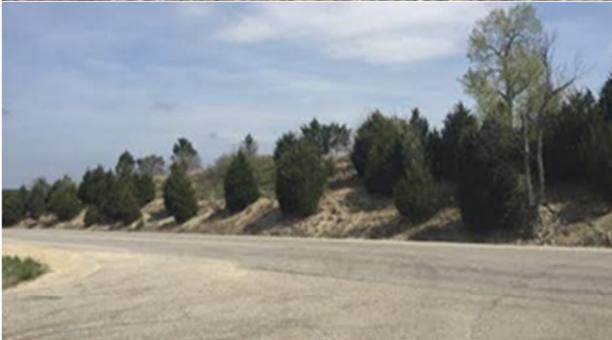
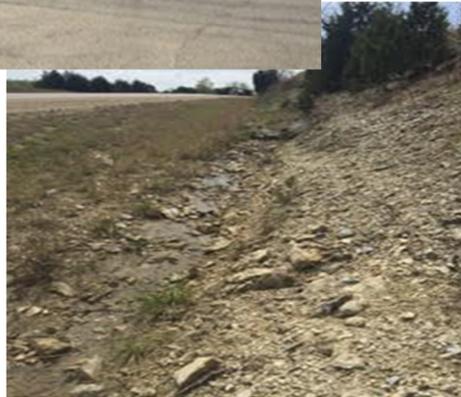
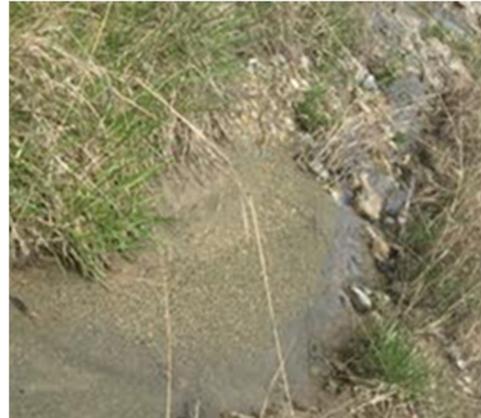
Seth Childs Outcrop: West Facing

The west facing outcrop at the Seth Childs was similar in structure and vegetation make-up but had some notable differences from the east facing slope that could lead to a proposal of more erosion taking place. As you can see moisture was one of the notable differences compared to the other side. This outcrop also had more limestone at the base as well as sediment deposited

at the base in the rill which was full of water. From the observations, both outcrops had a decent amount of eroded sediment but that this side had indications of more deposits and maybe slightly

less vegetation. At this point It is not evident if it is the aspect or the relation of the aspect to the weather and moisture patterns that erode them at possibly slightly different scales.
