Identification of Sediment Sources in the Tributaries of Marion County Park & Lake to Develop Future
Erosion Management Plan

Chuck Balkenbusch, Tessa Zee, Lucas Linder
Kansas State University

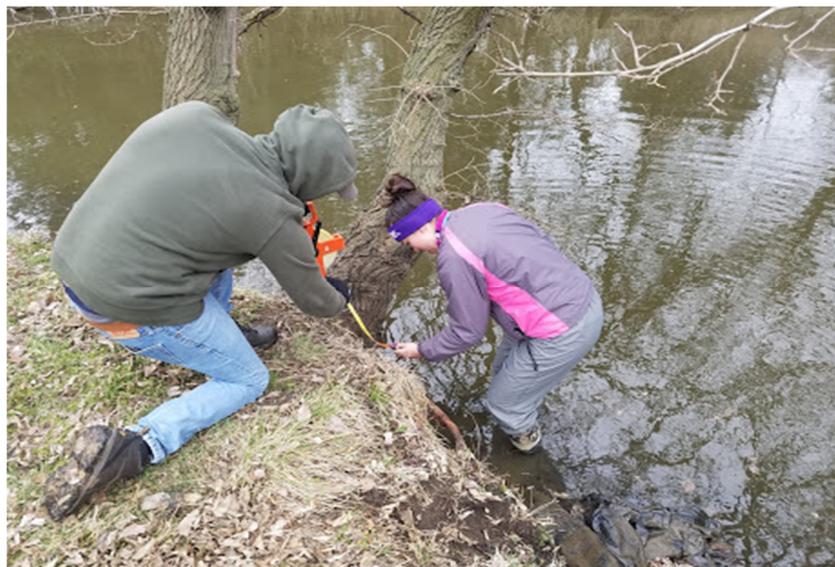
Image 2: Sampling soil sample N7-S at Northern Stream Site B.

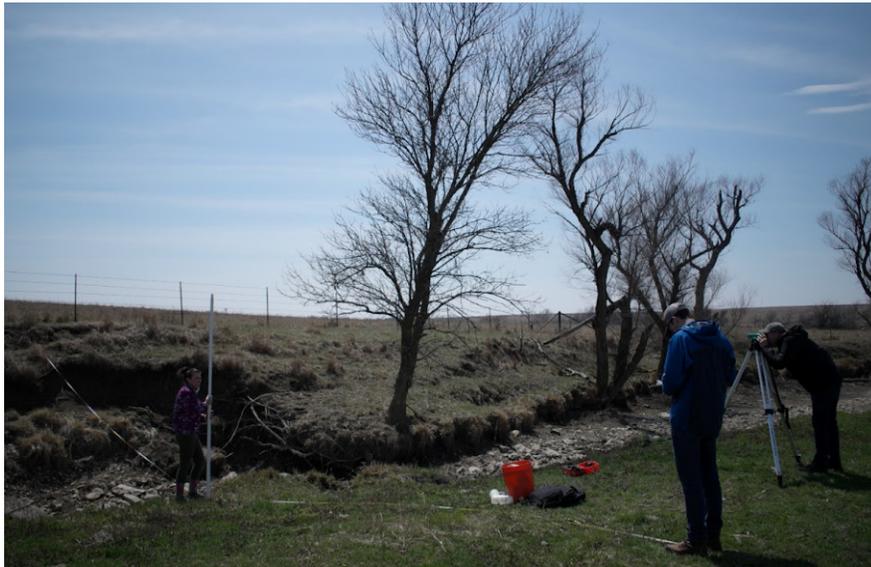
Image 3: Taking stream profile measurements using a level sight and leveling staff.

Stream cross section measurements were taken from three locations on the Northern Stream Site A where soil samples N1-S, N2-S, N3-S, N4-S, and N5-S were taken. These measurements were used to gather baseline data for comparison with future measurements. Also, these measurements are an indication of how the stream cuts through the landscape as it gets closer to the lake. Measurements were taken using a leveled sight on a tripod and a levelling staff. Once the sight is set up, a tape measure is laid across the stream profile in question. The leveling staff is placed at zero on the tape measure, and a height measurement is obtained by using the sight. The levelling staff is then placed along the measuring tapes at points where there is an elevation change and a measurement is taken through the sight.

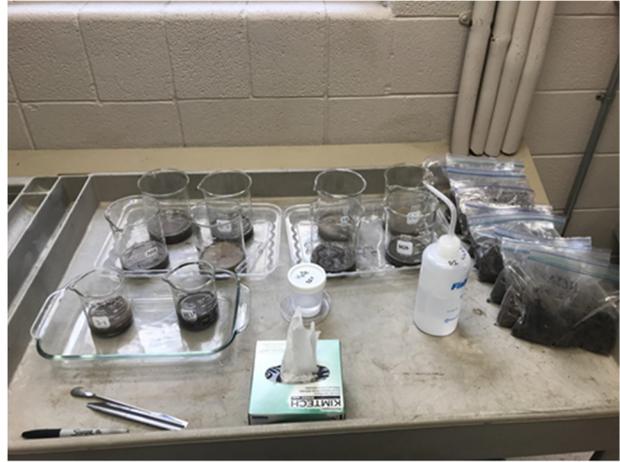
Image 4 & 5: Mastersizer 3000 (left) and samples settling before decanting (right).

Particle size measurements of soil samples were done using the Malvern Mastersizer 3000. Samples were bathed in 25% hydrogen peroxide solution, added 3 mL at a time, for several days to remove organic particles. It was determined that enough of the H_2O_2 was added once a physical reaction of the sample stopped. Samples were then bathed in DI water twice, then given ample time between decanting to increase settling time. This process ensured no clay particles were lost. Finally, samples were run using the Malvern Mastersizer 3000 according to procedure.

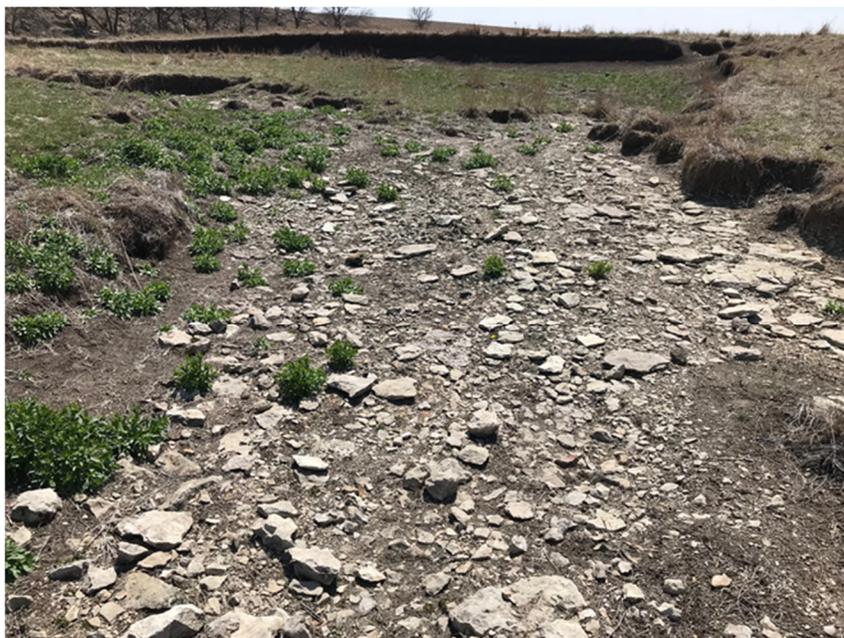
for water to pool up with a very steep cut bank on the right side. The brunt of the energy during a flooding event would erode the steep cut bank as shown in Image 6. This profile was taken looking downstream (Figure 7). The small indentation on the left is where normal stream flow would flow through. The rocks before this bend appeared to be part of the bedrock. These rocks were very tabular and appeared to be exposed and cracked bedrock. Characteristics of stream sediment like grain-size and flux affect the erosion of the channel as sediment moved downstream and said lithology also controls downstream evolution of the channel (Mueller et al., 2016). The size of sediments affects how much stream power is needed for the sediment to play a role in stream erosion. The soil samples taken here were N1-S and N2-S which had Dx50s of 67.7 and 84.8 microns respectively. Both had less than 10% clay.

Image 6: Site A-1. Downstream look at steep cut bank exposed at the horizon of the picture. Tabular blocks at stream bottom.

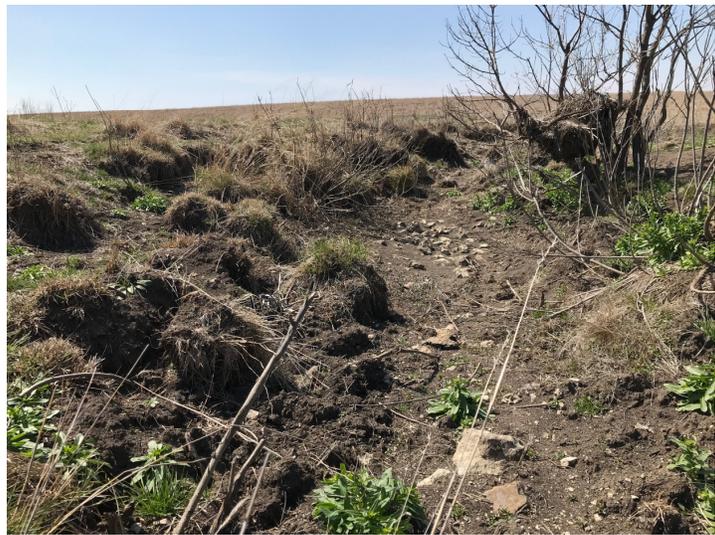
Site A-2 was on a bend as well, the deeper cut channel suggests a stronger erosive potential here compared to A-1 (Image 7). This profile was taken looking downstream (Figure 8). On the inside of the curve, which would be on the right of the profile, woody vegetation was rooted and behind that extended a floodplain. Evidence of slumping can be seen in grass clumps detaching and moving down the slope. Sample N3-S was taken here with a Dx50 of 60.8 microns, also with less than 10% clay.

Image 7: Site A-2. Evidence of bank slumping and detachment in the grass clumps moving downward on the left bank. Flood debris can be seen caught in the tree on the right. Picture taken looking downstream.

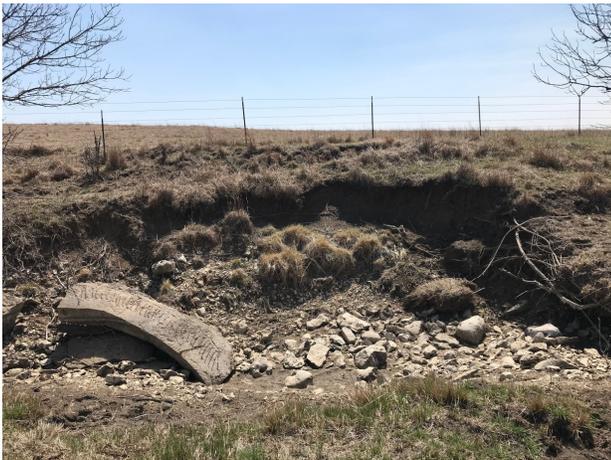
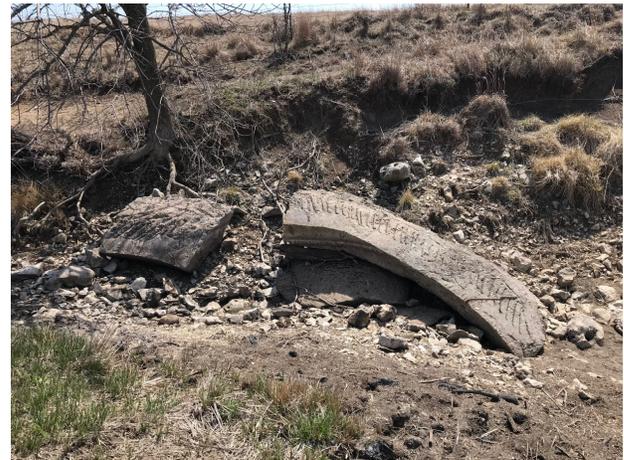
For site A-3, this area was probably the most prone to erosion. The landowners placed two large concrete slabs, one 2.85 meters long to slow the erosion that was occurring. The erosion and the slabs are in the picture below (Image 8 & 9). The profile was taken looking downstream (Figure 9). The erosion on the right of the picture was slowed and stopped to that extent by a tree, whose exposed roots are seen on the right of the photo. This area also shows bank slumping as shown by the grass clumps that are moving down the stream bank. Samples

Image 8 & 9: Slump and undercut erosion with two concrete slabs placed by landowner to slow flow at site A-3. Left slab is 1.2 m and right slab is 2.85 m.
