# Green Infrastructure at KSU: Initial Comparison of Performance between Native Design and Traditional Turf

NRES Capstone – Spring 2016 – Dr. Trisha Moore

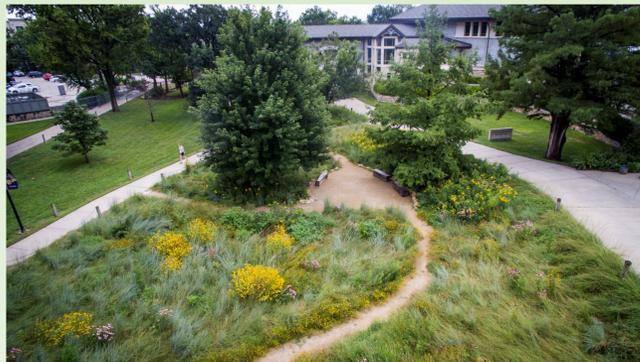
Image 1: The Meadow located on K-State campus (photo by K-State Communications and Marketing)

The Meadow is a recent green infrastructure addition to K-State's Manhattan, Kansas campus. The Meadow was established in 2013 and modeled after the Konza Prairie to feature natural grasses, flowers, and trees. The primary function of this green infrastructure site is education-based instead of having an intended function such as flood or erosion control. However, it does have strong potential to mitigate floods.

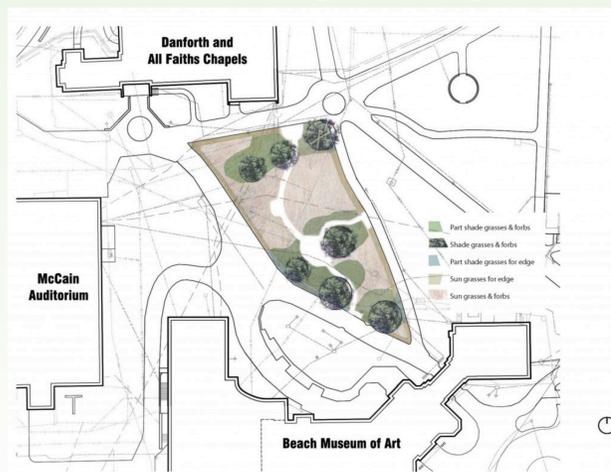
Image 2: The Meadow schematic (image by landscape architect Prof. Katie Kingery-Page)

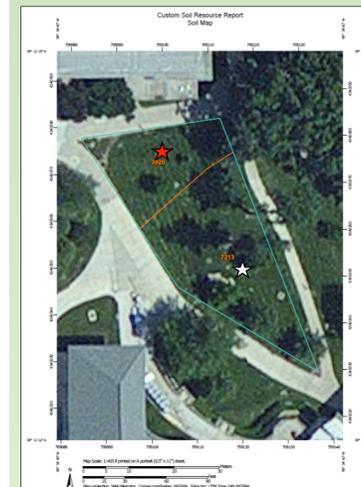
Riley County, Kansas (KS161)			
Map Unit Symbol	Map Unit Name	Acres in AOI	Percent of AOI
3920	Smolan silt loam, 3 to 7 percent slopes	0.1	32.5%
7213	Reading silt loam, moderately wet, very rarely flooded	0.2	67.5%
Totals for Area of Interest		0.3	100%

Image 3: Web Soil Survey Report. Each infiltration site is a separate soil type. The NW Meadow (32.5%) has a Saturated Hydraulic Conductivity (Ksat) of 2.84 [μm/s]. The Beehive (67.5%) has a Ksat of 3.33 [μm/s].
