Campus Creek Re-Envisioned

A Stream Restoration and Design Proposal

Students of LAR 648 Specialization Studio 2014
Professors Jessica Canfield & Tim Keane

Kansas State University
College of Architecture, Planning & Design
Department of Landscape Architecture and Regional & Community Planning

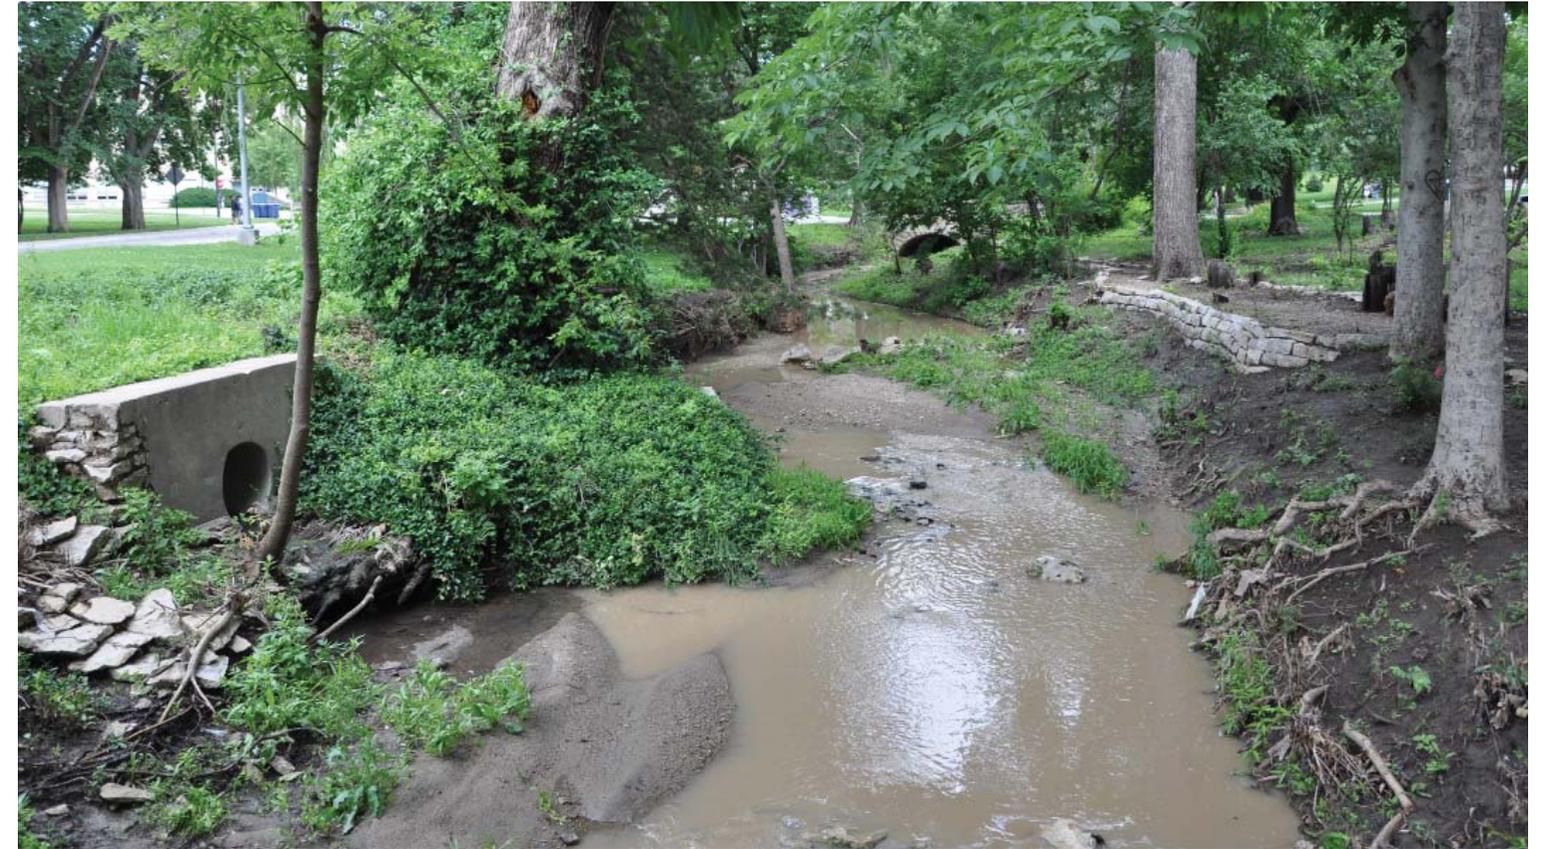
Campus Creek existing condition 2014

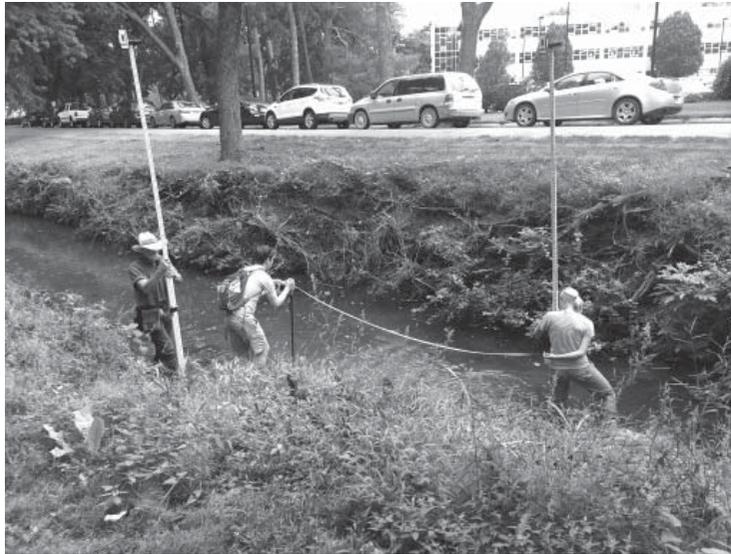
To create a longitudinal profile of the creek, we took to the field for data collection. Landscape architecture and engineering students measured stream bed depth and surface water elevation at key locations. Professor Keane illustrated surveying methods, then students took the reins to complete surveying of the entire stream.

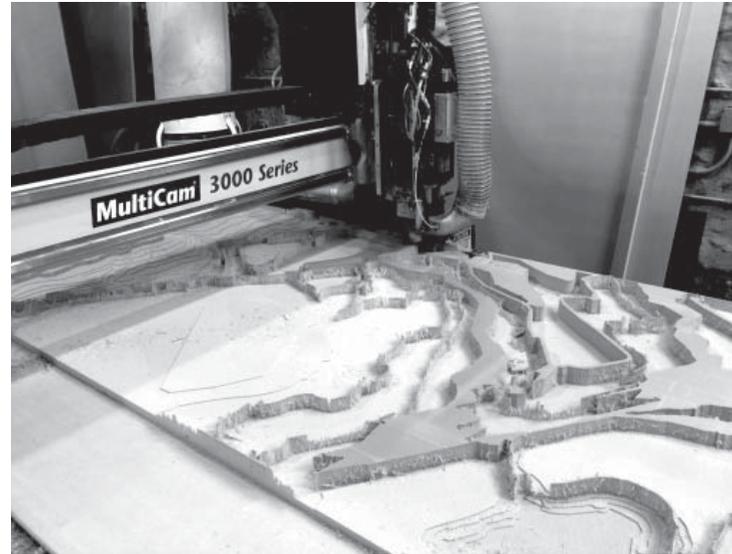
A 1/8" = 20' site model of the Campus Creek corridor was created by landscape architecture student Wesley Moore and Instructional Technologist Richard Thompson using topographic survey data collected in spring 2014 by instructor Ryan McGrath and civil engineering students. The 16' long model was milled on the college's CNC router.

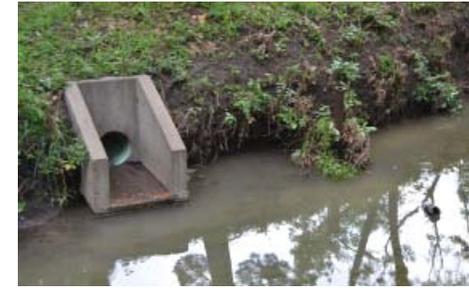
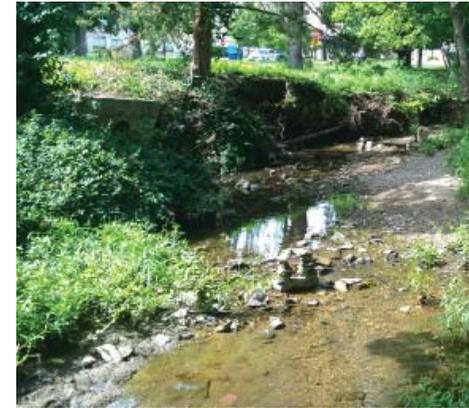
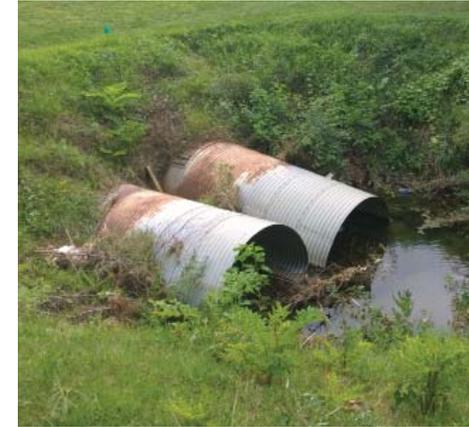
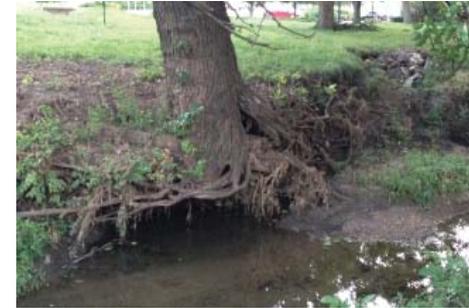
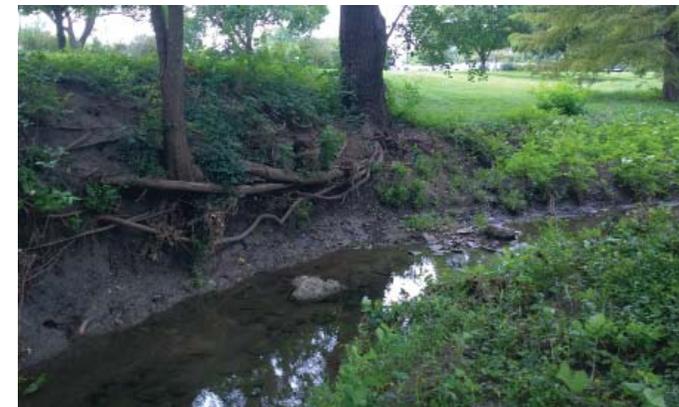
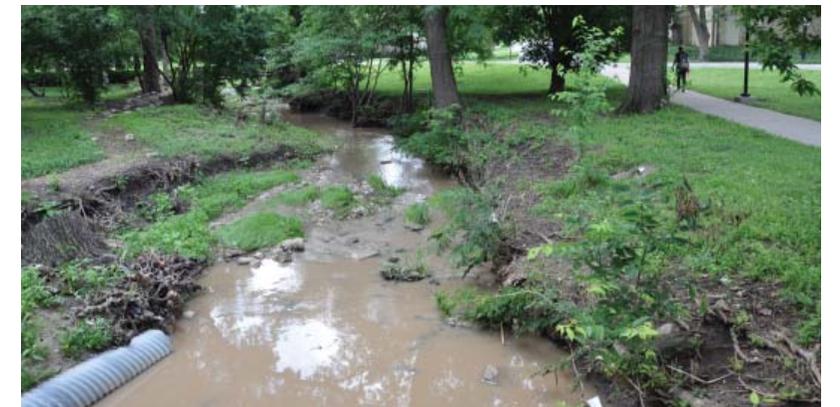
Campus Creek existing conditions 2014

One of the most serious issues with Campus Creek is flooding. During large storm events the creek will jump its banks and over-top roadways, posing a hazard to adjacent buildings, parked cars, and pedestrians. The stream enters main campus through a culvert under Jardine Drive from the west and from the NBAF site at the north. The stream exits campus through an undersized culvert under N. Manhattan Ave. The stormwater is then carried eastward in a pipe buried underneath Bertrand Ave. The pipe outlets into an open air drainage channel at Tuttle Creek Blvd, which eventually outlets into the Kansas River.

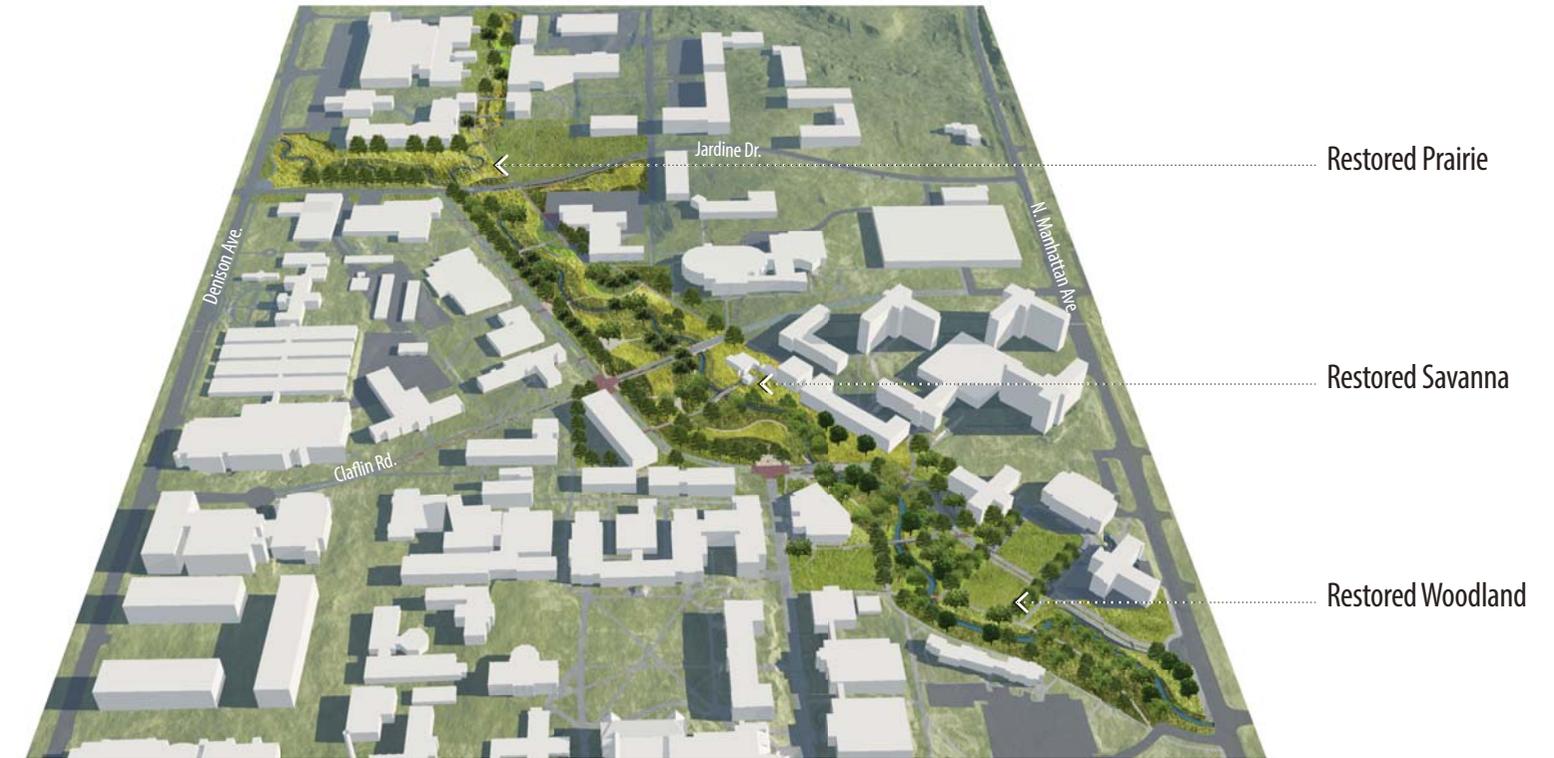
To coincide with the three restored channel types, three planting zones were developed. Each zone reflects a native ecosystem found within the Flint Hills ecoregion. The chosen ecosystem types correspond to restored stream channel conditions and also respond to campus' contextual constraints.

stream will be re-vegetated as a Flint Hills savanna-type landscape. This landscape will be characterized by a dominance of short and tall grass species, with a mixture of native shrubs and trees as well. Trees will be kept to a minimum in this zone, reflecting native ecosystem conditions. The southern most stream reach will be the woodland zone. The woodland will be populated with a dense, shade-tolerant understory composed of grasses, perennials, ground covers, shrubs and small trees. The canopy will consist primarily of medium- to large-sized riparian tree species that create a dense layer of shade.

Planting Design Concept

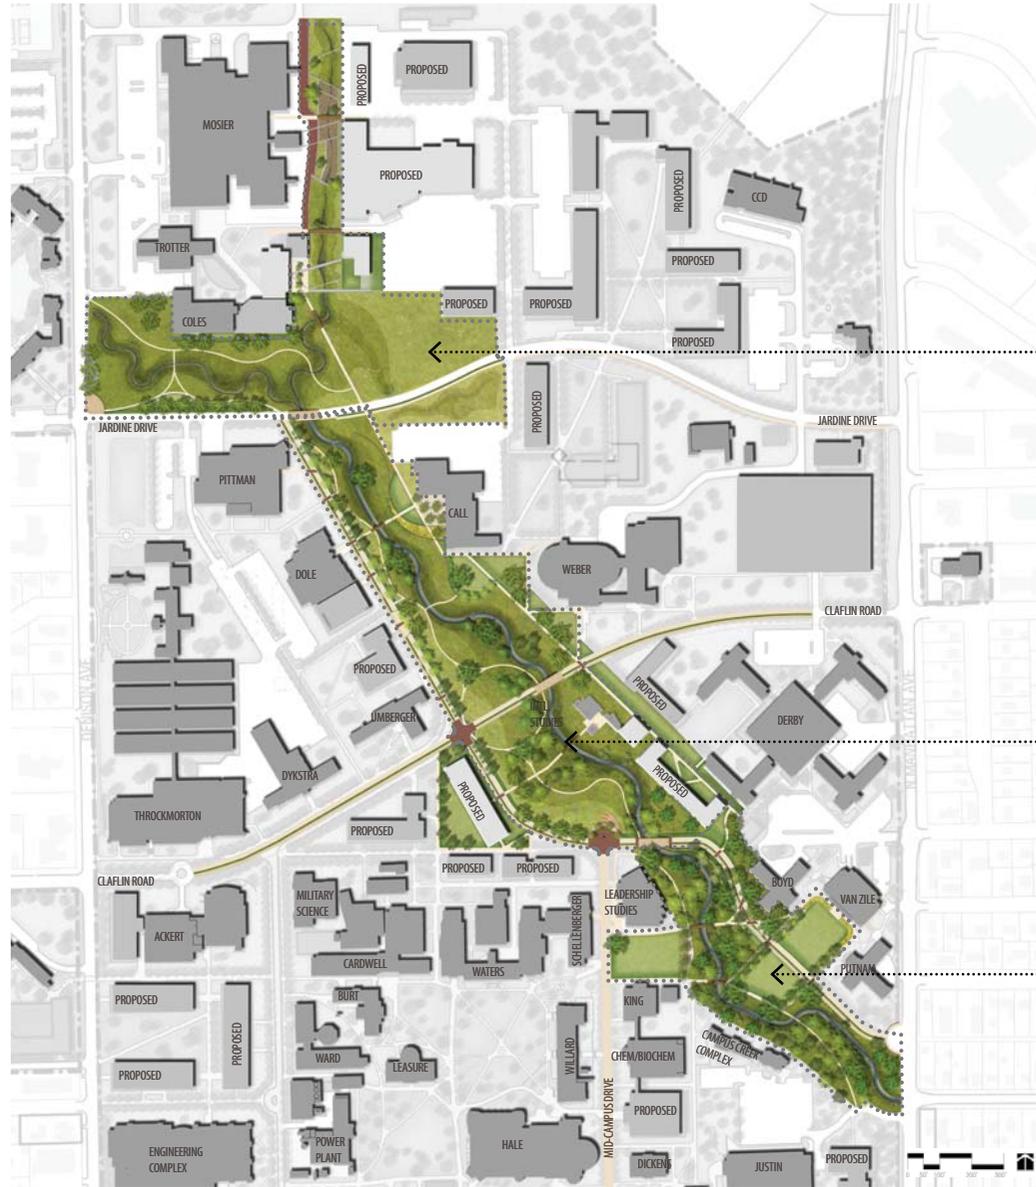
Our design proposal deepens and expands conceptual recommendations proposed for Campus Creek in the Kansas State University 2012 Campus Master Plan Update. In doing so our design focuses on three main issues: increasing flood storage capacity; improving and enhancing the landscape; and, adding new amenities, including seating and trails. Drawing inspiration from the local Flint Hills ecoregion, the re-envisioned master plan proposes a highly designed and engineered multi-functional stormwater conveyance system that looks and functions more like a natural stream. The overall system is divided into three distinct zones: the woodland, the savanna, and the prairie; which collectively will be able to safely convey, and temporary store, flood waters from storms up to 100-yr. events. The re-designed corridor also provides the campus community with new open space areas to recreate, study, gather and enjoy the outdoors. For this multi-functional design proposal to truly be successful, future campus planning efforts need to respect the newly defined flood plain boundary and refrain from adding future structures within the floodplain.

Zone 3: The Prairie
A Living Laboratory
Wet-Meadow Walk

Zone 2: The Savanna
Mid-Campus Crossing
Creek Gallery
Daylighted Stream

Zone 01: The Woodland
The Clearing
The Overlook

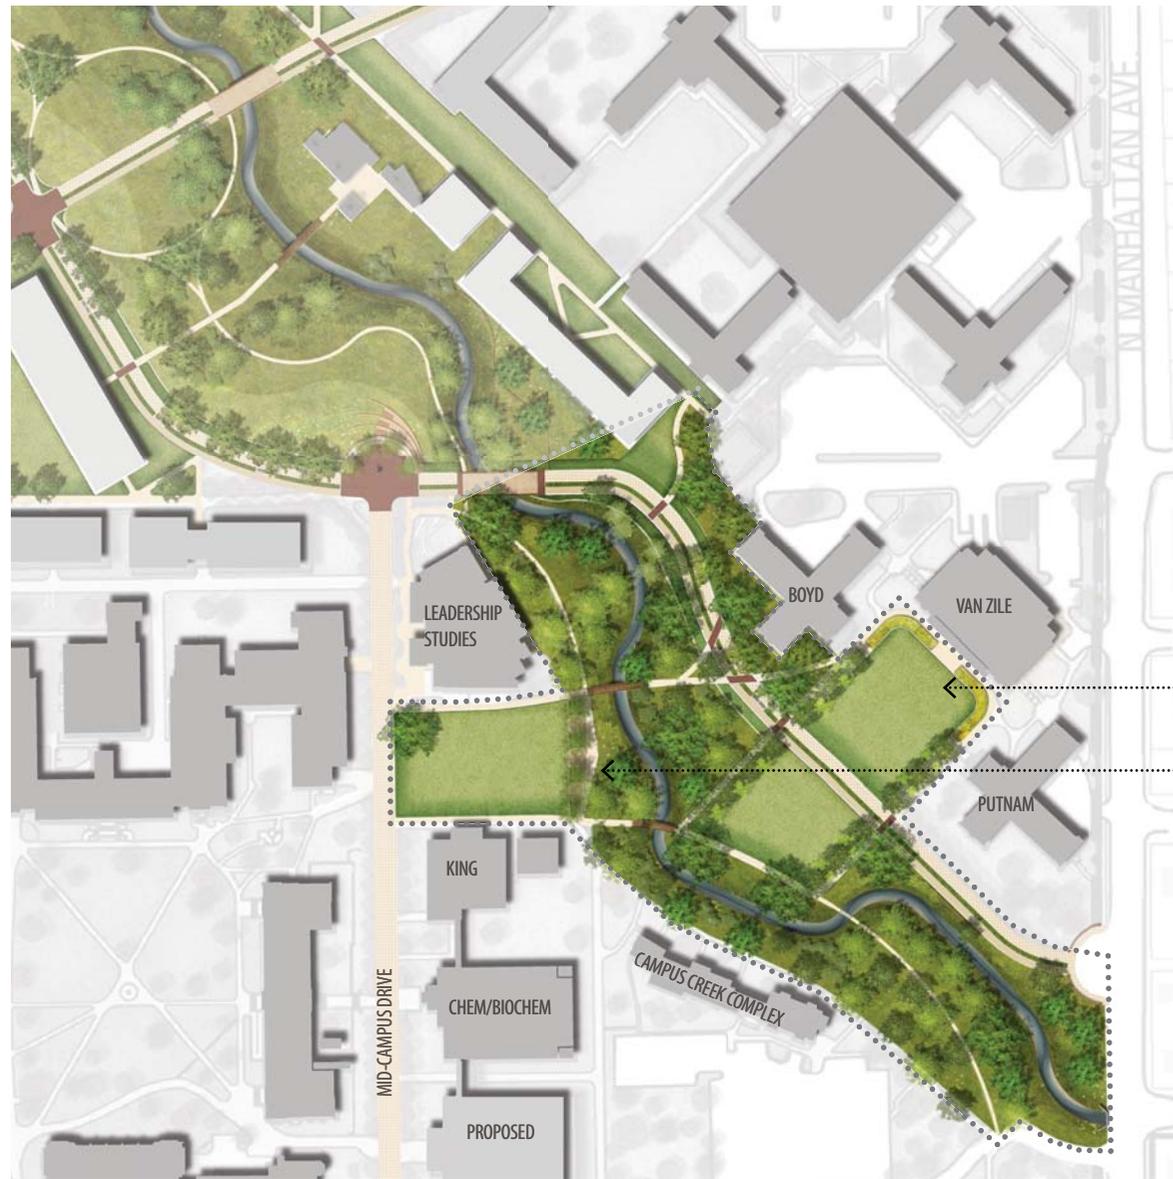
The Clearing

The Overlook

Often found along the edges of large bodies of water and lining stream corridors, woodlands are one of the few places in native Kansas landscapes where a consistent, moderately dense overhead canopy can be found. These ecosystems occur predominantly in riparian areas and offer habitat opportunities for numerous native wildlife species, ranging from macro-invertebrates to large mammals. Within an urbanized setting, woodlands offer a starkly contrasting aesthetic to the built environment. These areas can be utilized to offer spaces for repose and respite within the greater up-tempo urban setting.

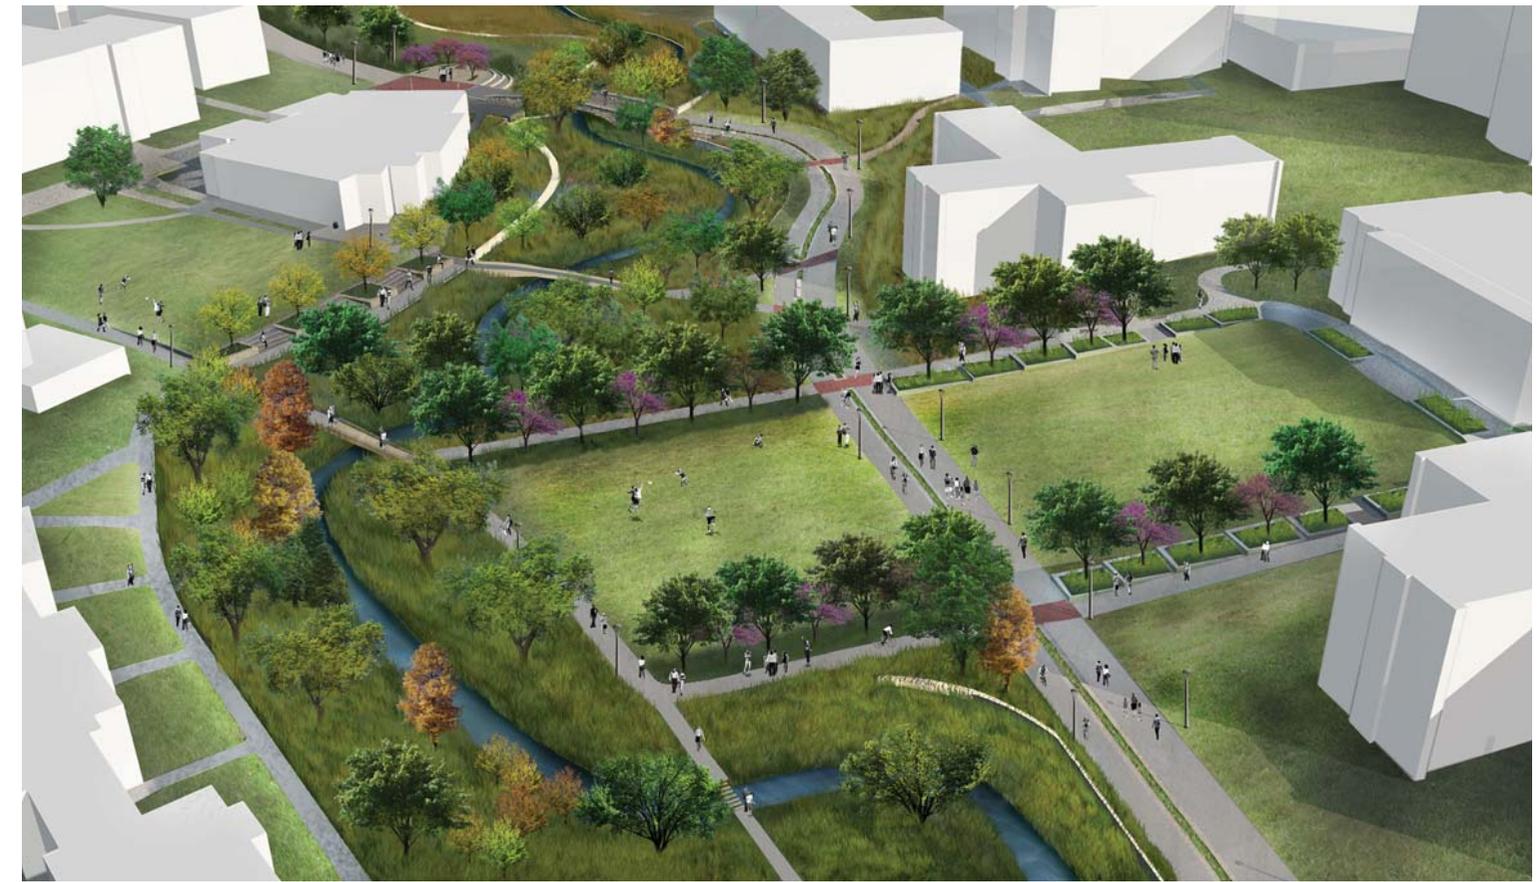
Aerial perspective looking north towards Leadership Studies building

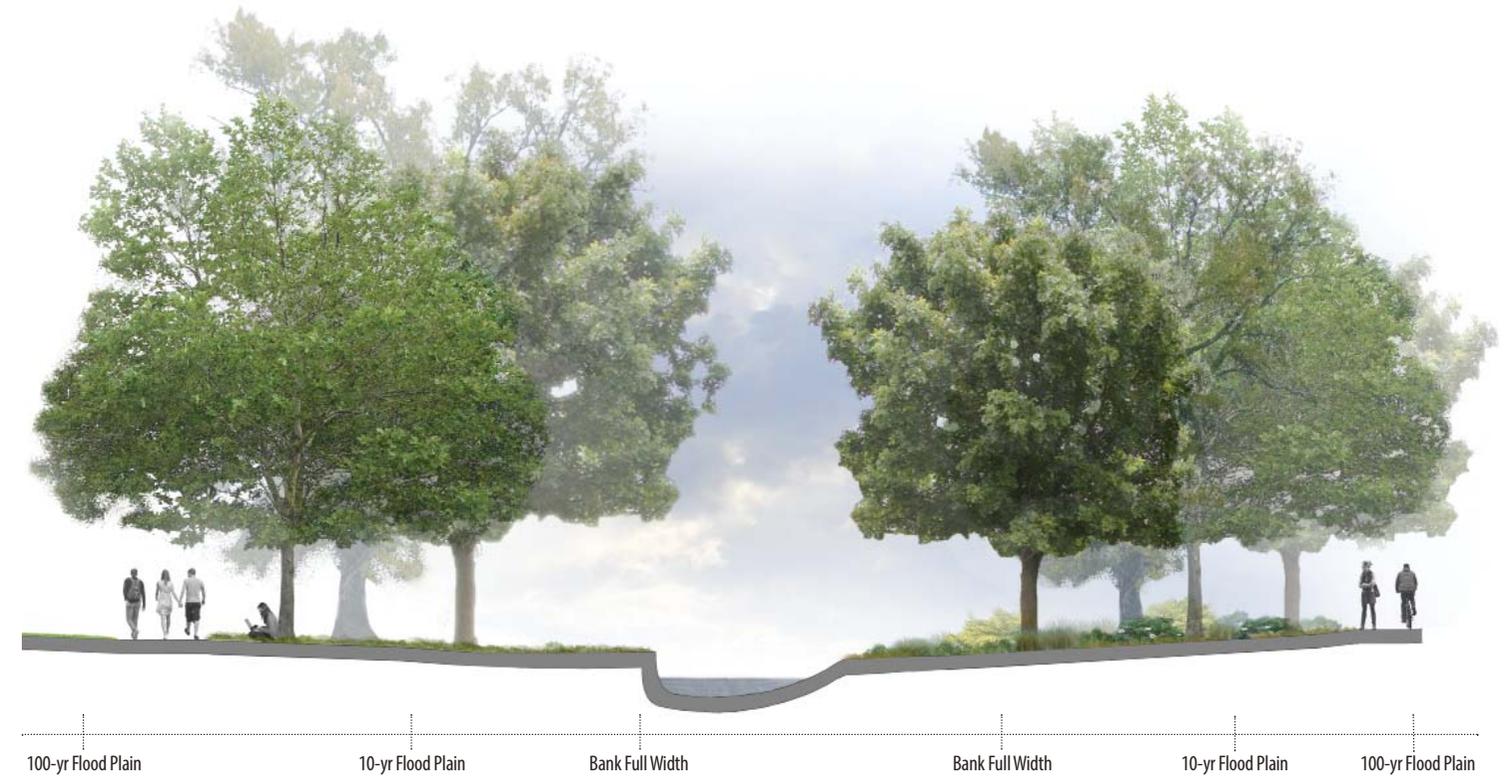
The Clearing is a grand lawn bordered by tall oak trees and native eastern redbuds. It is envisioned as a “backyard” for students living in nearby dormitories and a place for recreational activities, such as frisbee, soccer, and movies on the lawn, to occur.

A new pedestrian promenade replaces the current vehicular road, as recommended by the Kansas State University 2012 Master Plan. The 30 foot-wide promenade has one lane designated for bicycle traffic and another for pedestrians. A vegetated stormwater swale separates cyclists and pedestrians and helps collect and cleanse stormwater runoff from adjacent paved areas.

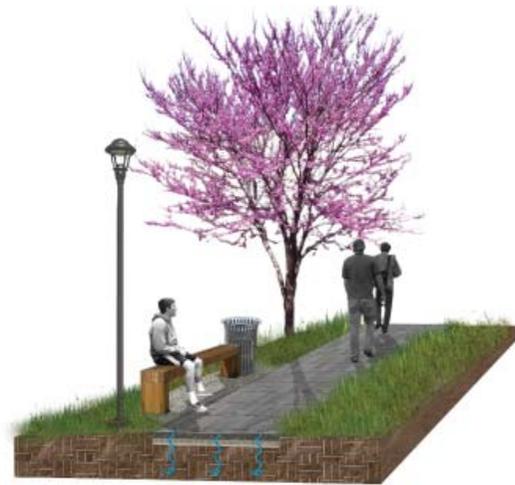
Seating Nooks

New benches and permeable paving trails help increase usability and activity within the Campus Creek Corridor. New lighting helps increase nighttime safety.

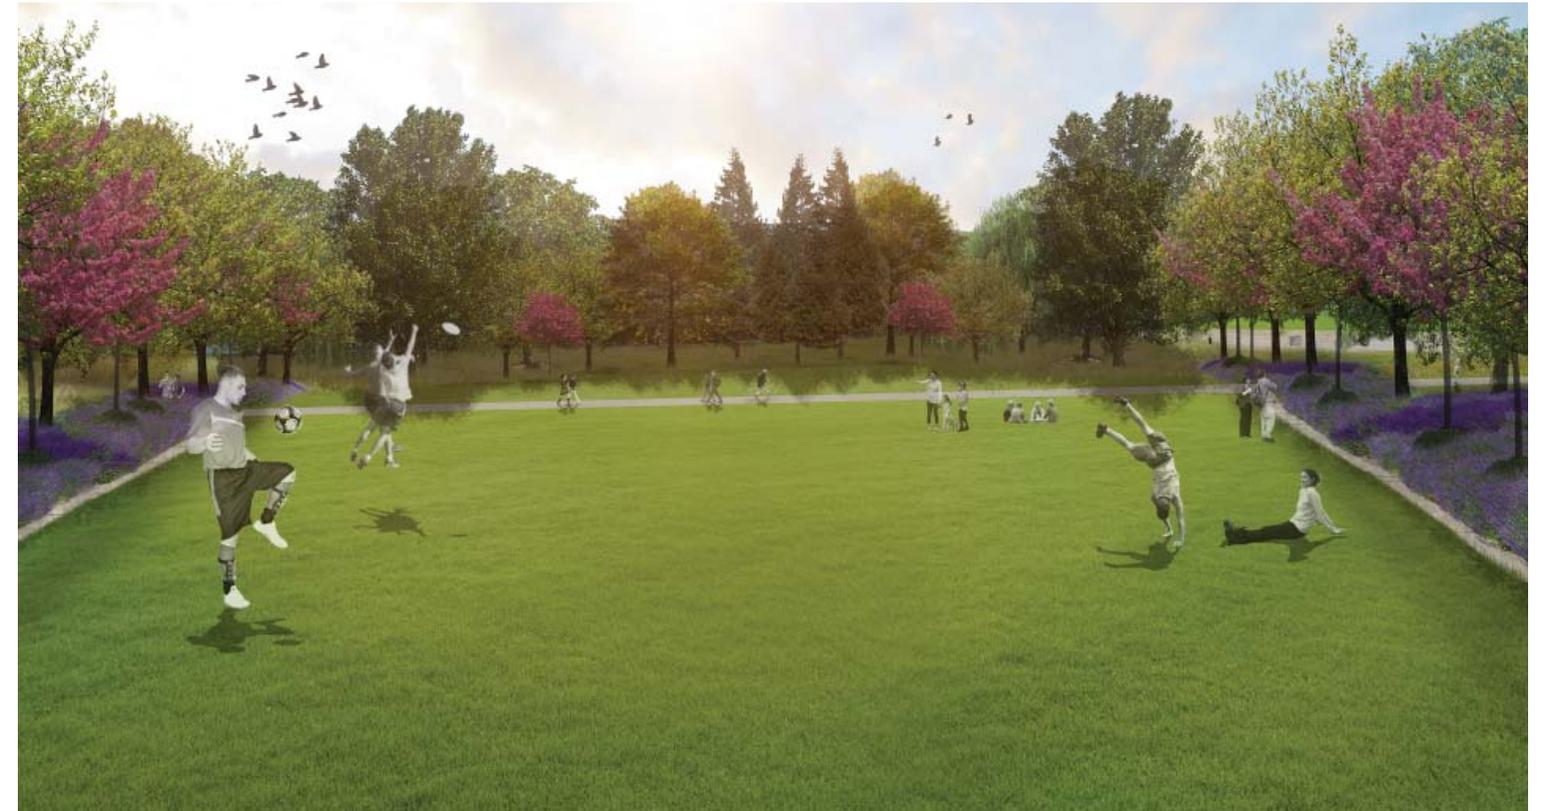
Looking south-west towards Campus Creek

To increase flood protection for the Leadership Studies, the stream channel was moved farther away from the building. The expanded floodplain area offers space for a new boardwalk trail next to the building, and enhanced views from the Leadership Studies' second floor balcony and outdoor amphitheater.

A new bridge located north of Leadership Studies will connect pathways, increase walkability, and offer passersby beautiful views up and down the Creek. The large trees will also provide students places to hang a hammock and relax in the shade.

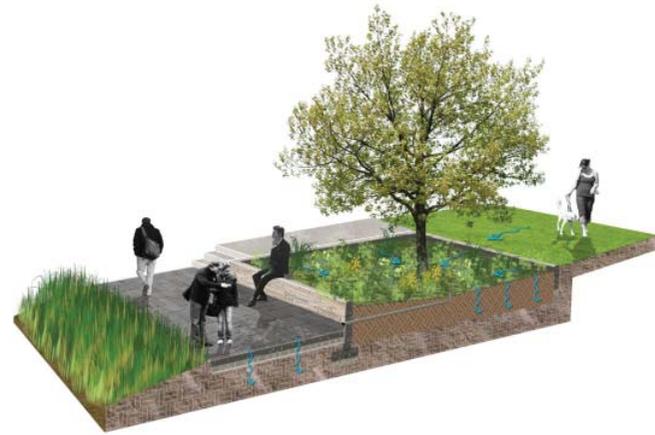
Rain Garden Planters

These features are designed capture stormwater runoff and filter it through native vegetation. After storm events, passersby can watch the stormwater slowly soak into the soil below.

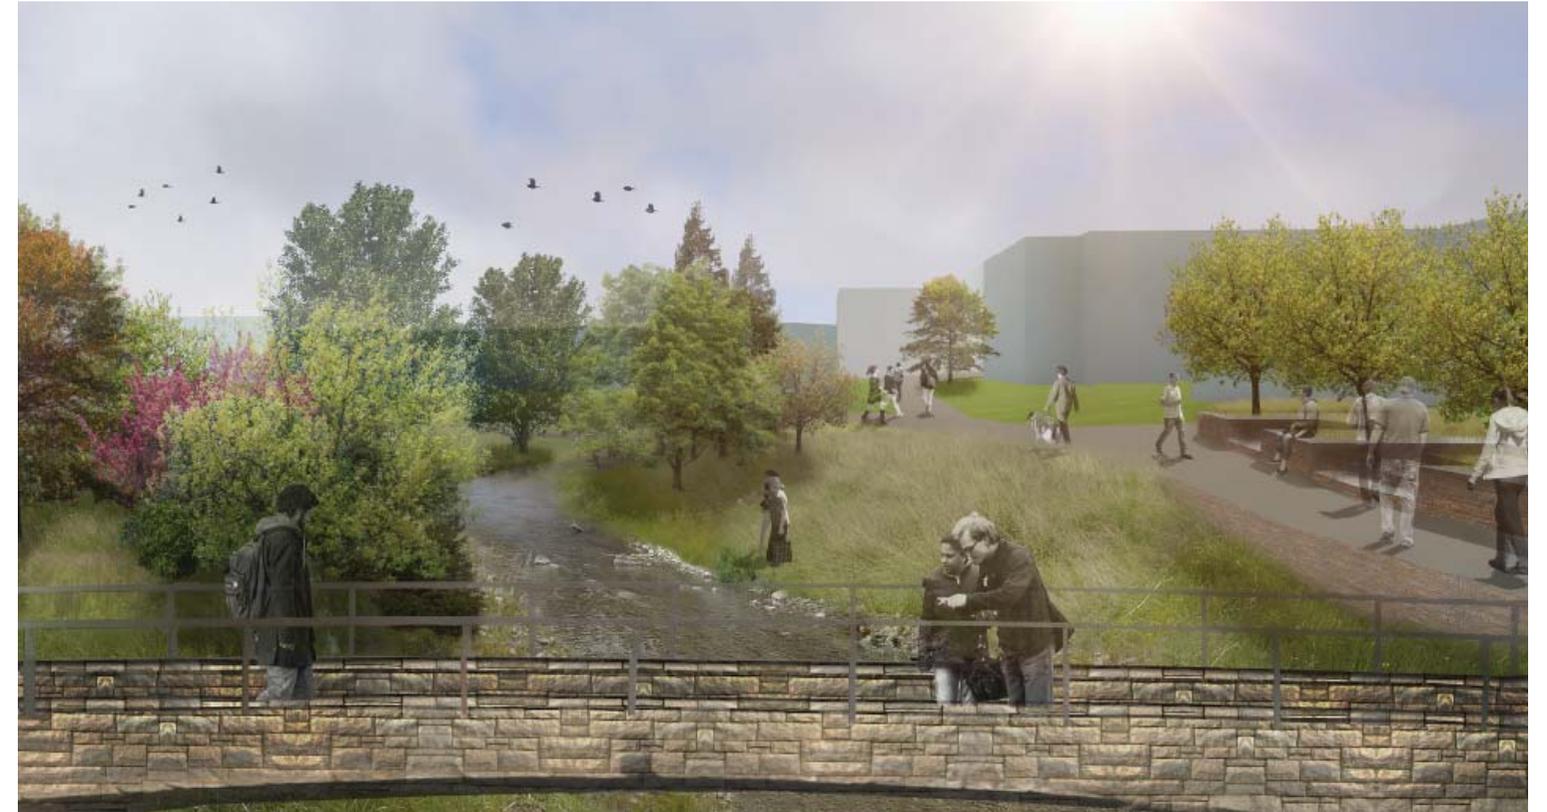
Looking south down Campus Creek, proposed building in background

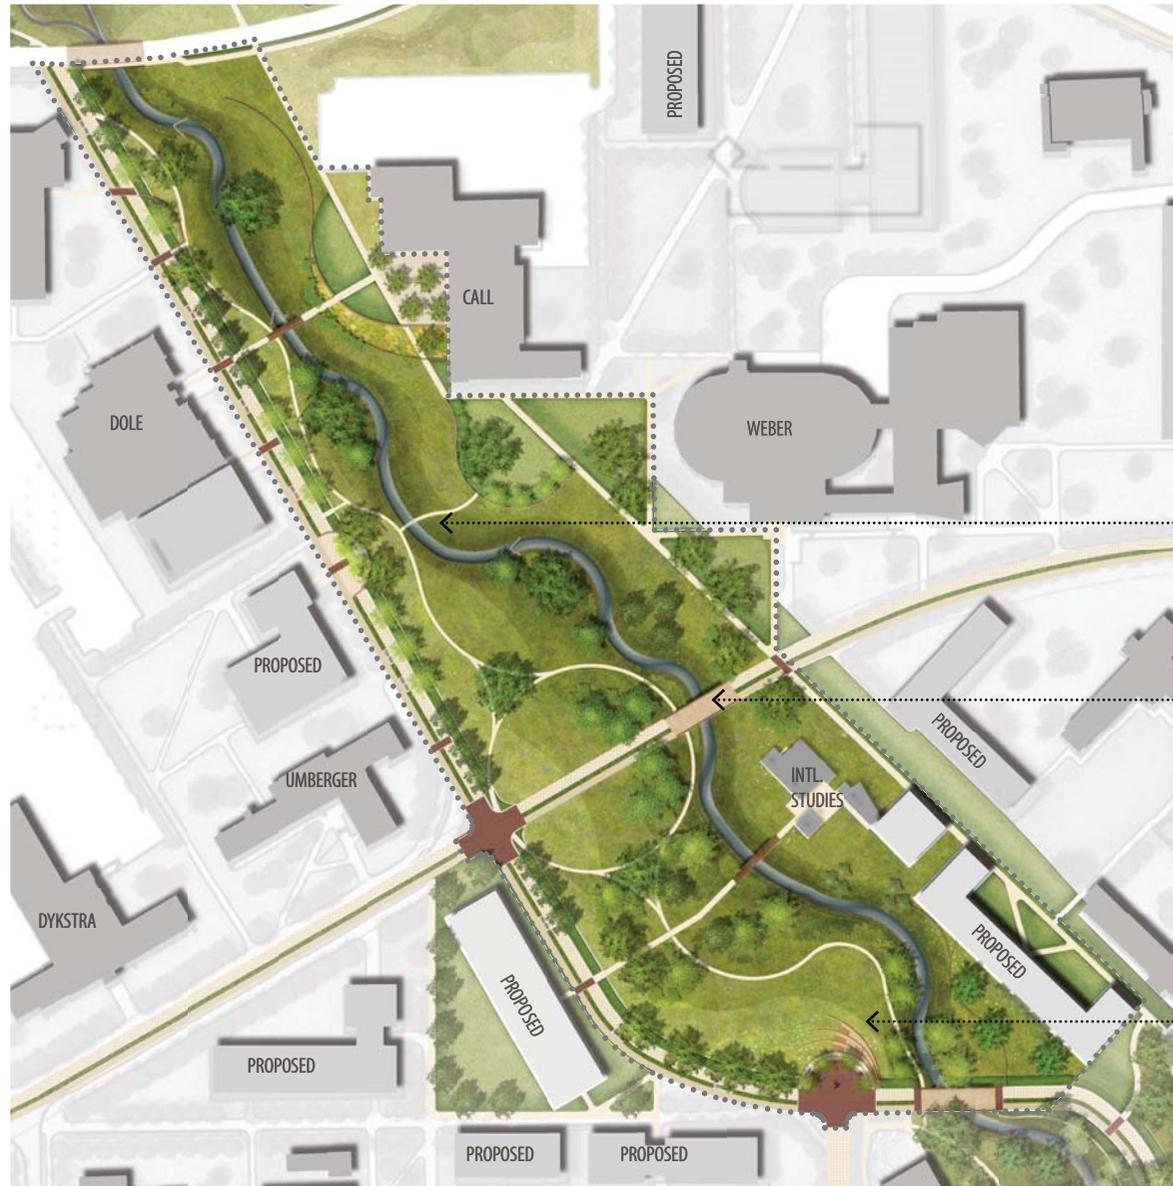
The Daylighted Stream

Mid-Campus Crossing

The Creek Gallery

Grasslands populated with scattered trees and understory growth characterizes the savanna ecosystem. Savannas occur in bottomlands and into upland areas throughout the Flint Hills. These landscapes are the model for most urban parks and many college campuses. Utilizing savannas in urban areas creates an opportunity to increase stormwater infiltration rates, reduce pollutant runoff, and increase carbon sequestration. The plantings in savannas consist primarily of shade-tolerant grasses and forbs and native, riparian shrub and tree species.

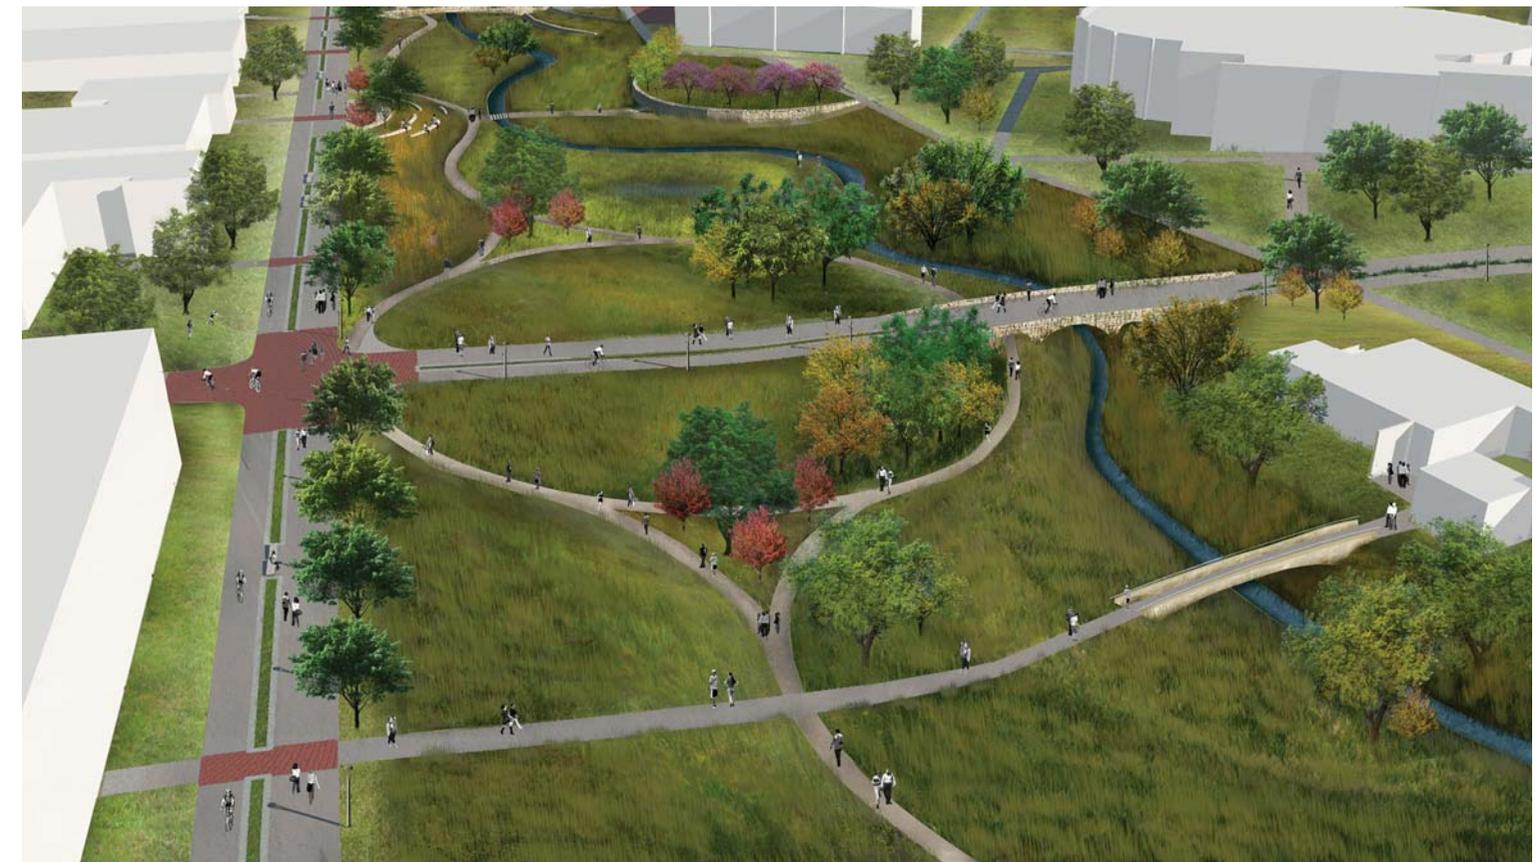
Aerial view looking north towards Mid-Campus Crossing

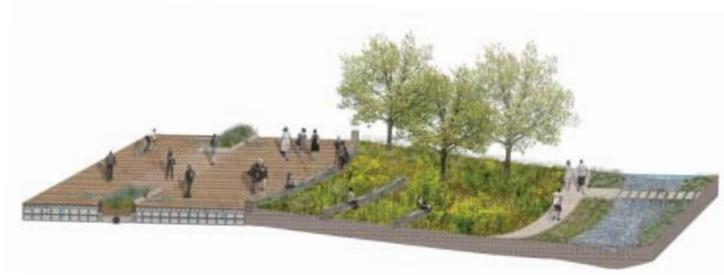
Stepping Stone Crossing

Large stepping stones placed within the creek bed allow pedestrians to cross the stream at low flow.

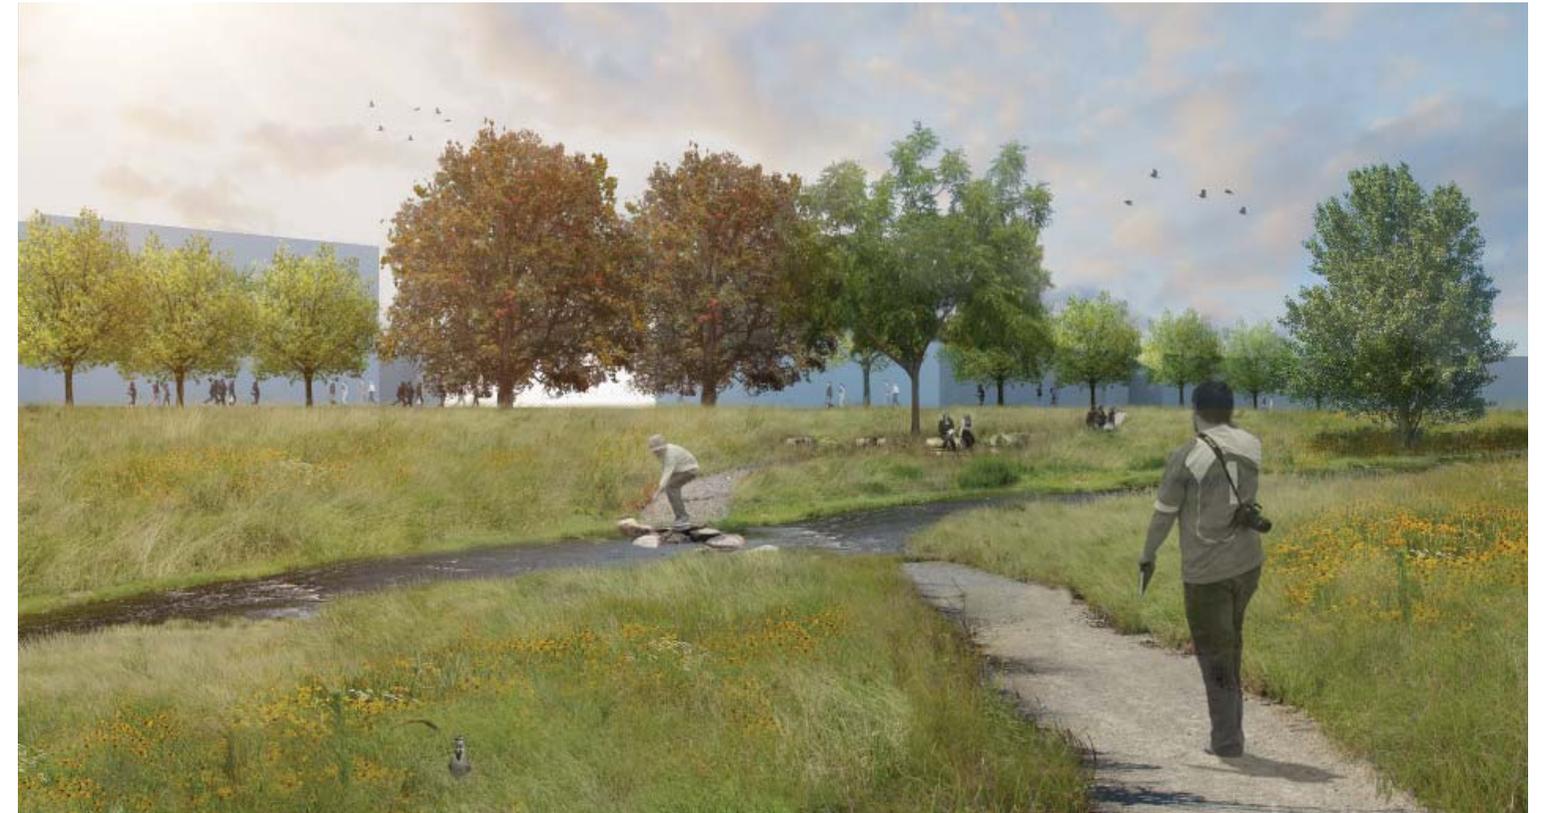
Looking North-East across the daylighted stream, proposed building in background

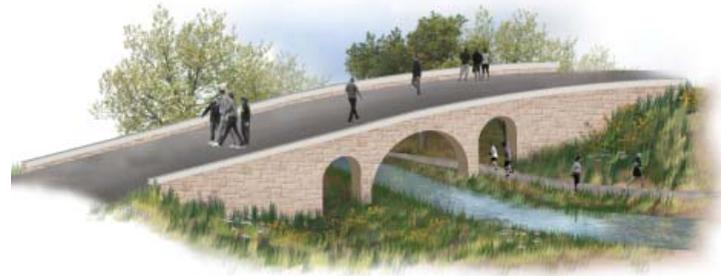
Bridges

The new limestone bridges have been designed to accommodate flood waters during large storm events, and, when at low flow, allow the stream and nature trail to pass underneath side-by-side.

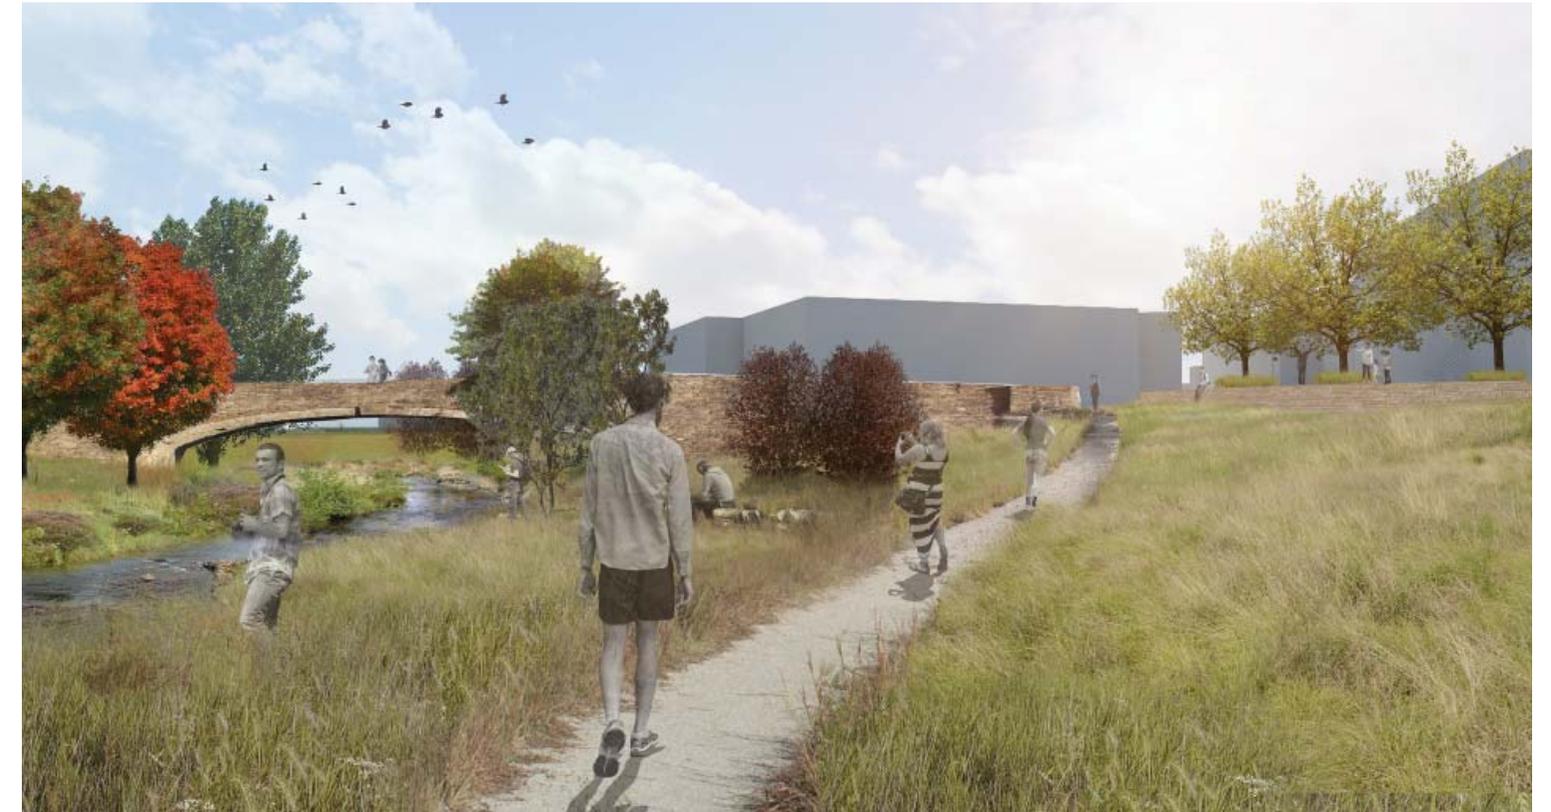
Looking South with Leadership Studies at right, proposed building in background

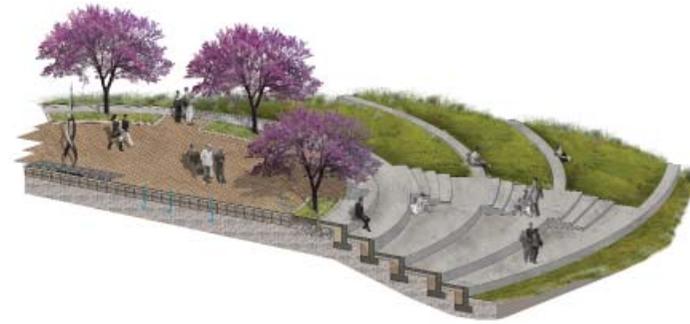
Mid-Campus Plaza

The plaza utilizes permeable paving and structural cells, which allow stormwater to infiltrate directly through the surface and into soil below.

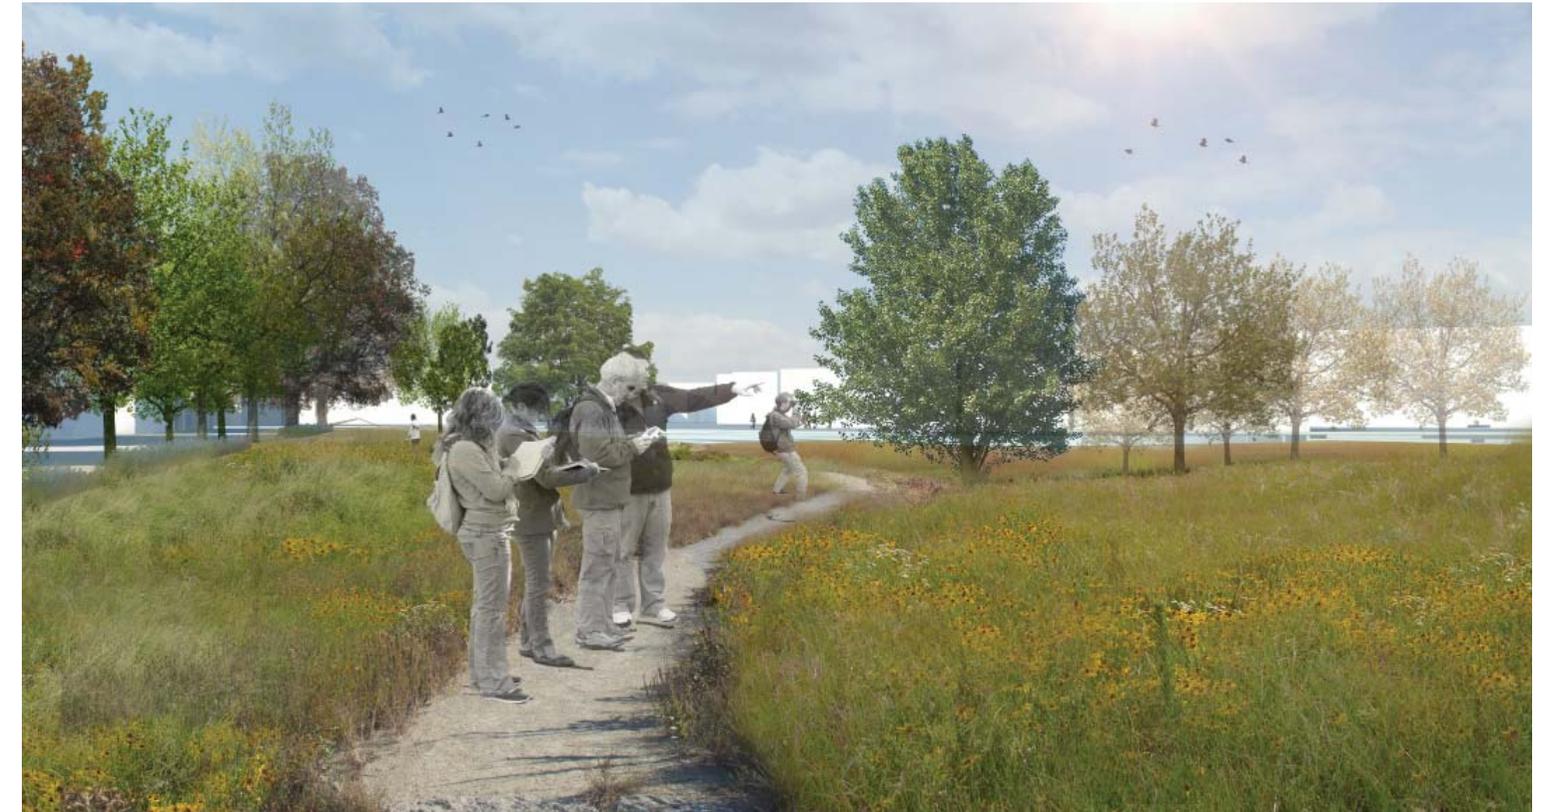
Looking north with new pedestrian promenade at left, stream at right
