Campus Creek Re-Envisioned

A Stream Restoration and Design Proposal

Students of LAR 648 Specialization Studio 2014
Professors Jessica Canfield & Tim Keane

Kansas State University
College of Architecture, Planning & Design
Department of Landscape Architecture and Regional & Community Planning

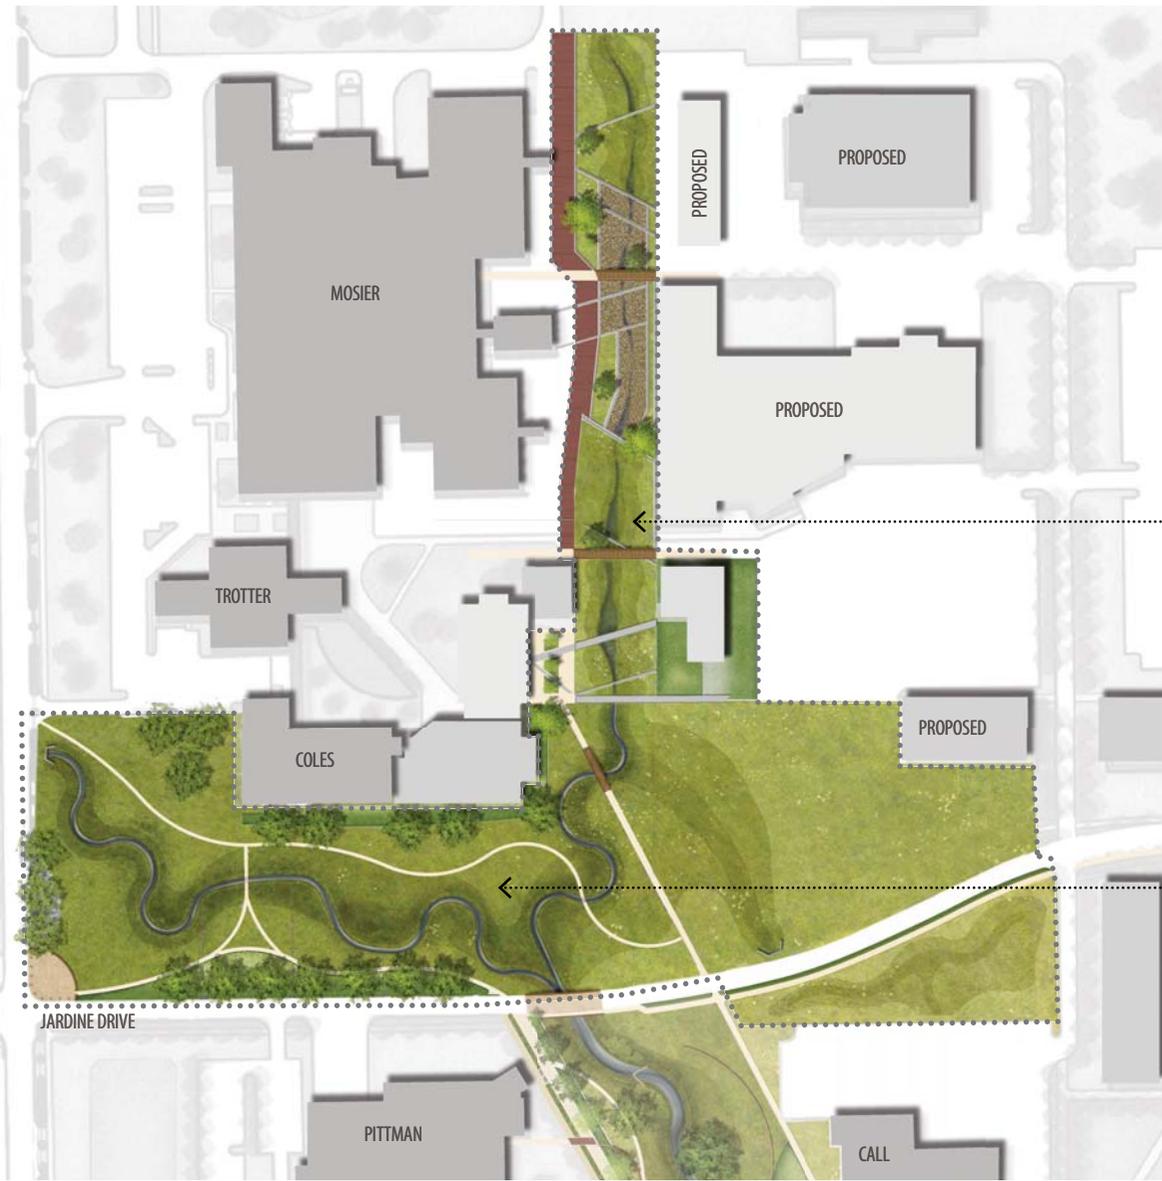
Wet-Meadow Walk

A Living Laboratory

Perhaps the most iconic of any Kansas ecosystem is the prairie. Characterized by a mixture of drought-tolerant tallgrasses and forbs, prairie ecosystems are found in areas with wide fluctuations of moisture, high winds, and wildfires. The plants and animals that inhabit the native prairie are highly adapted to this increasingly rare environment. The Northern portion of the Campus Creek Corridor will be restored to a prairie environment in order to improve hydrology and to pay homage to the native landscape.

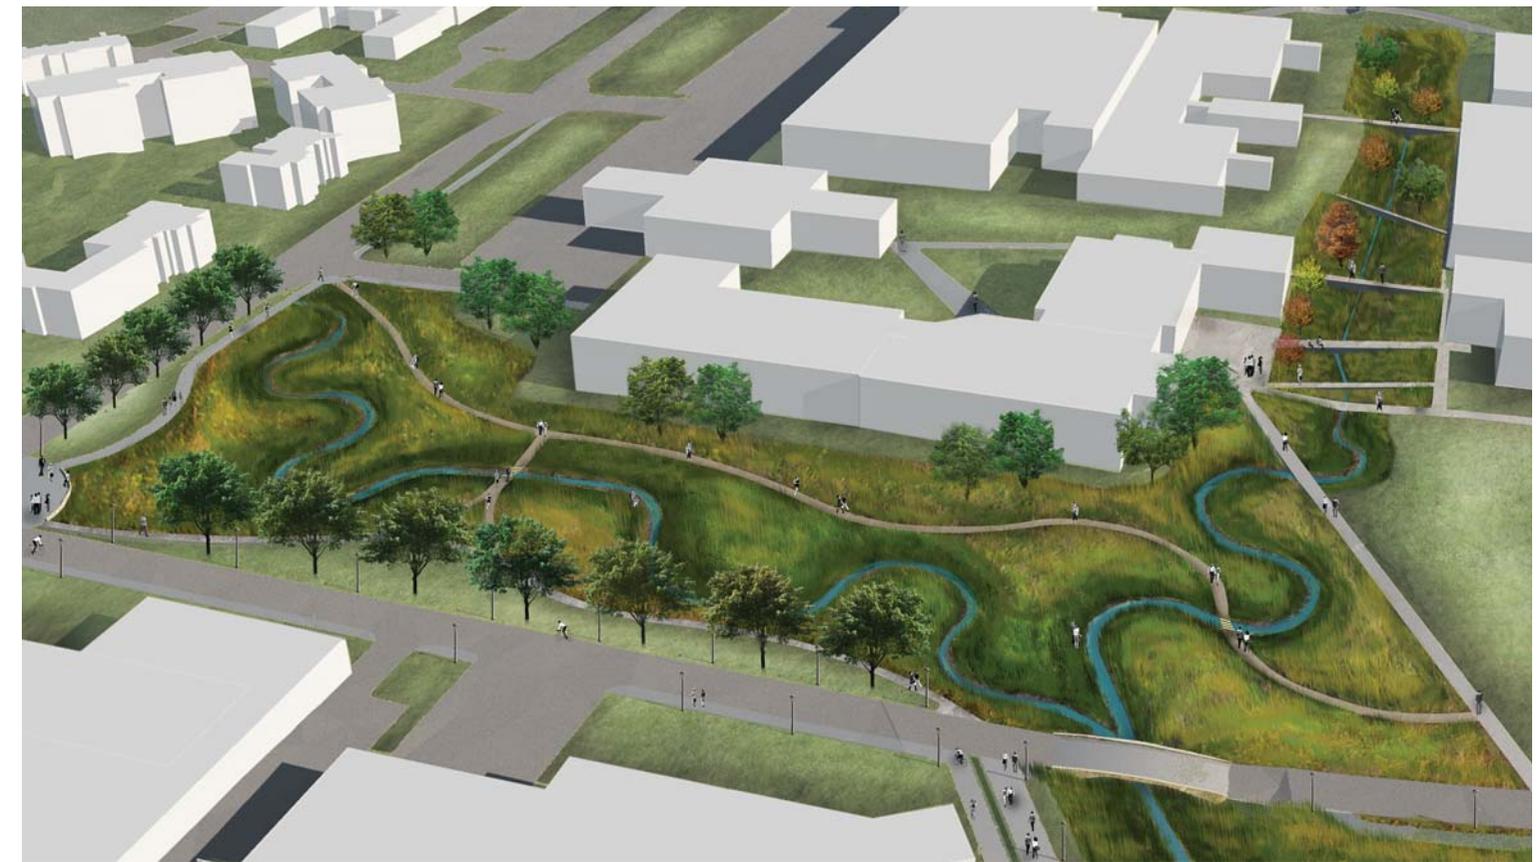
Aerial perspective looking north towards Vet Med Complex

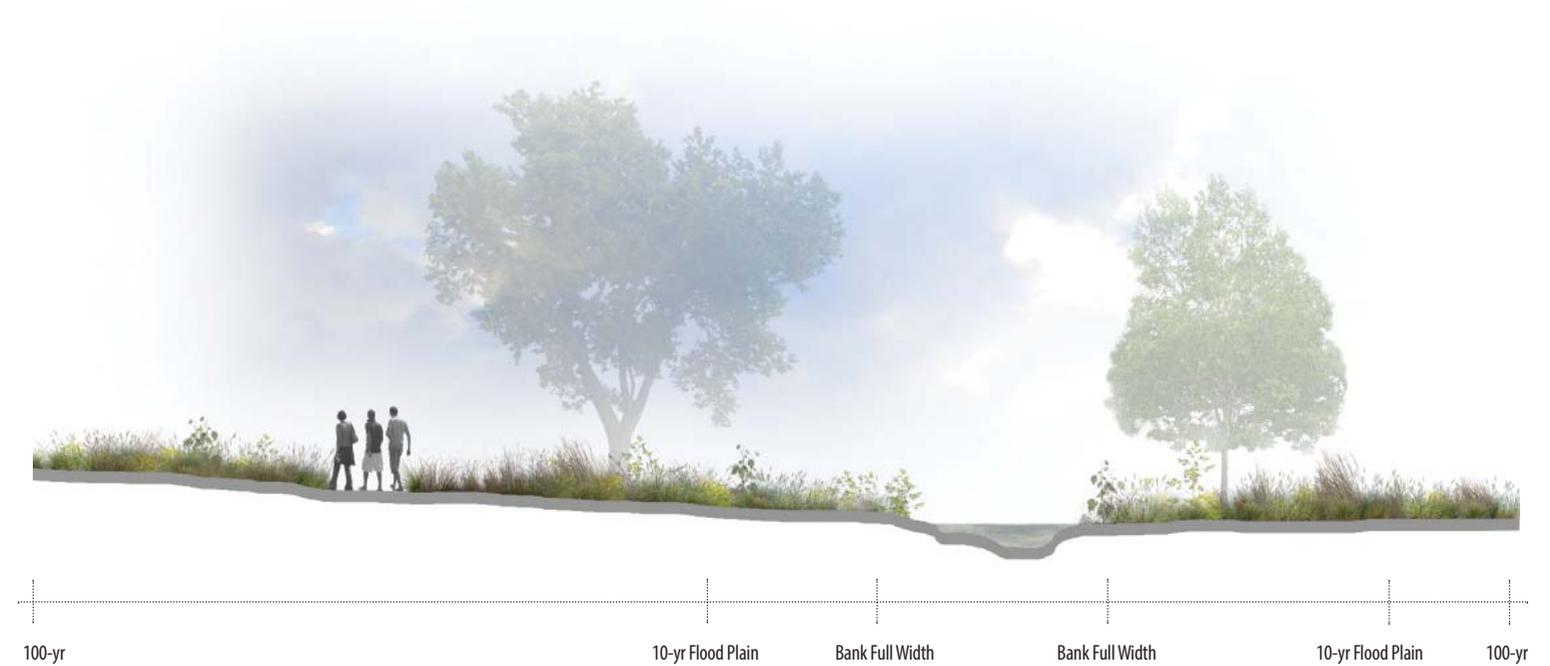
Wet-Meadow Walk

To accommodate facility expansion around the Veterinary Medical Complex, the Kansas State University 2012 Master Plan proposes burying Campus Creek's northern tributary. However, if designed and engineered in accord with natural systems, this stretch of the stream can become a wonderful stormwater asset, rather than a liability. To increase flood storage capacity and help slow velocity, this area will have a "chain" of wet-meadow infiltration gardens, interconnected by check-dams/weirs. The wet-meadows act as green sponges, capturing and soaking-up stormwater. In large storm events the wet-meadow basins will fill and excess runoff will overtop the check-dams and be slowed before flowing downstream.

A series of boardwalks will span across the wet-meadow basins—uniting existing and future buildings. As students walk from building to building, they will pass infiltration gardens planted with native species from the Flint Hills ecoregion. This stretch of Campus Creek provides excellent opportunities for on-site research, where water quality and infiltration can be continually monitored.

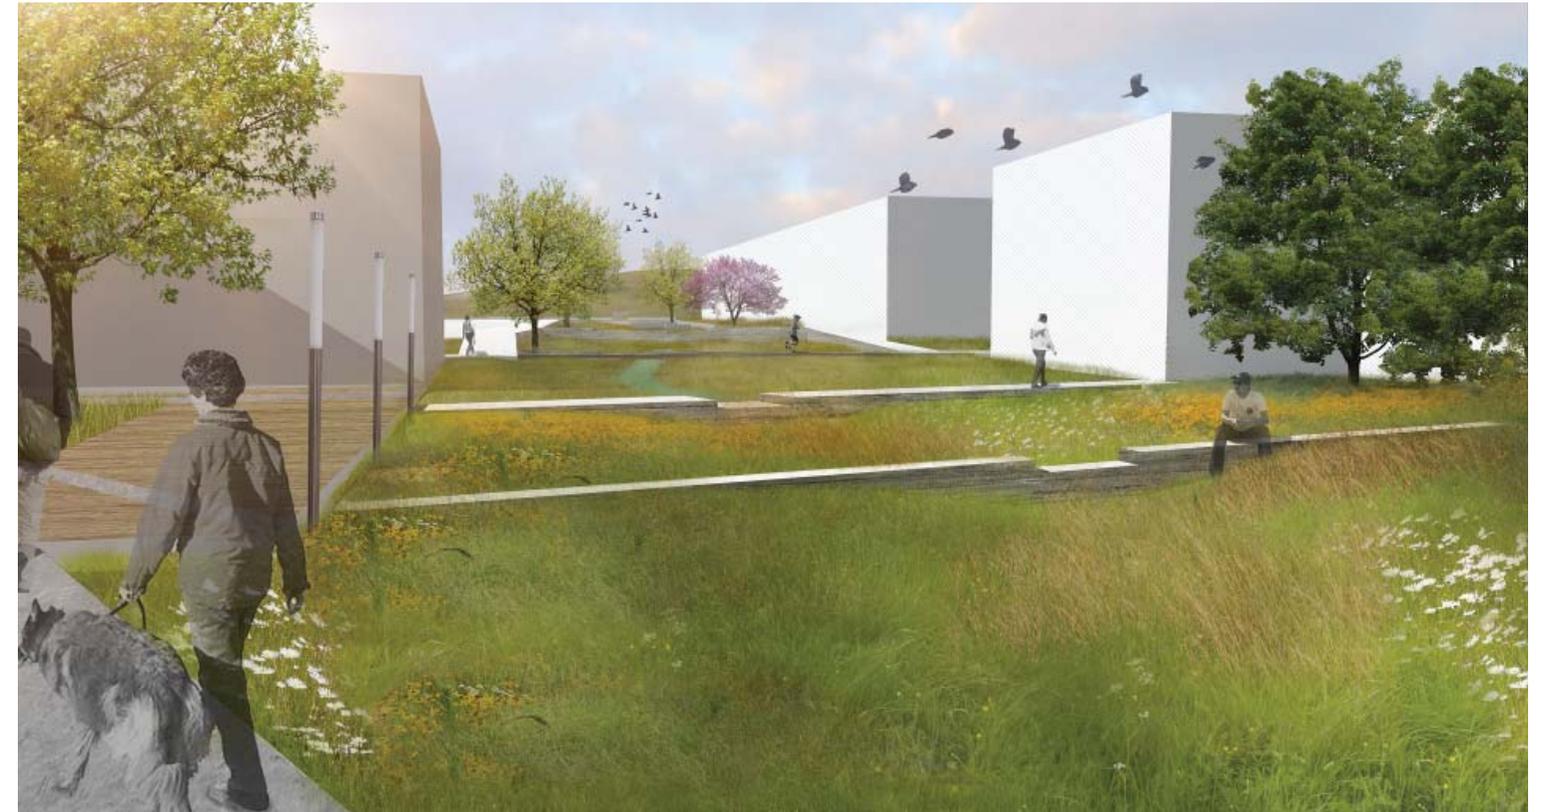
Looking North between Vet Med. Complex and proposed expansion at right.

The open space immediately south of the Veterinary Medical Complex will provide significant flood storage capacity; lessening downstream flood impacts for the rest of campus. During large storms the basin will fill—holding floodwaters for 100+yr. storm events. As the water level changes passersby may observe natural hydrological processes. To increase infiltration capacity, along with biodiversity and habitat quality, the landscape in this area will be restored with native prairie species, which are tolerant of seasonal flooding and provide visual interest year-round. Removing the existing irrigated lawn will also lessen irrigation and maintenance requirements.

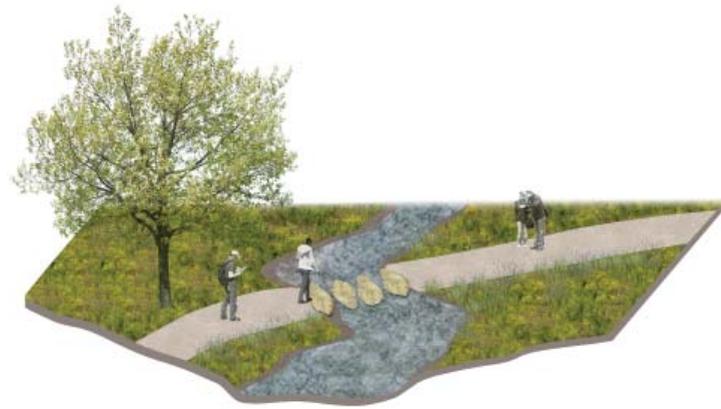
Creek Access

Large stepping stone boulders set within the creek bed allow pedestrians to engage with the stream edge and to cross at low flow.

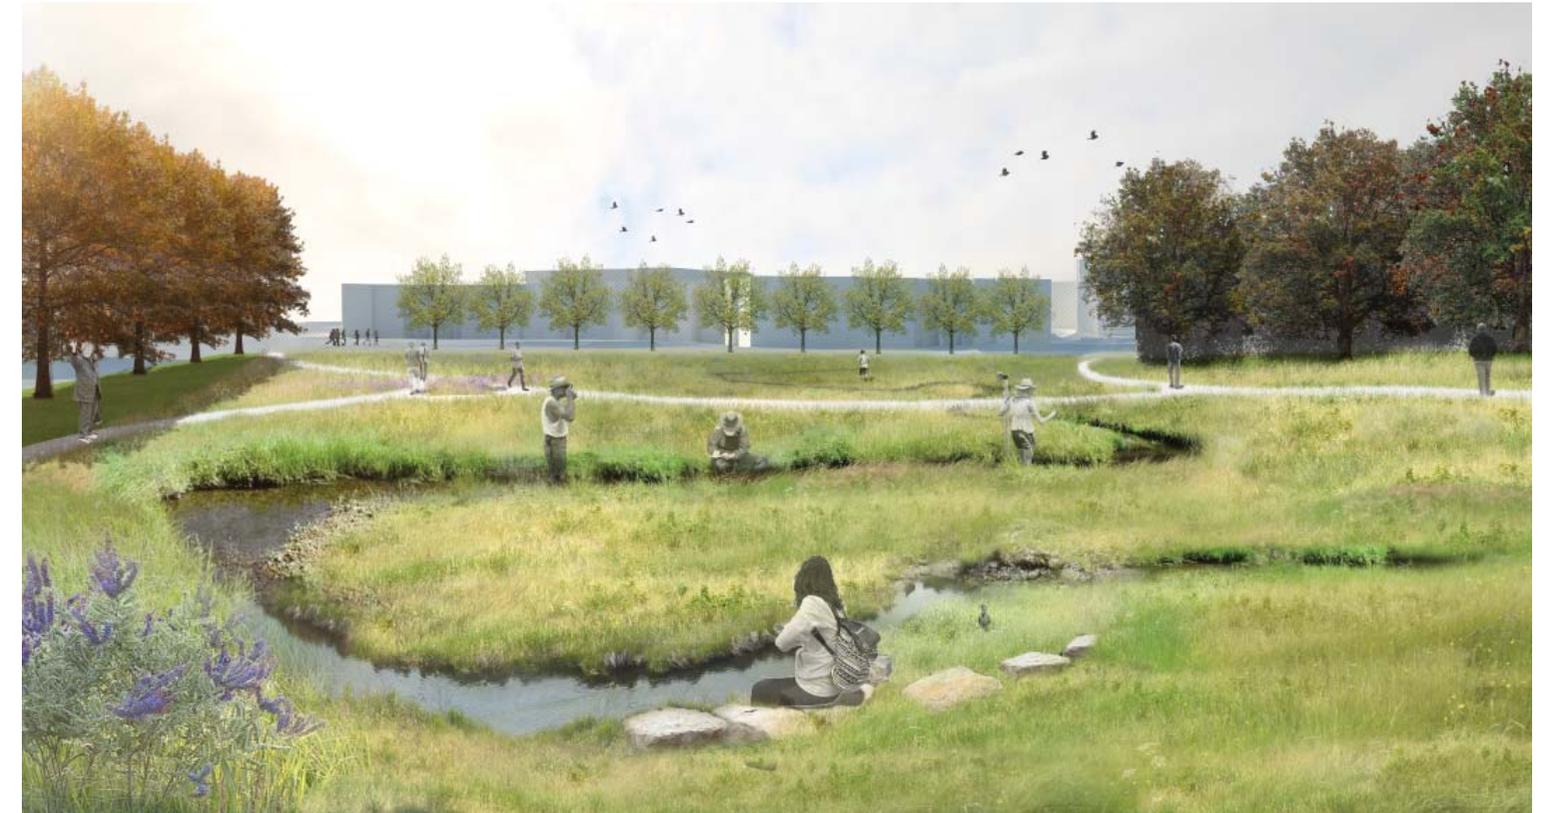
Looking East towards Jardine, Coles Hall at right

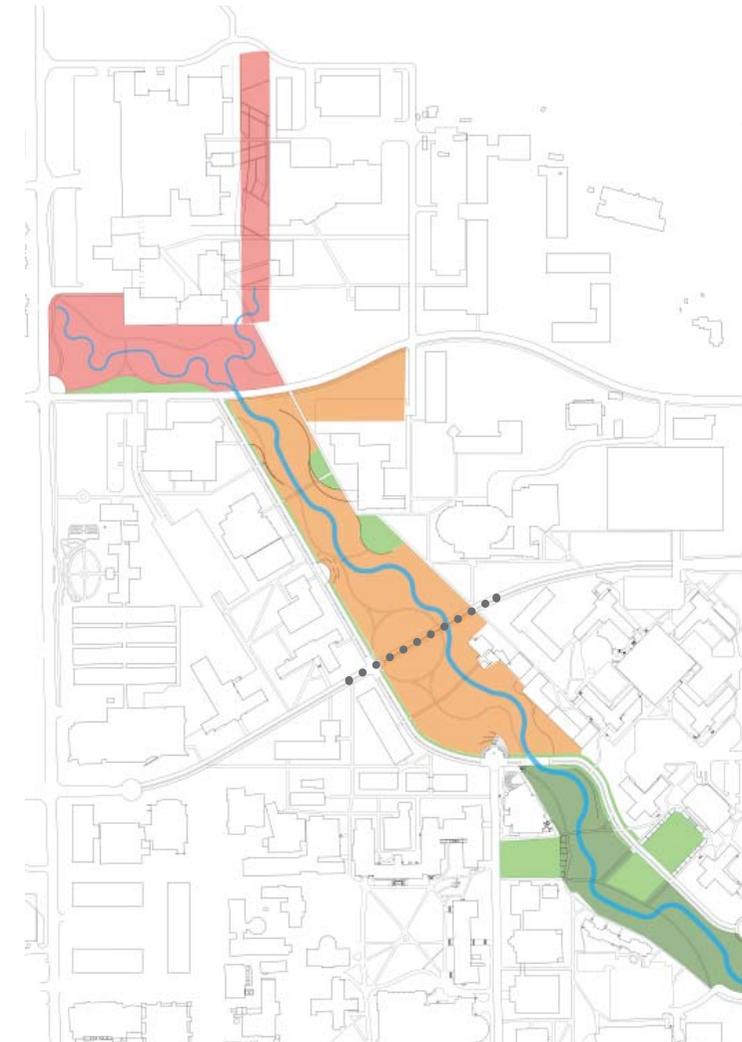
Phasing for Re-Envisioning Campus Creek is recommended to take place in two stages. The division between the two phases is Claffin Road. Phase 1 construction will occur from Manhattan Avenue to Claffin Road and Phase 2 proceeds upstream from Claffin Road toward Jardine Drive and the Veterinary Medical complex. It was determined that Claffin Road was a good point for the phase division due to existing contextual conditions and an opportunity to add a grade check in the stream (creating stability). Circulation and amenities should be added accordingly with each phase.
