2025 Kansas State University Master Plan Update Water Distribution System

March 12, 2013

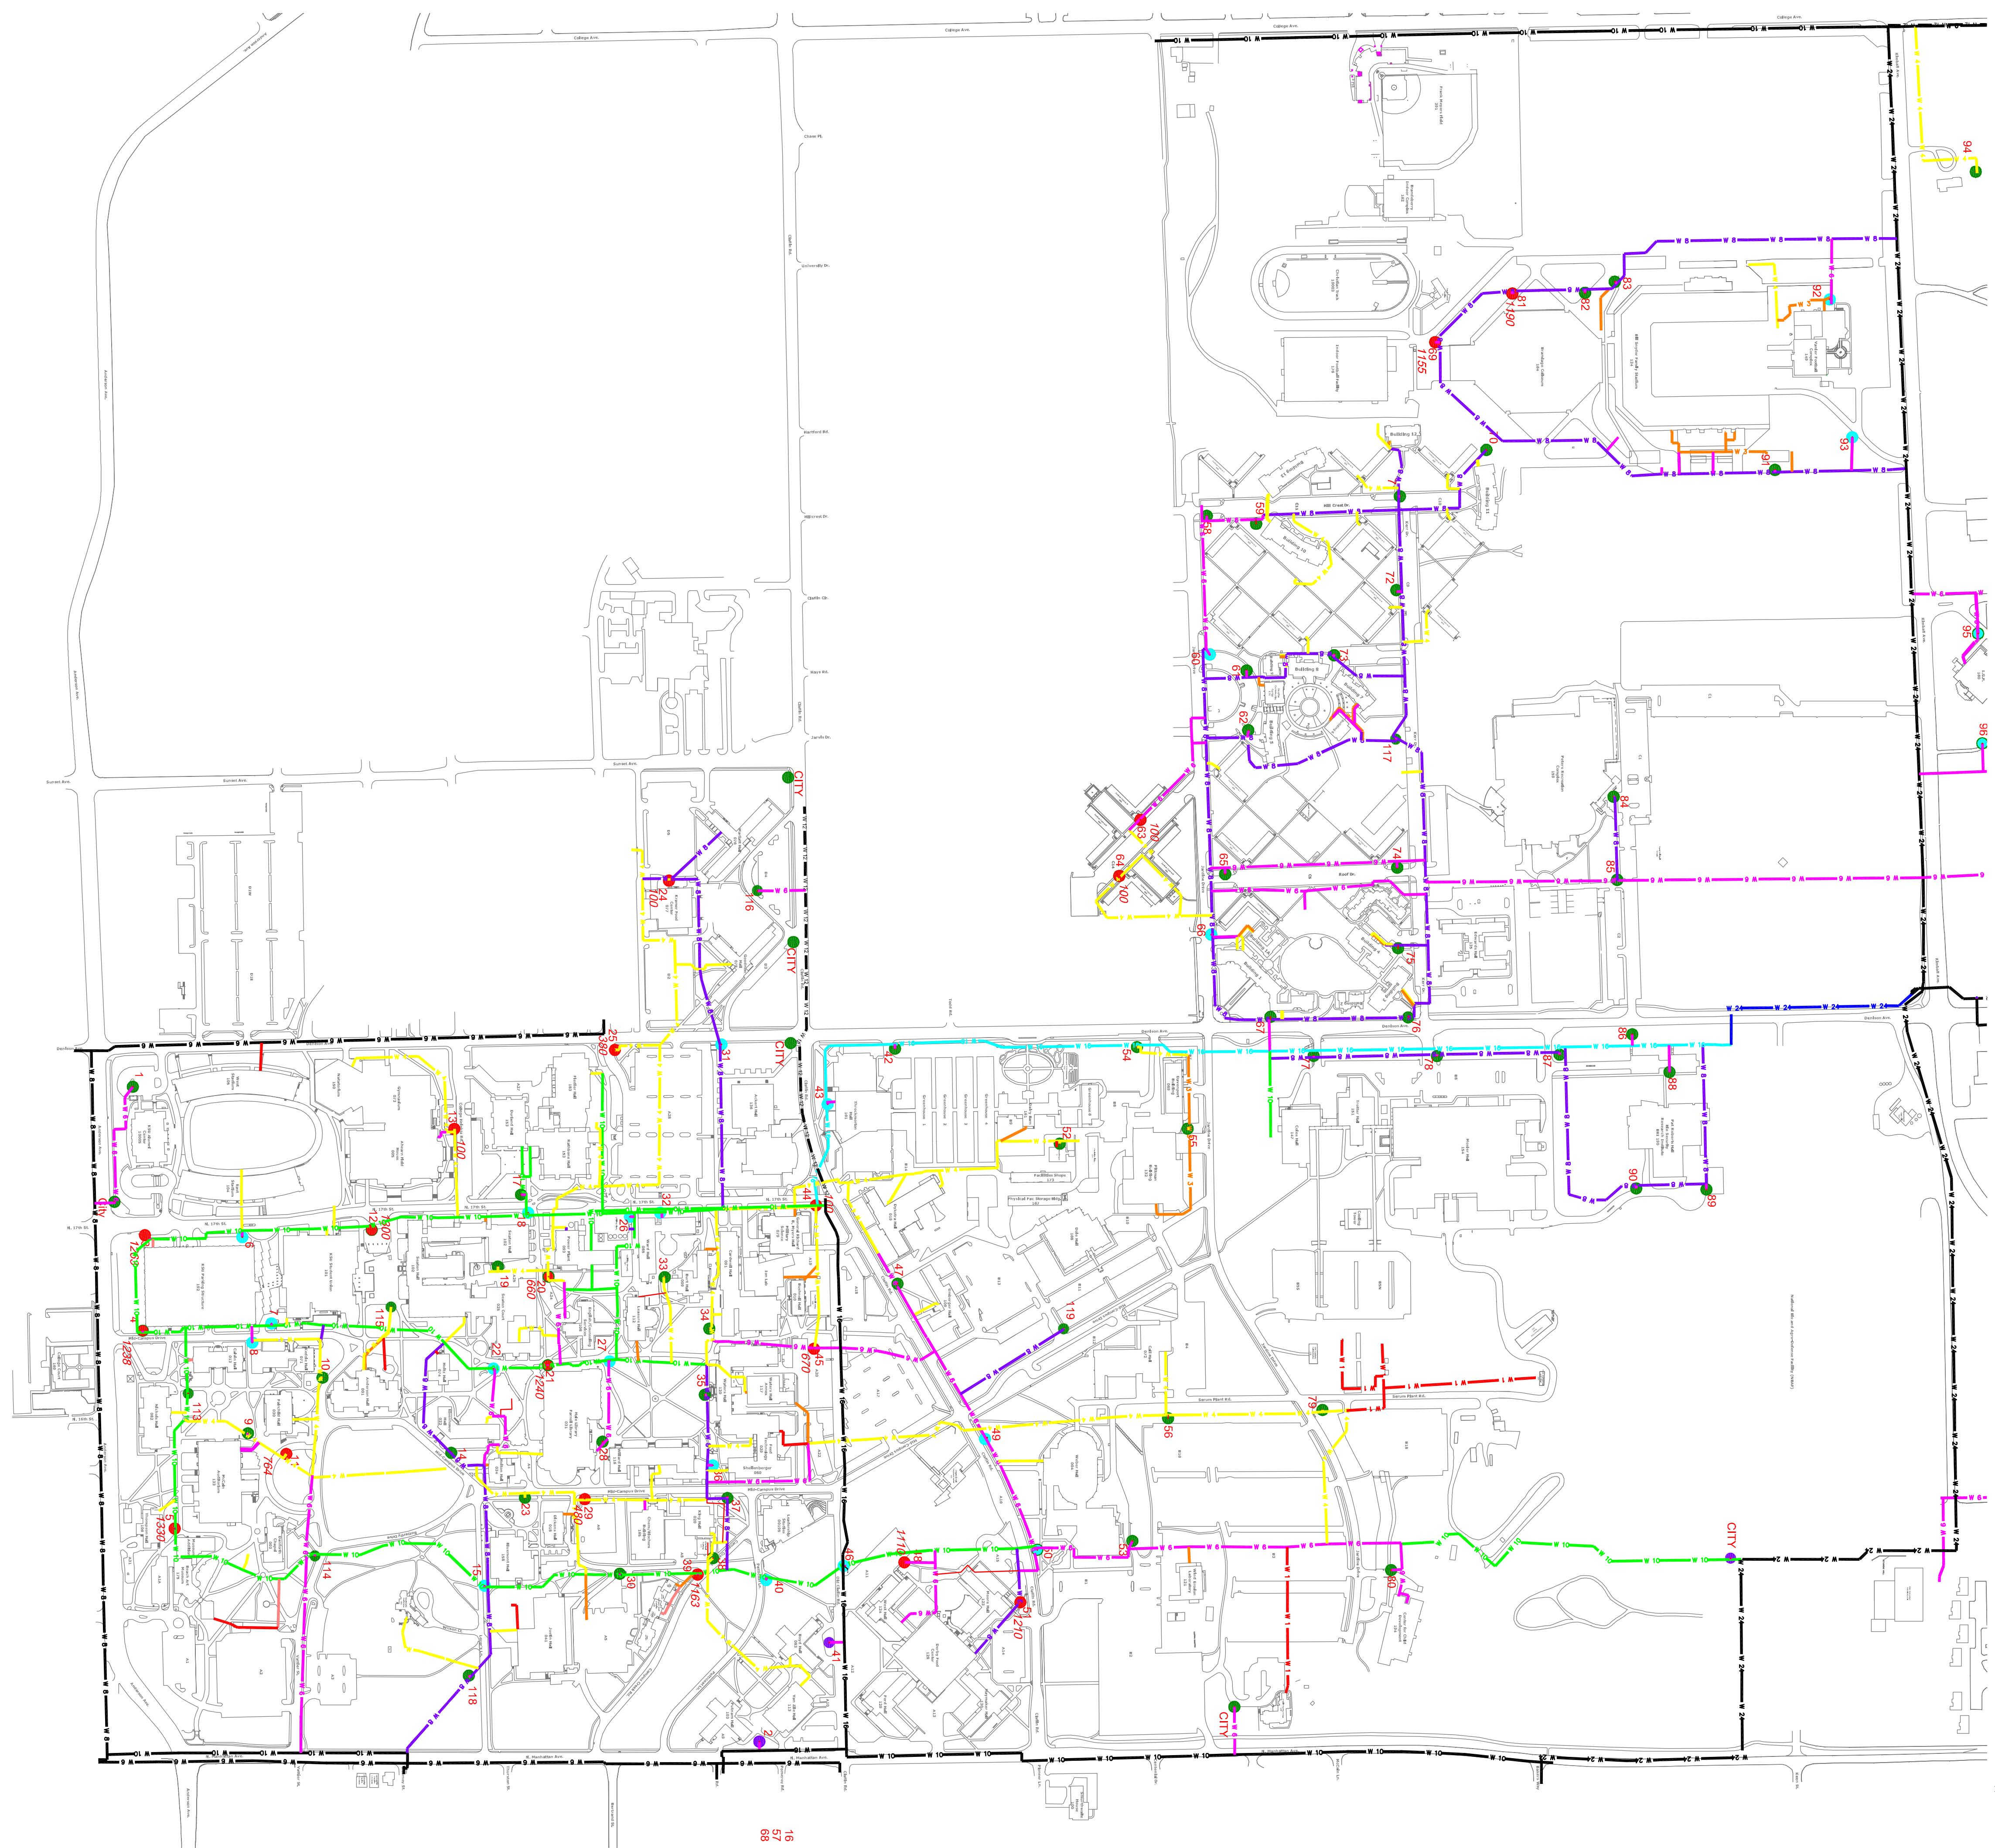
FIGURE 1A
EXISTING WATER SYSTEM - SIZING

The water distribution system that is owned and operated by Kansas State University consists of multiple types and sizes of pipe. Below is a table that summarizes the current inventory of water distribution piping which includes Ductile Iron Pipe (DIP), Cast Iron Pipe (CIP), Plastic PVC pipe, Galvanized Pipe, and Copper Pipe. The inventory was created from existing As-Built plans with the best information available to the engineer at the time of this report. A map of the water distribution system that illustrates the water main sizes (Figure 1) and a map that illustrates the water main material (Figure 2) are located at the end of this section.

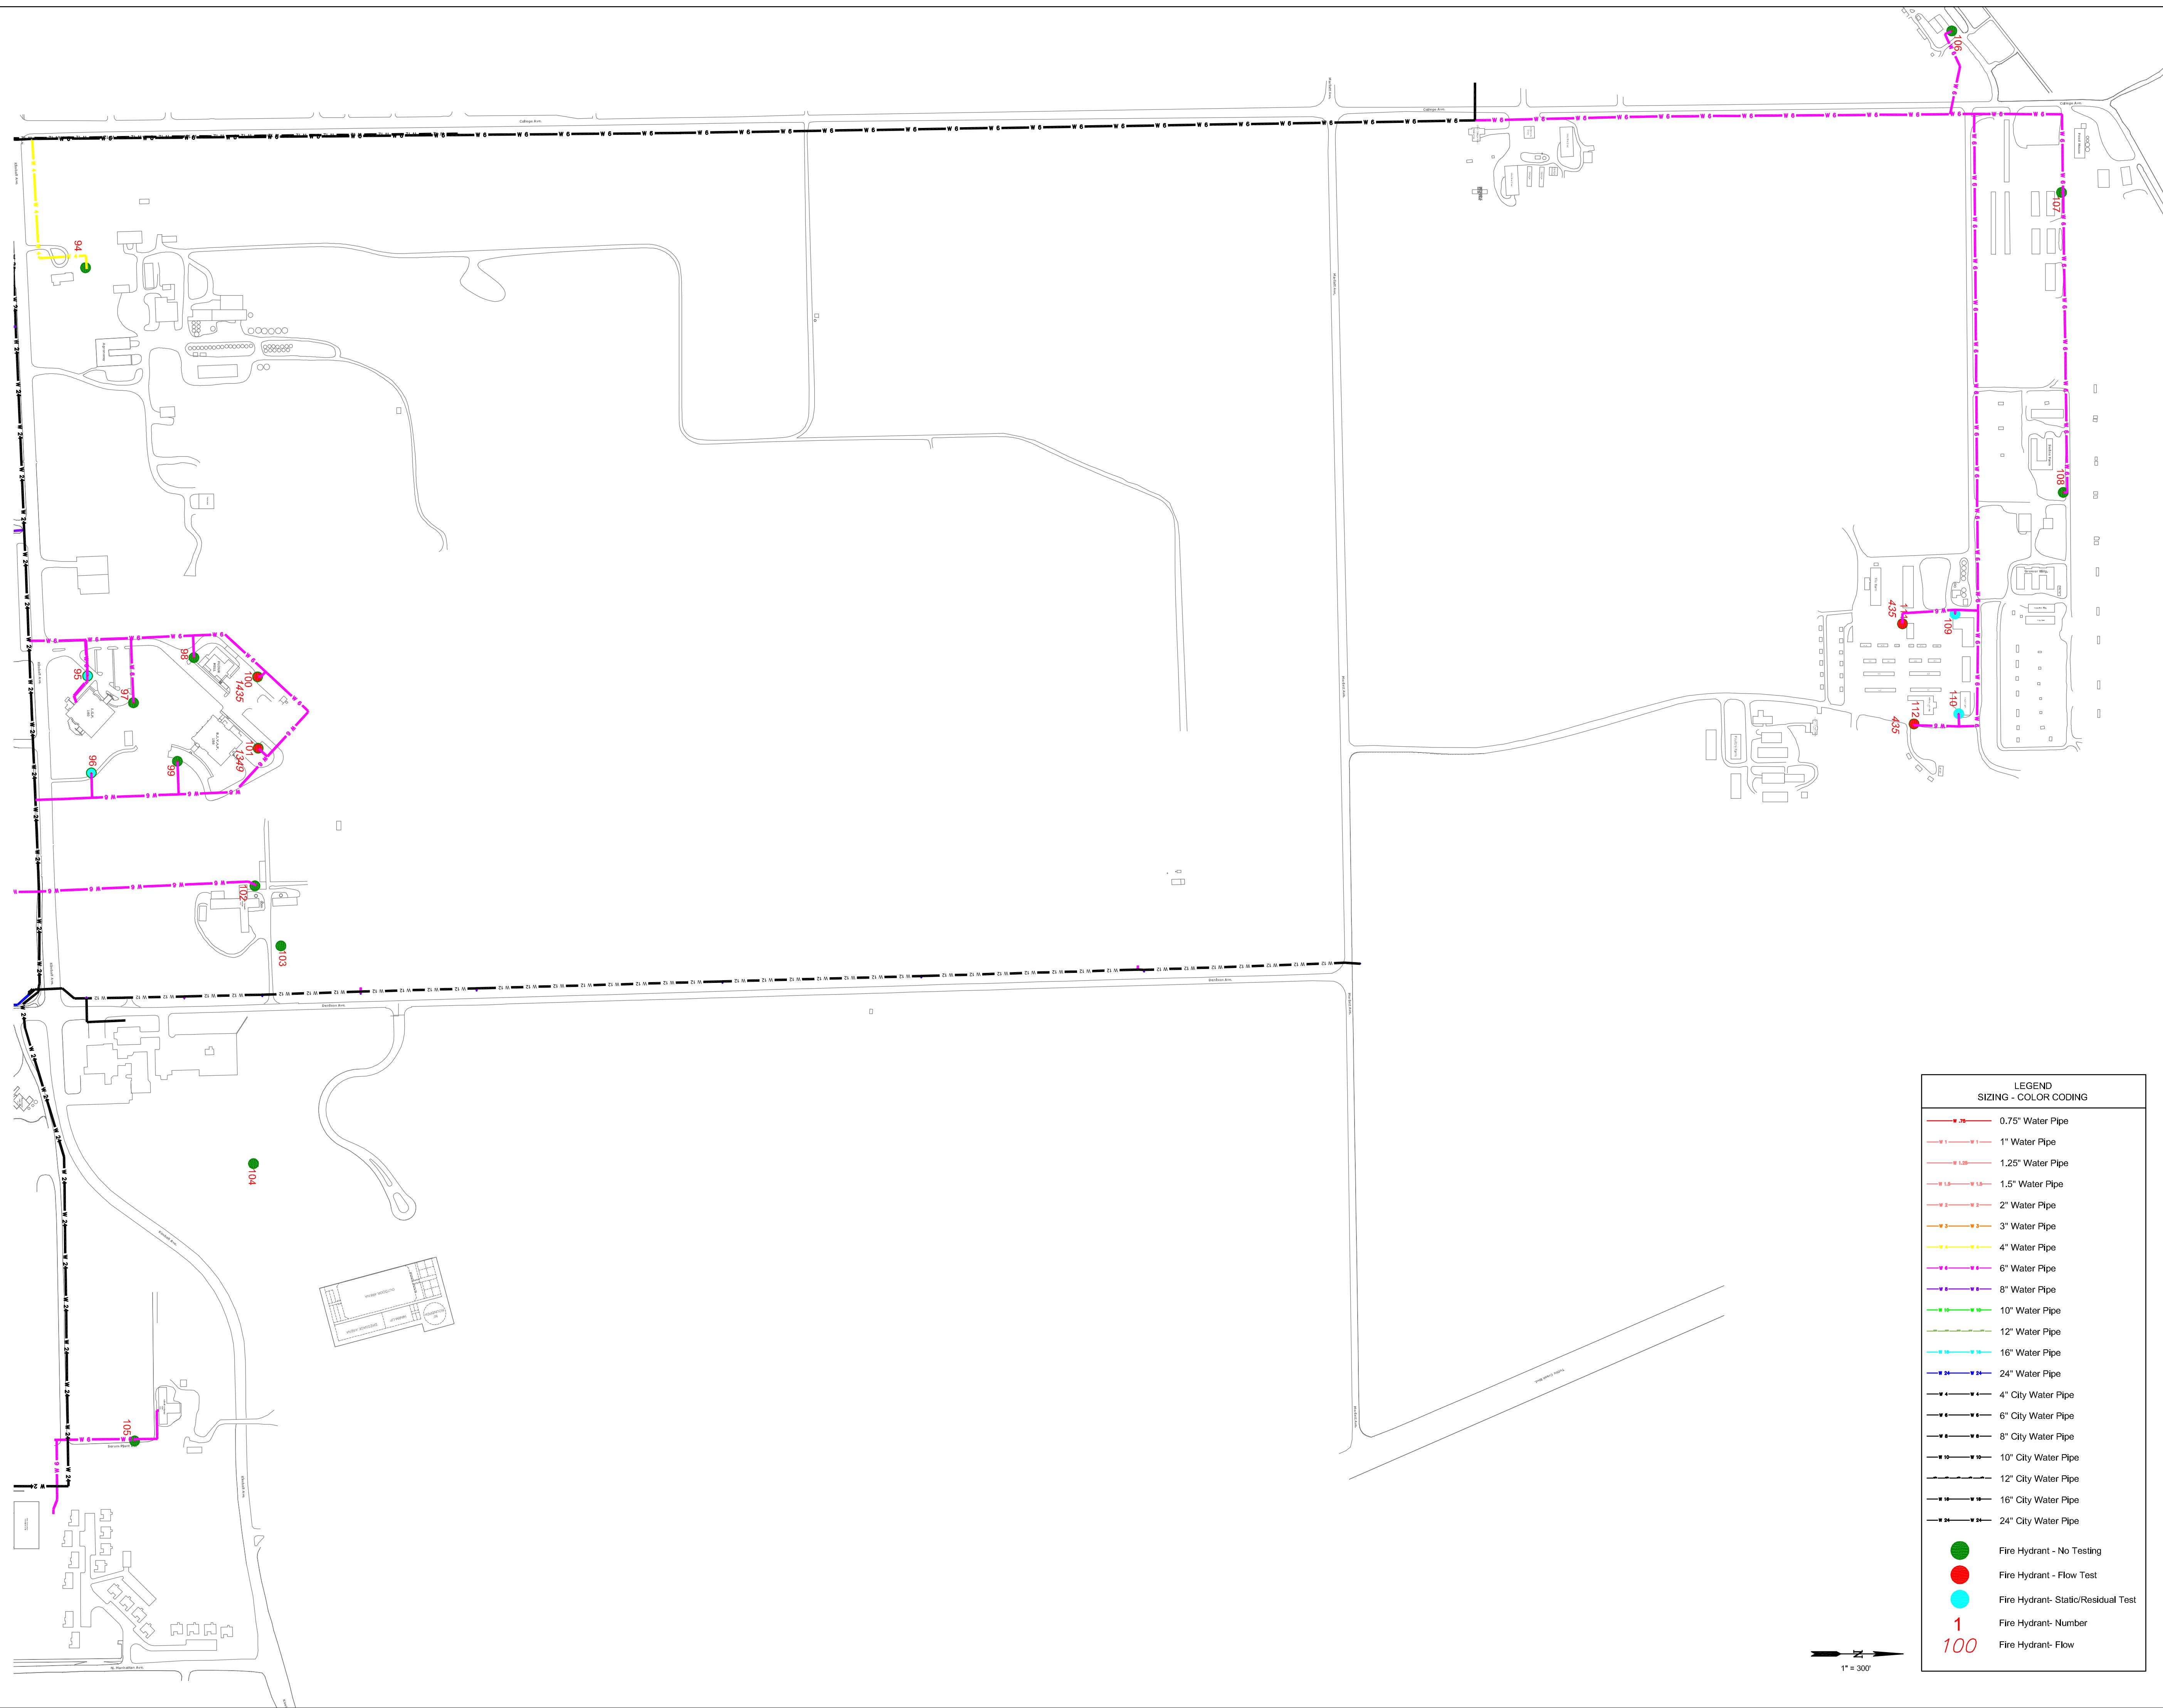
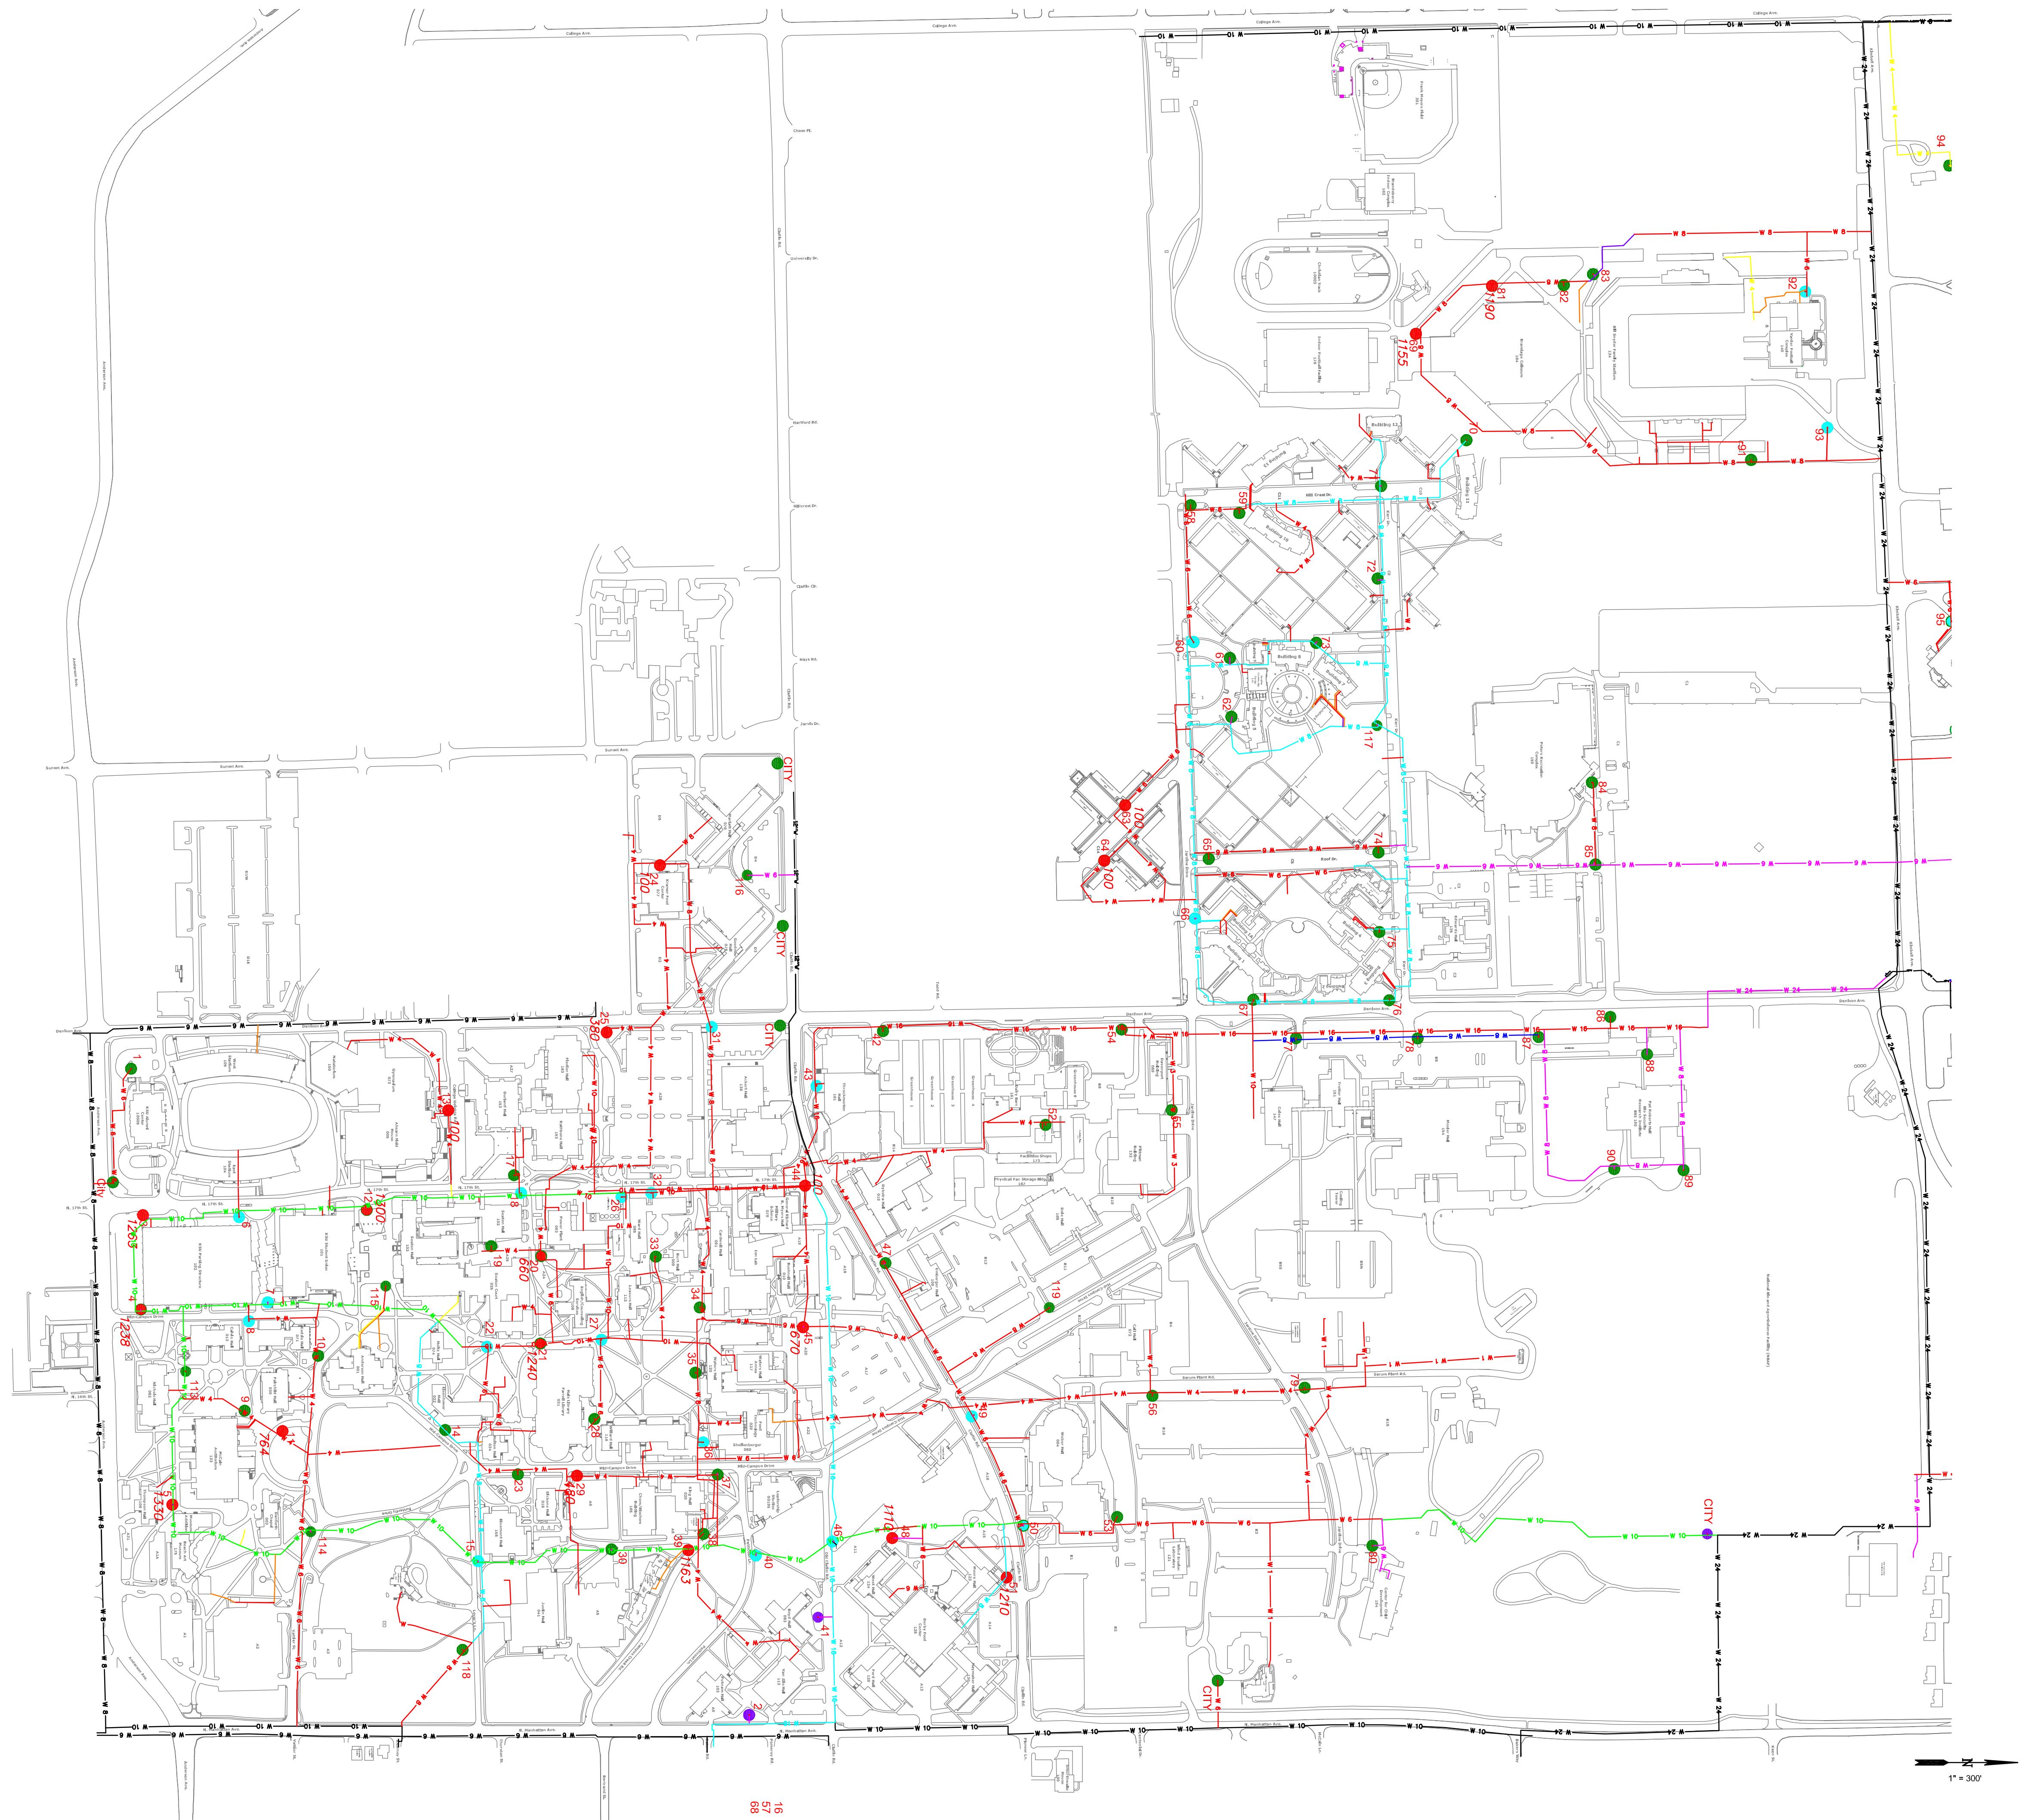
EXISTING WATER SYSTEM - MATERIAL

The majority of the water distribution piping is of unknown material, however due to the age of the distribution system and the flows observed during field testing, it is expected that the majority of the unknown pipe material is cast iron.

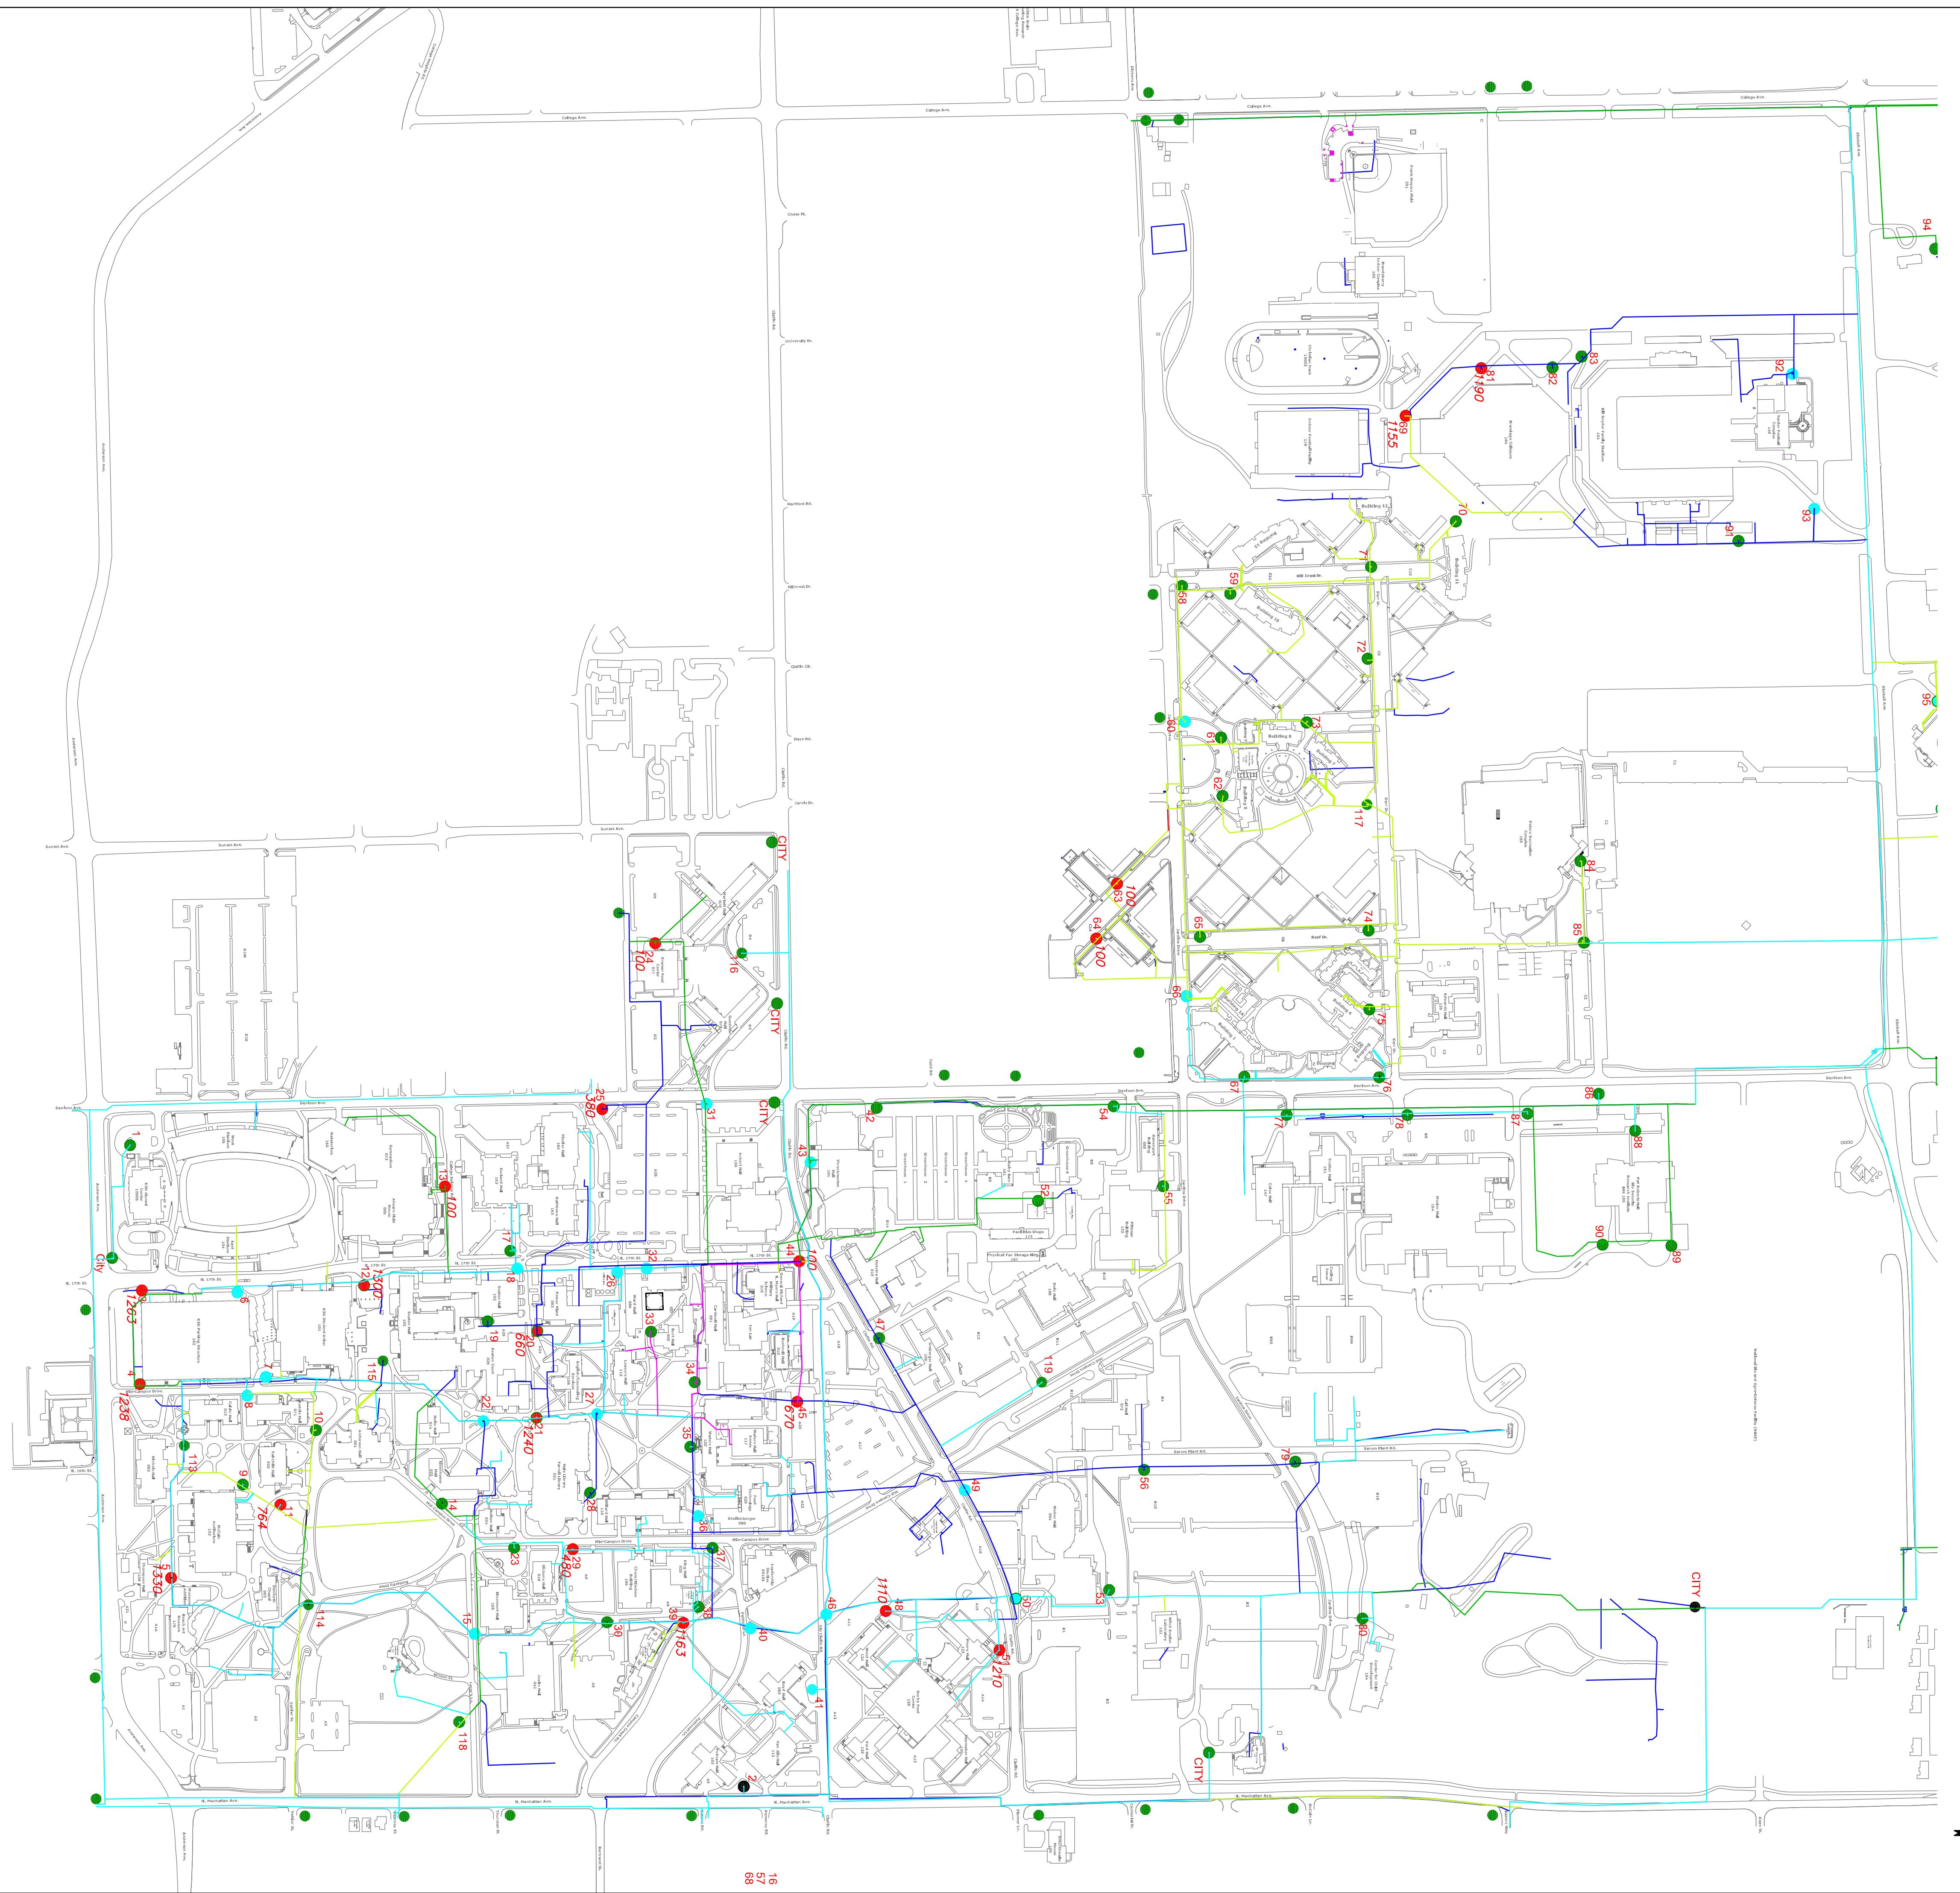
FIGURE 3A
EXISTING WATER SYSTEM - "C" FACTORS

The main objective during the calibration process is to determine the coefficient of friction, or “C” factor for each type and size of pipe. The “C” factor is adjusted to reflect the reduced amount of flow a particular pipe can allow as the pipe ages or as encrustation builds. As a point of reference, new PVC pipe typically has a “C” factor around 150. After approximately 20 years under normal service conditions PVC pipe typically has a “C” factor around 140. Ductile Iron Pipe as well as Cast Iron Pipe typically has a “C” factor around 130 new and can range greatly from around 110 to 80 after 20 years. The exact amount that the “C” factor is reduced after a period of time can vary greatly depending on multiple variables including water quality and amount of water usage. A “C” factor of 60 is considered to be very low. A “C” factor that is as low as 60 is equivalent to an approximate reduction in pipe diameter of 25%. While a “C” factor of 40 is equivalent to an approximate reduction in pipe diameter of 36%. The K-State calibrated computer model produced expected “C” factors that ranged from 40 to 130. A map that illustrates the expected “C” factors for the water mains in the K-State Water Distribution System (Figure 3) is located at the end of this section.

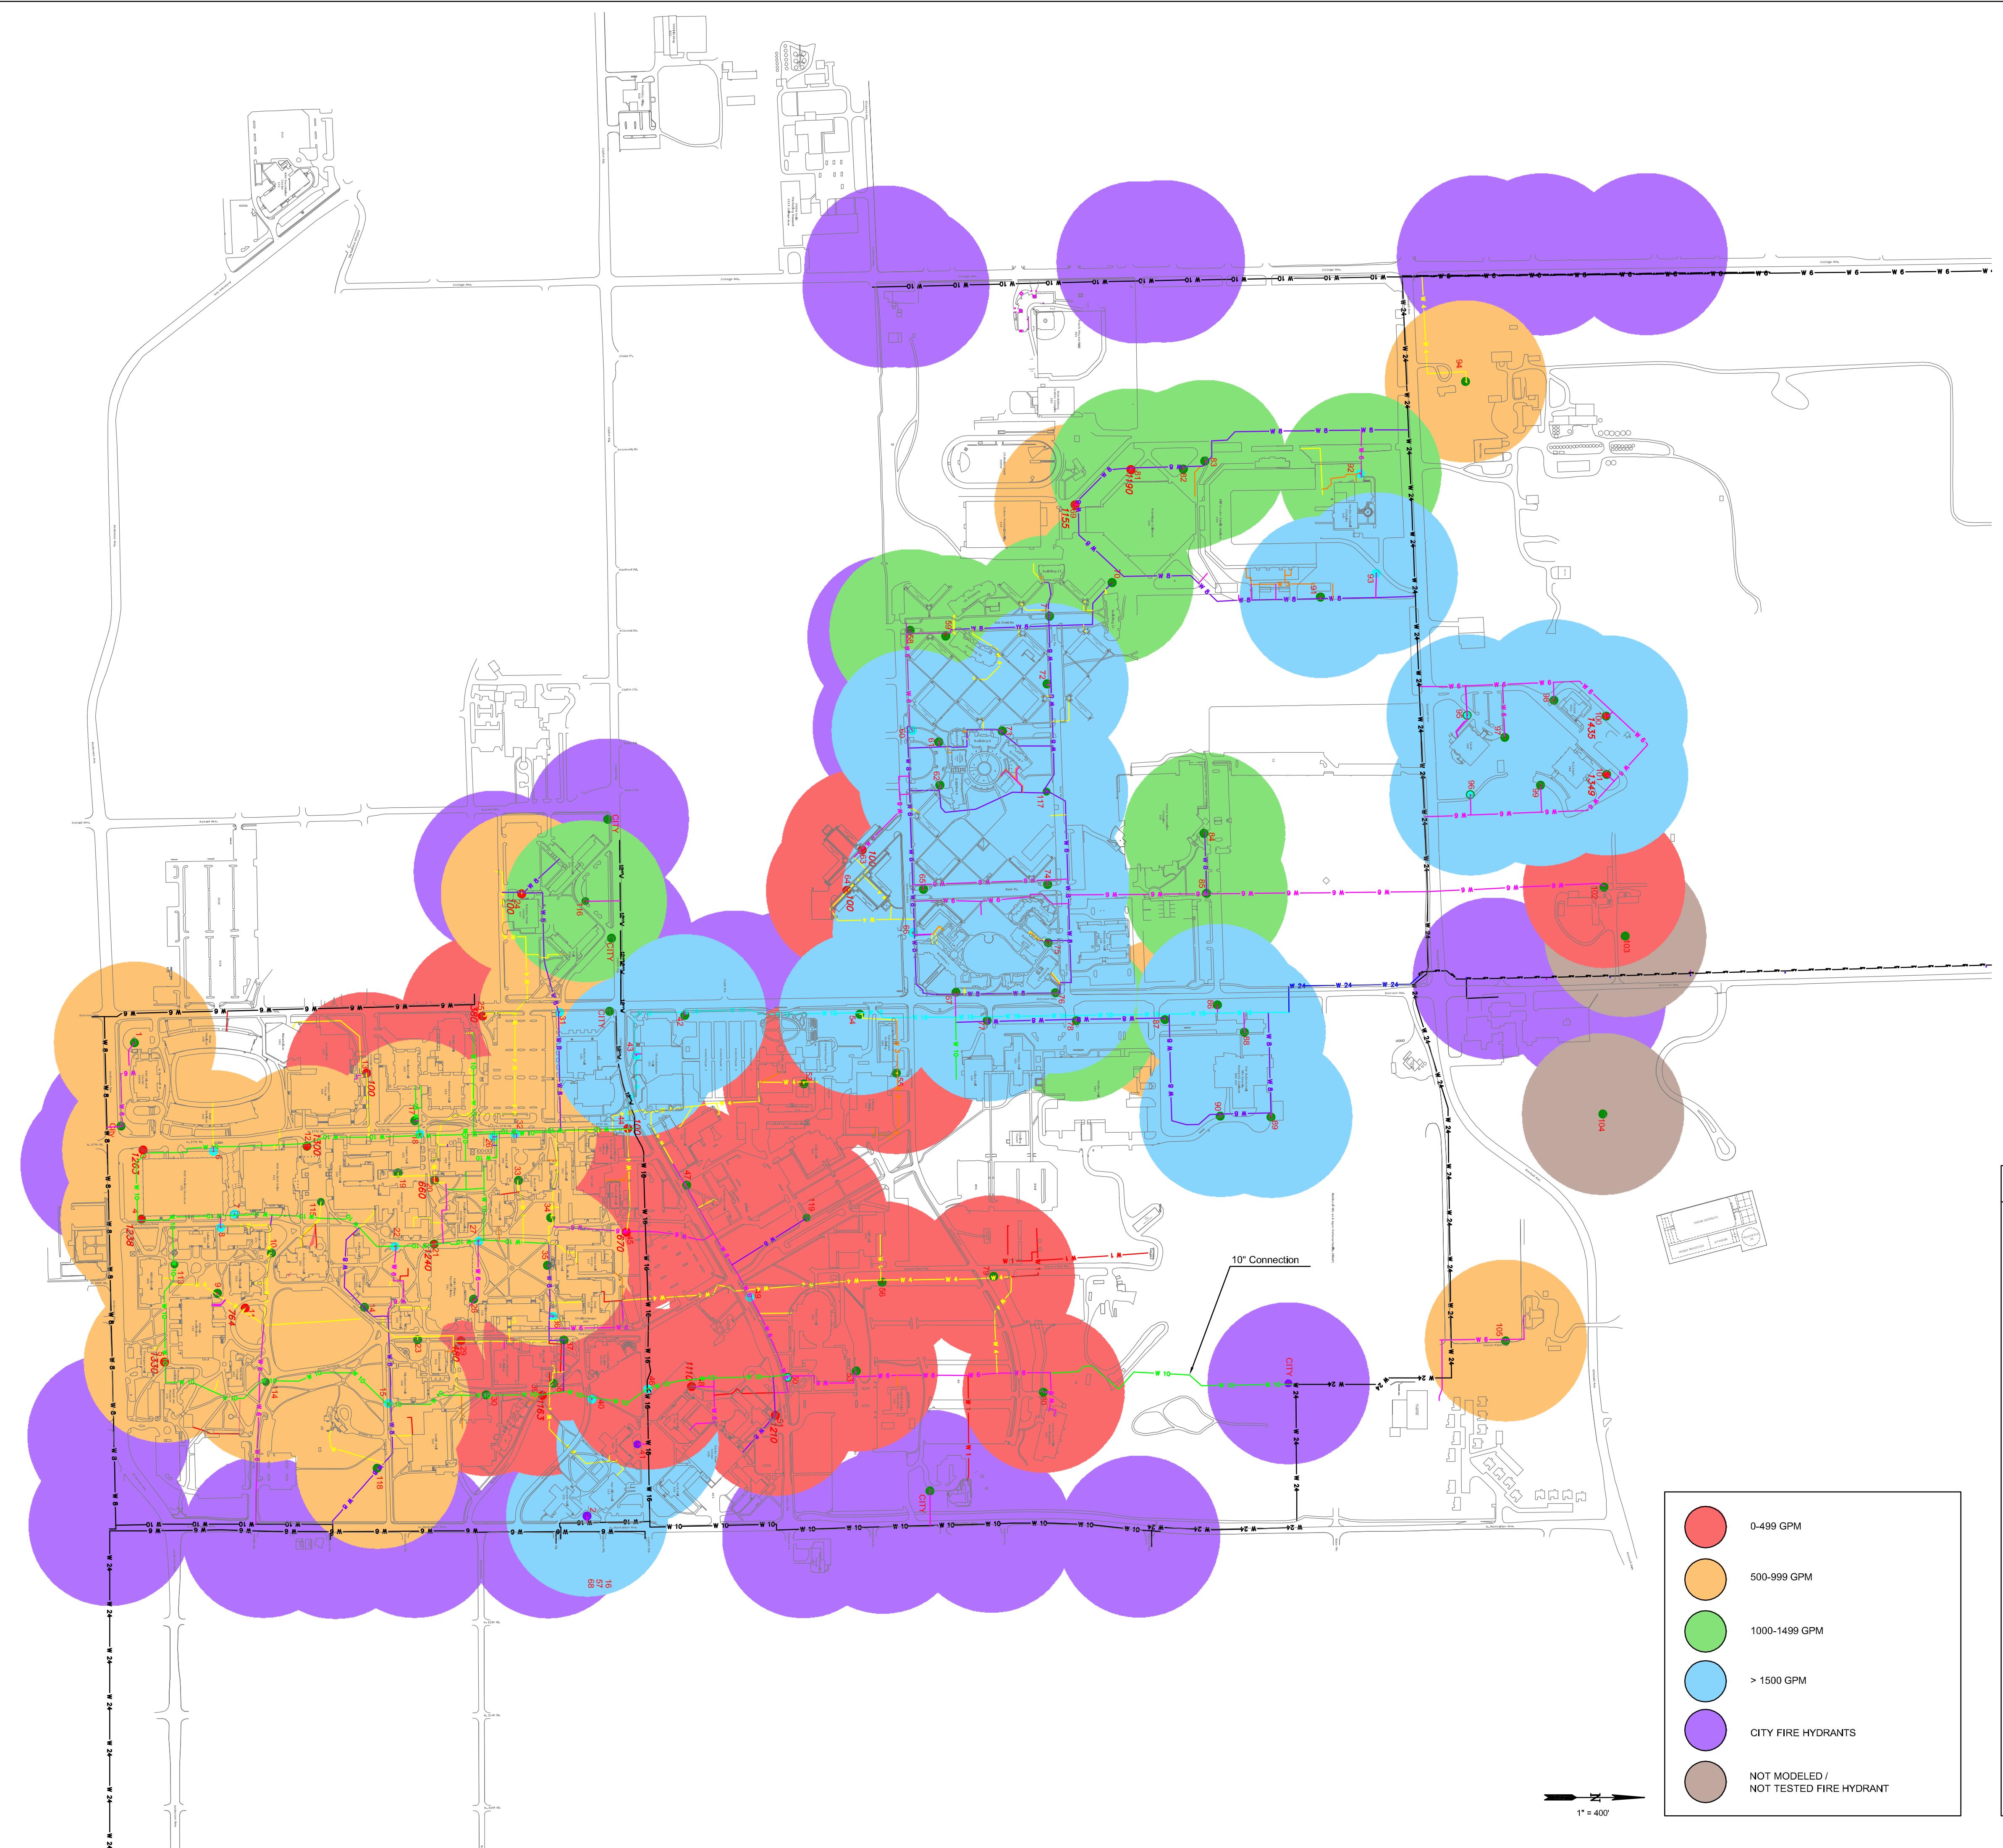
AVAILABLE FIRE HYDRANT - 10" CONNECTION - CLOSED

<u>Classification</u>	<u>Flow at 20 psi.</u>	<u>Color Code</u>
Class C	Less than 500 gpm	Red
Class B	500 to 999 gpm	Orange
Class A	1000 to 1499 gpm	Green
Class AA	1500 and above	Blue

During testing 7 out of the 27 fire hydrants tested could not achieve a flow rate greater than 500 gpm. After creating a distribution model using WaterCAD, it was found that 17 out of the 114 total fire hydrants could not achieve 500 gpm while maintaining 20 psi within the system during normal demand usage with the 10" Connection open. A detailed fire code analysis would be required to determine the recommend flows for each hydrant due to the various size and usage of each building across the main campus. However, it typically is recommend that all fire hydrants be able to flow a minimum of 500 gpm and that fire hydrants near large facilities, such as schools, dormitories, etc. be able to flow a minimum of 1500 gpm.
