2025 Kansas State University Master Plan Update Water Distribution System

March 12, 2013

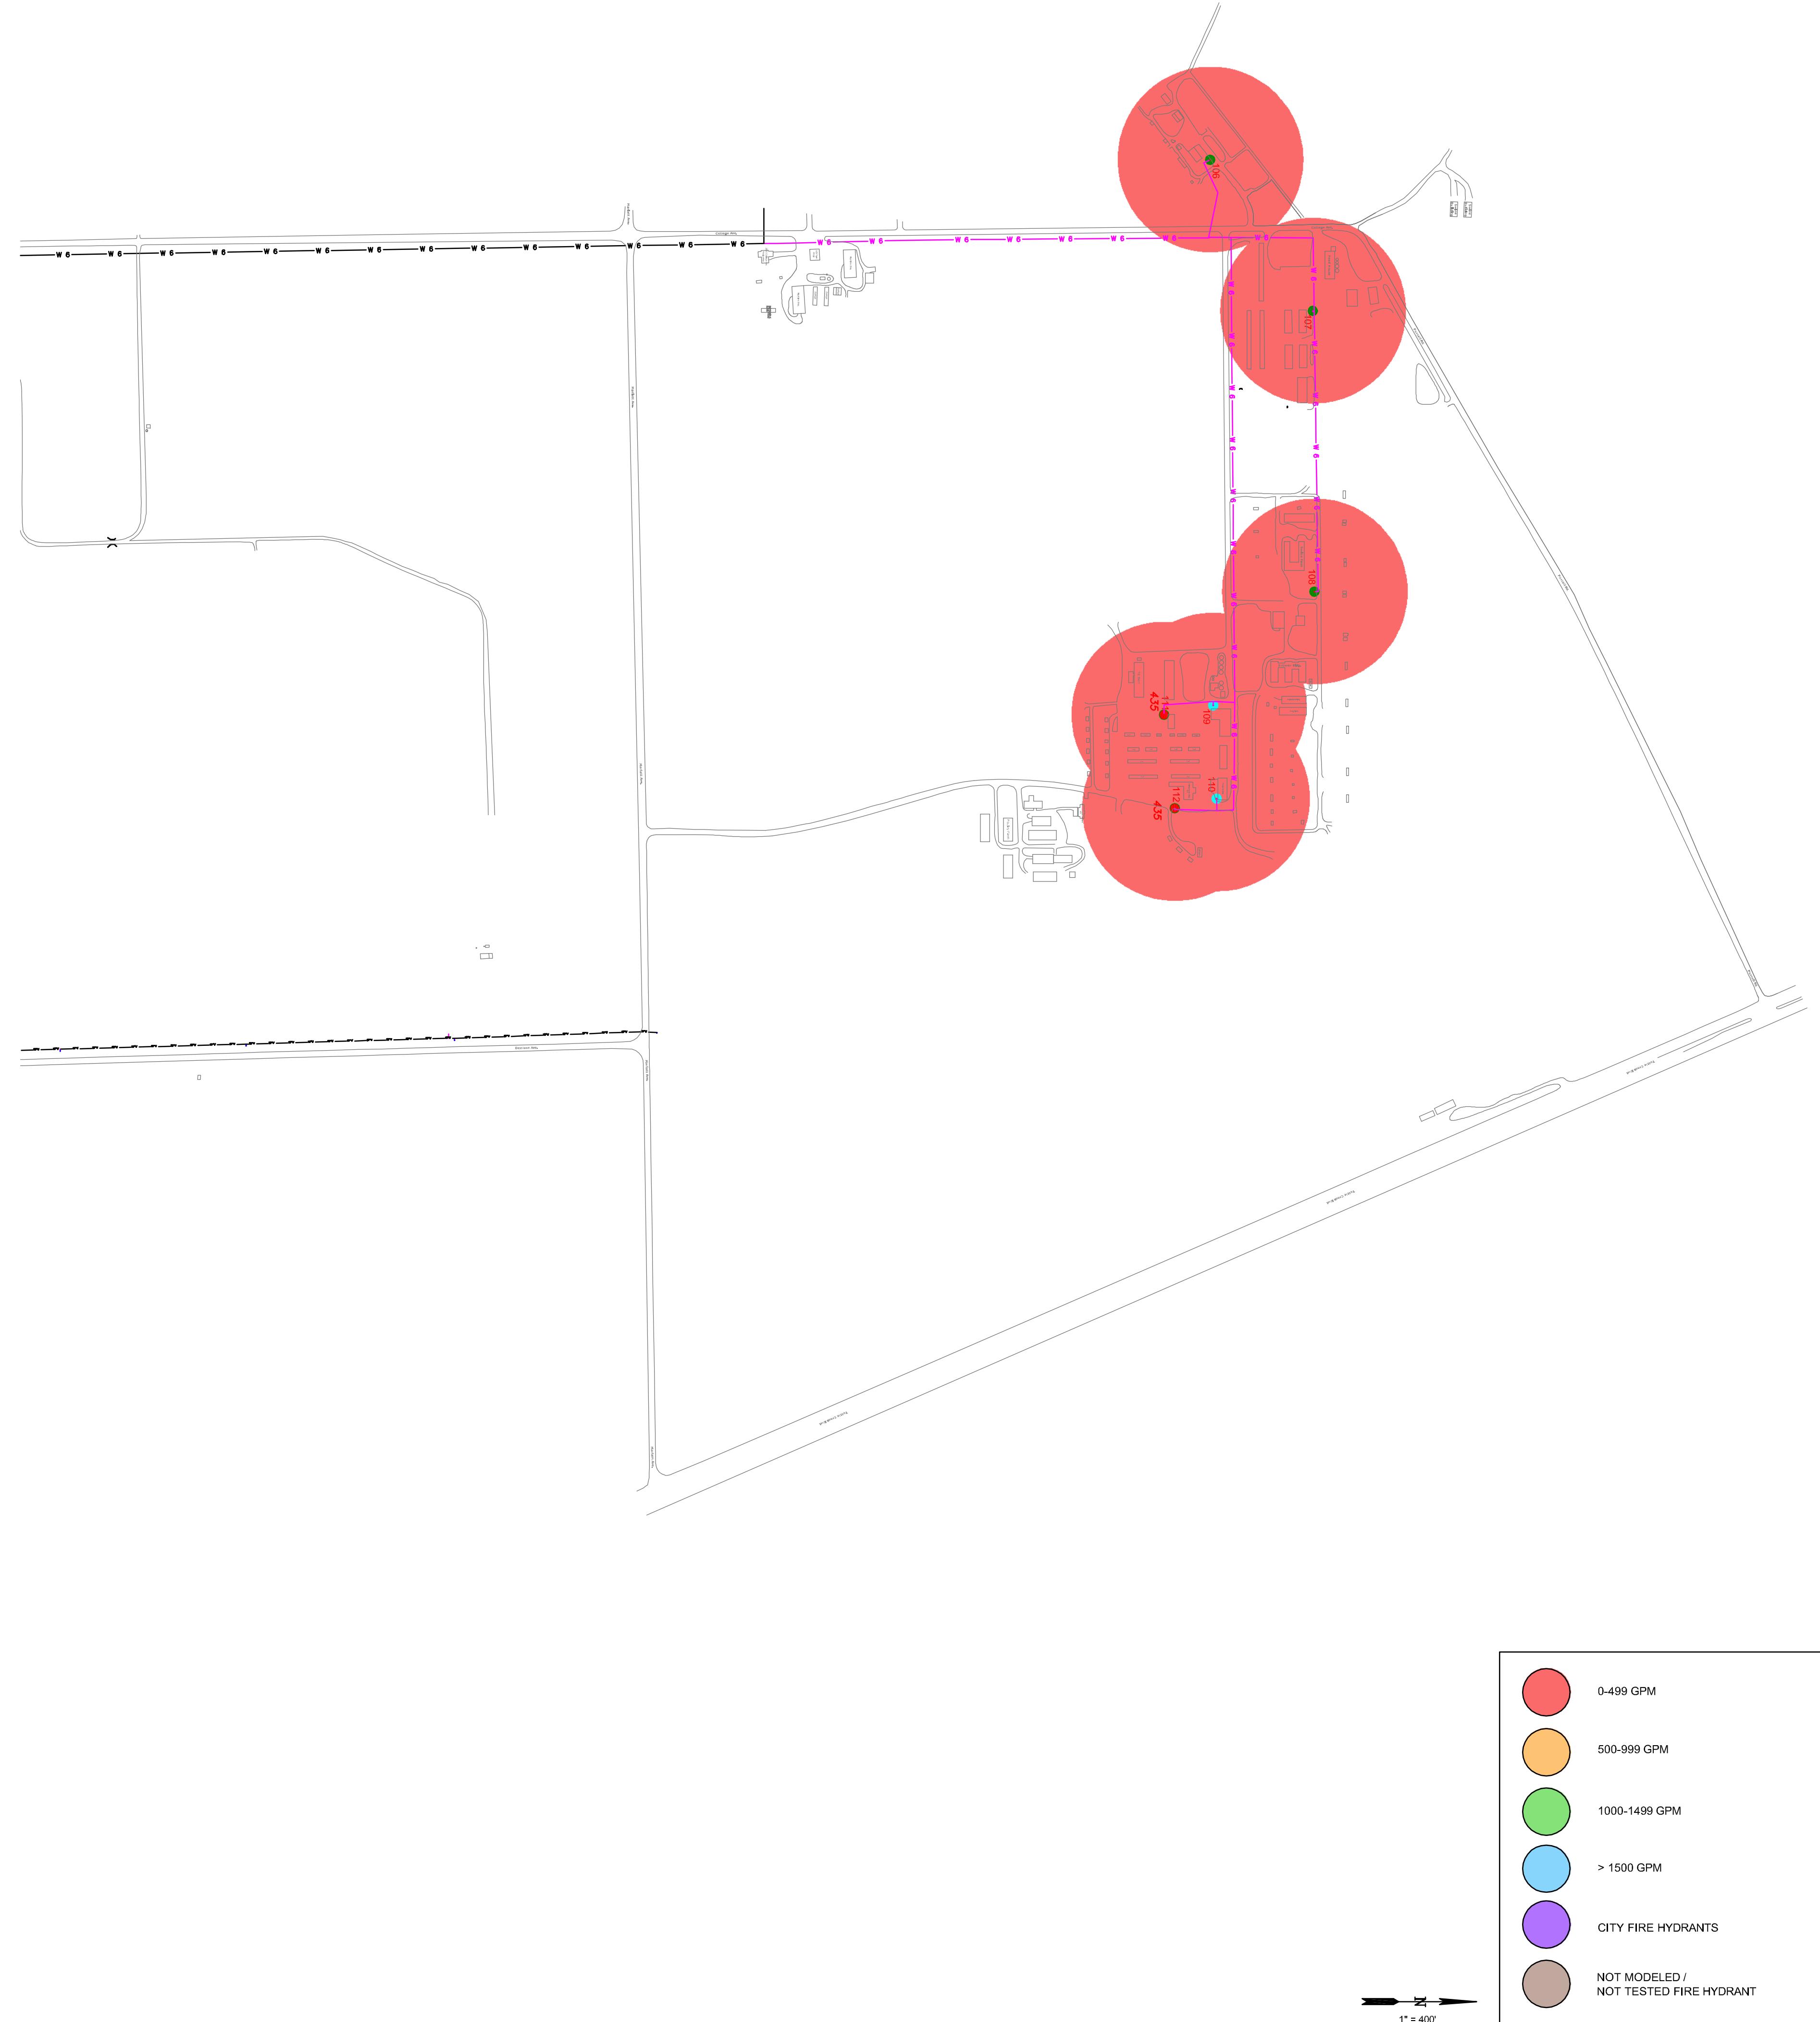
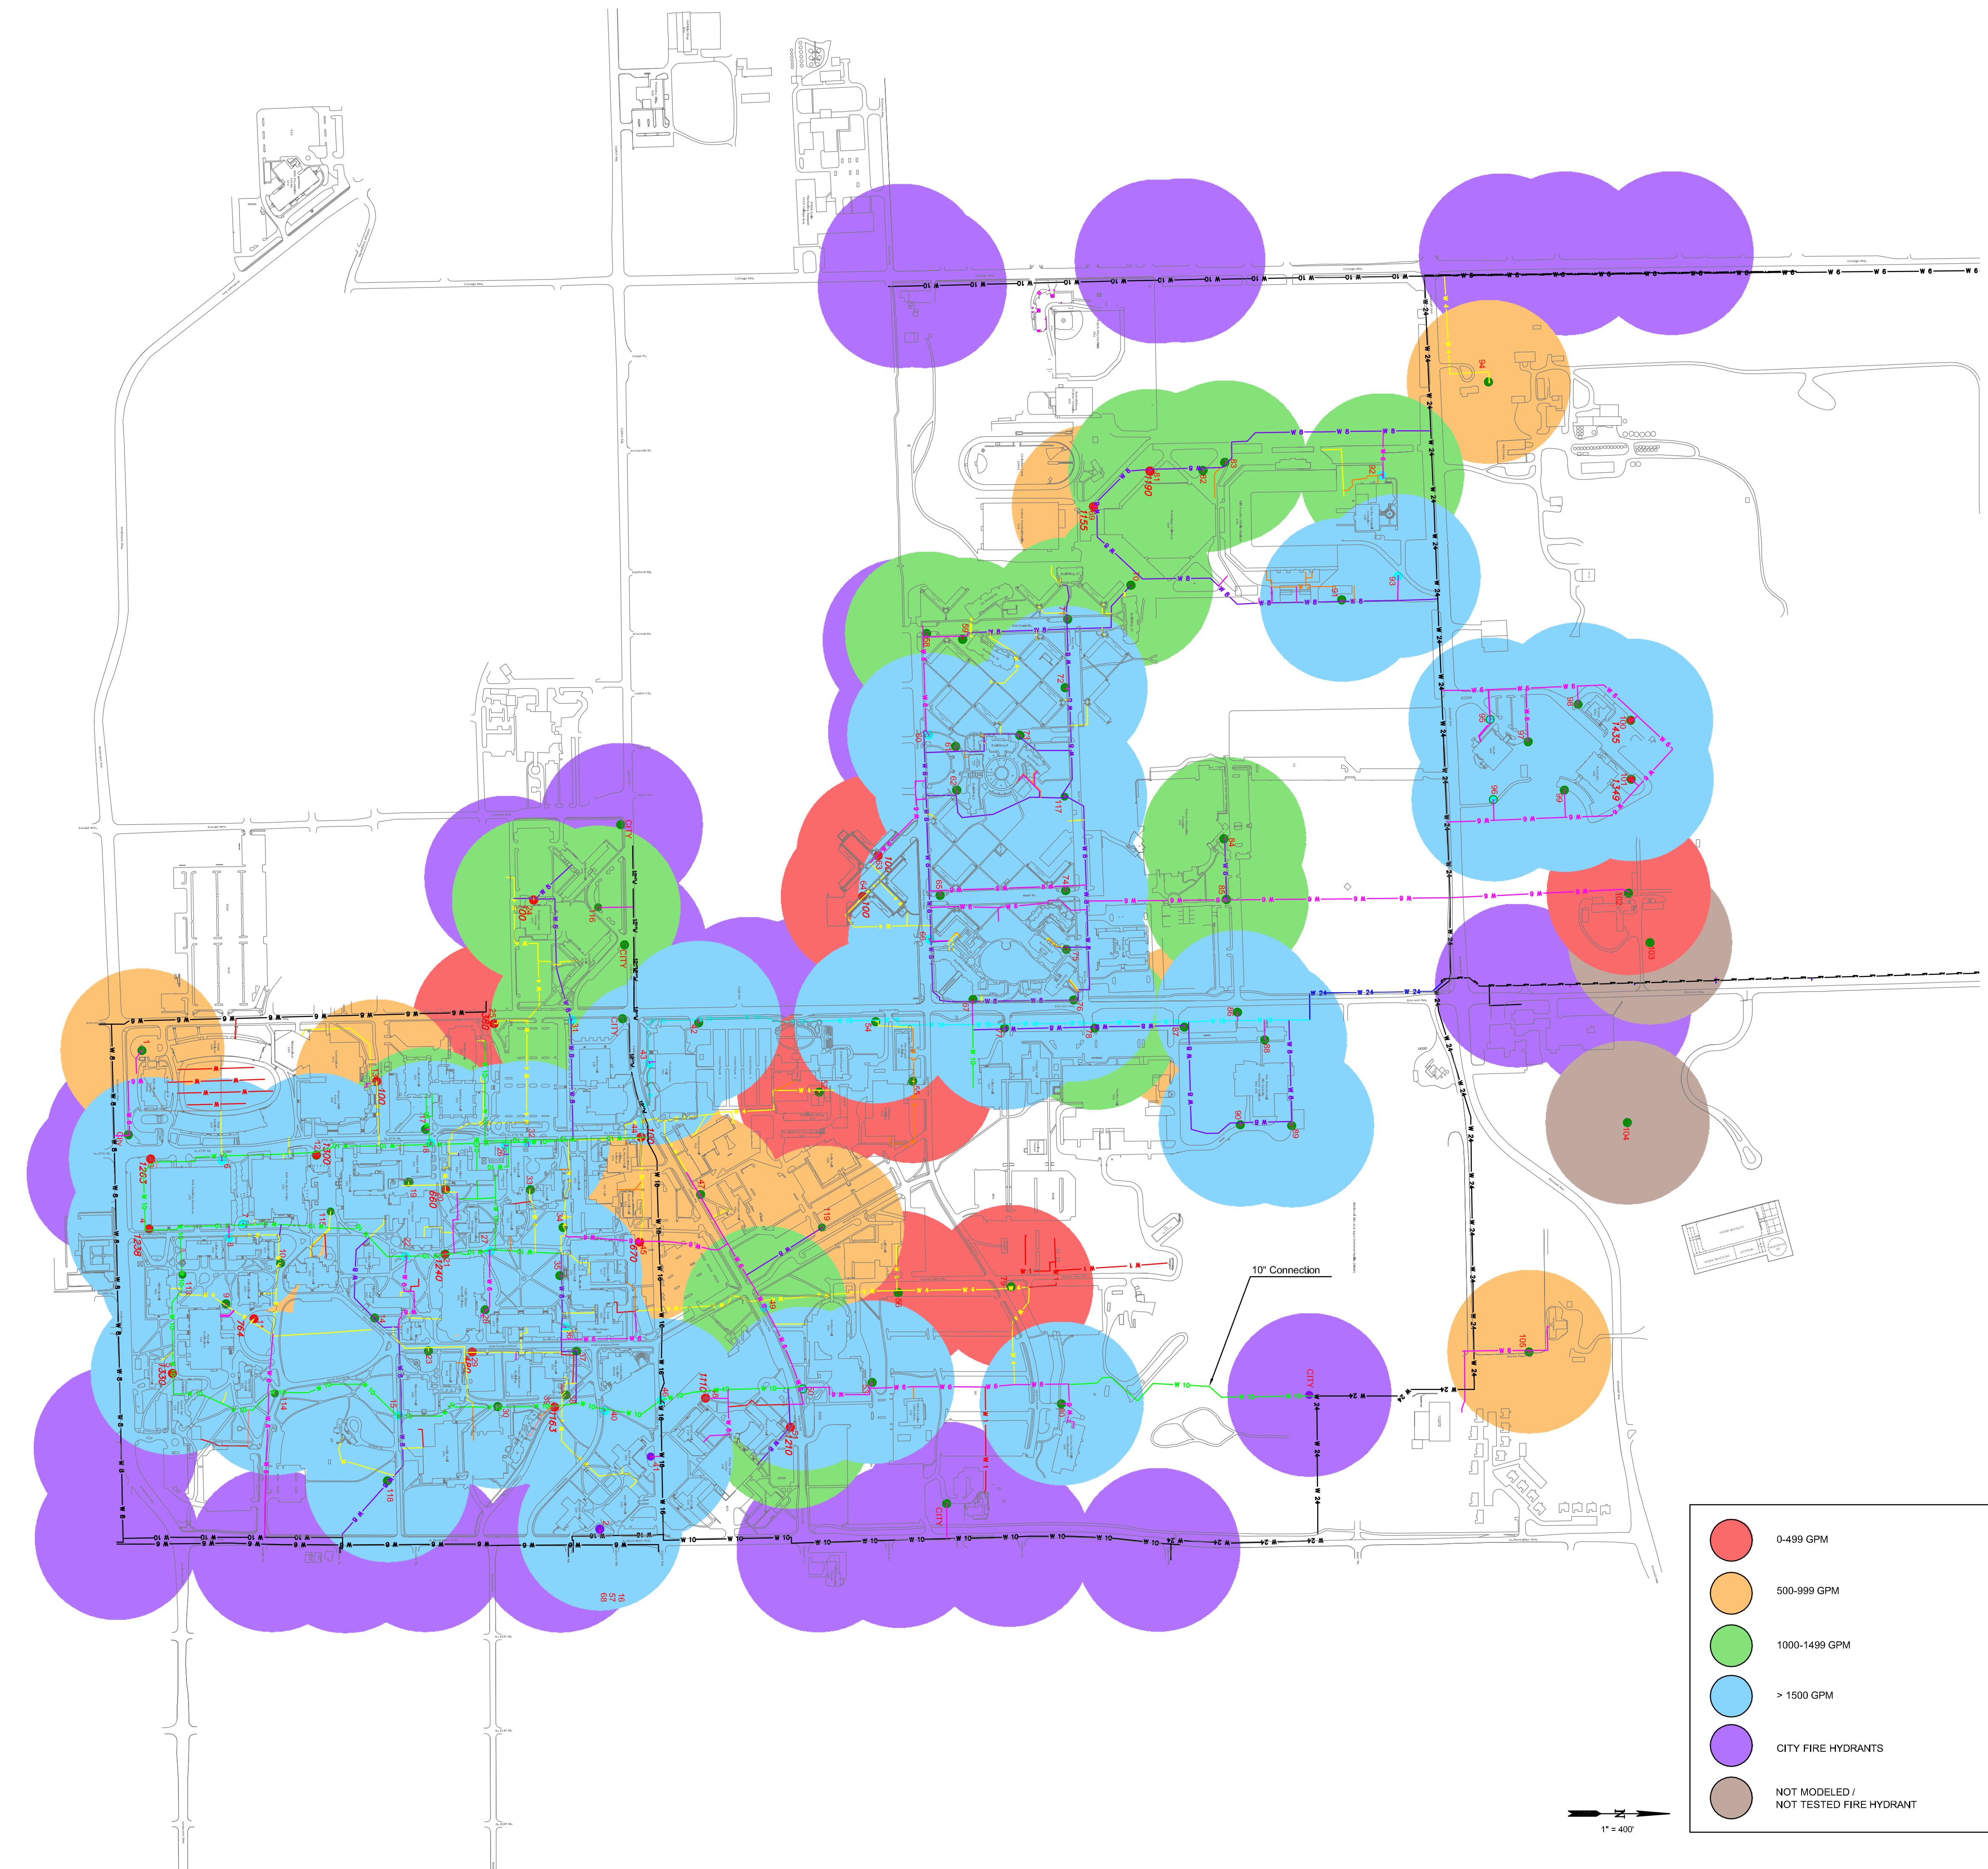
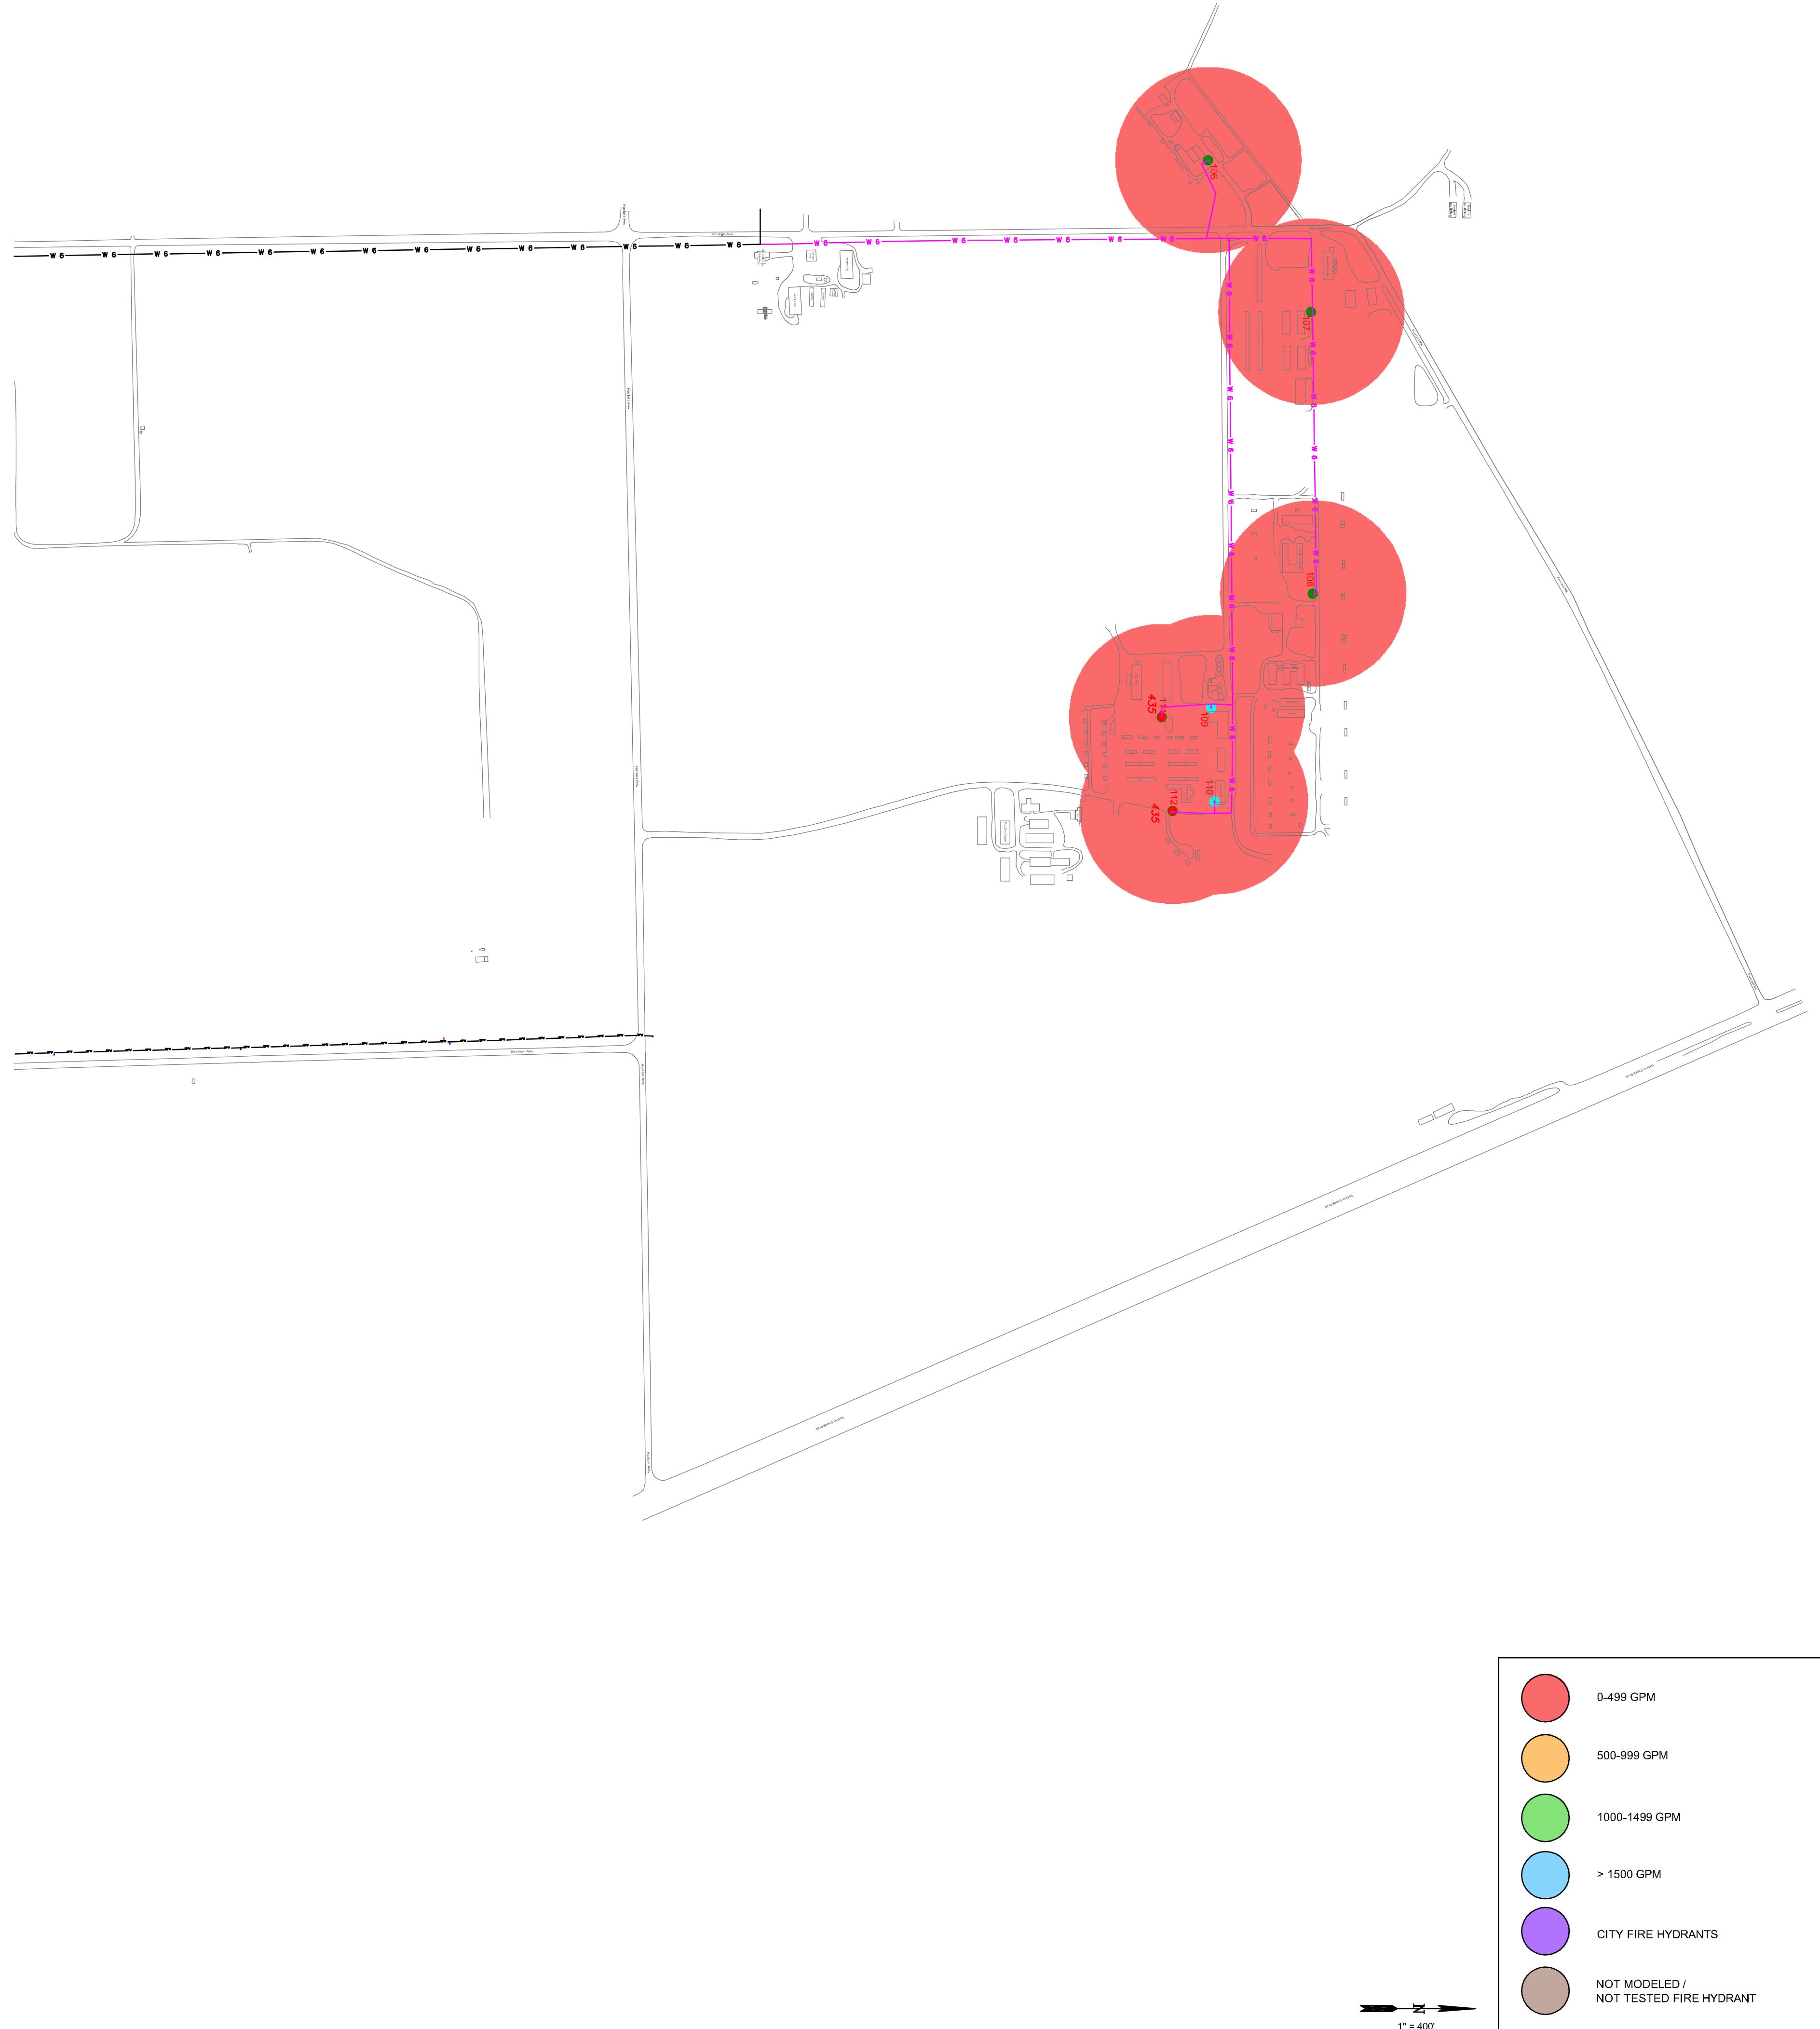
FIGURE 5A
AVAILABLE FIRE HYDRANT - 10" CONNECTION - OPEN

The Kansas Department of Health and Environment *Policies, General Considerations, and Design Requirements for Public Water Supply Systems in Kansas* states that fire hydrants should be placed at each street intersection and at intermediate points between intersections. Generally, hydrant spacing may range from 350 feet to 600 feet. This is the same standard as the Ten-States Standard (1997) and as recommended by the State Insurance Service Office. Two maps were created to illustrate the recommended 400 feet radius around each existing fire hydrant within the distribution system. These maps illustrate both the coverage and the NFPA Classification of each fire hydrant located within the distribution system and are located at the end of this section. Figure 4, illustrates the system coverage and available flows with the 10" Connection closed while Figure 5 illustrates the system coverage and available flows with the 10" Connection open.

As illustrated in Figure 5, the available fire hydrant flow at the time this report was completed, show fire hydrants that are expected to produce less than 1500 gpm at 20 psi. This is considered to be a secondary deficiency. The West Stadium Expansion project and the Basketball Training Facility were both under construction at the time that the computer water model was created. There is a potential that some gate valves were closed or that some waterlines were not in place during field testing. It is expected that upon completion of the construction projects, the fire hydrants in this area will produce the recommended fire hydrant flow rate. Therefore, at this time these fire hydrants are considered a secondary deficiency. It is recommended that these fire hydrants be tested upon the completion of construction and the results are included into the computer model in order to confirm the available flow rates.

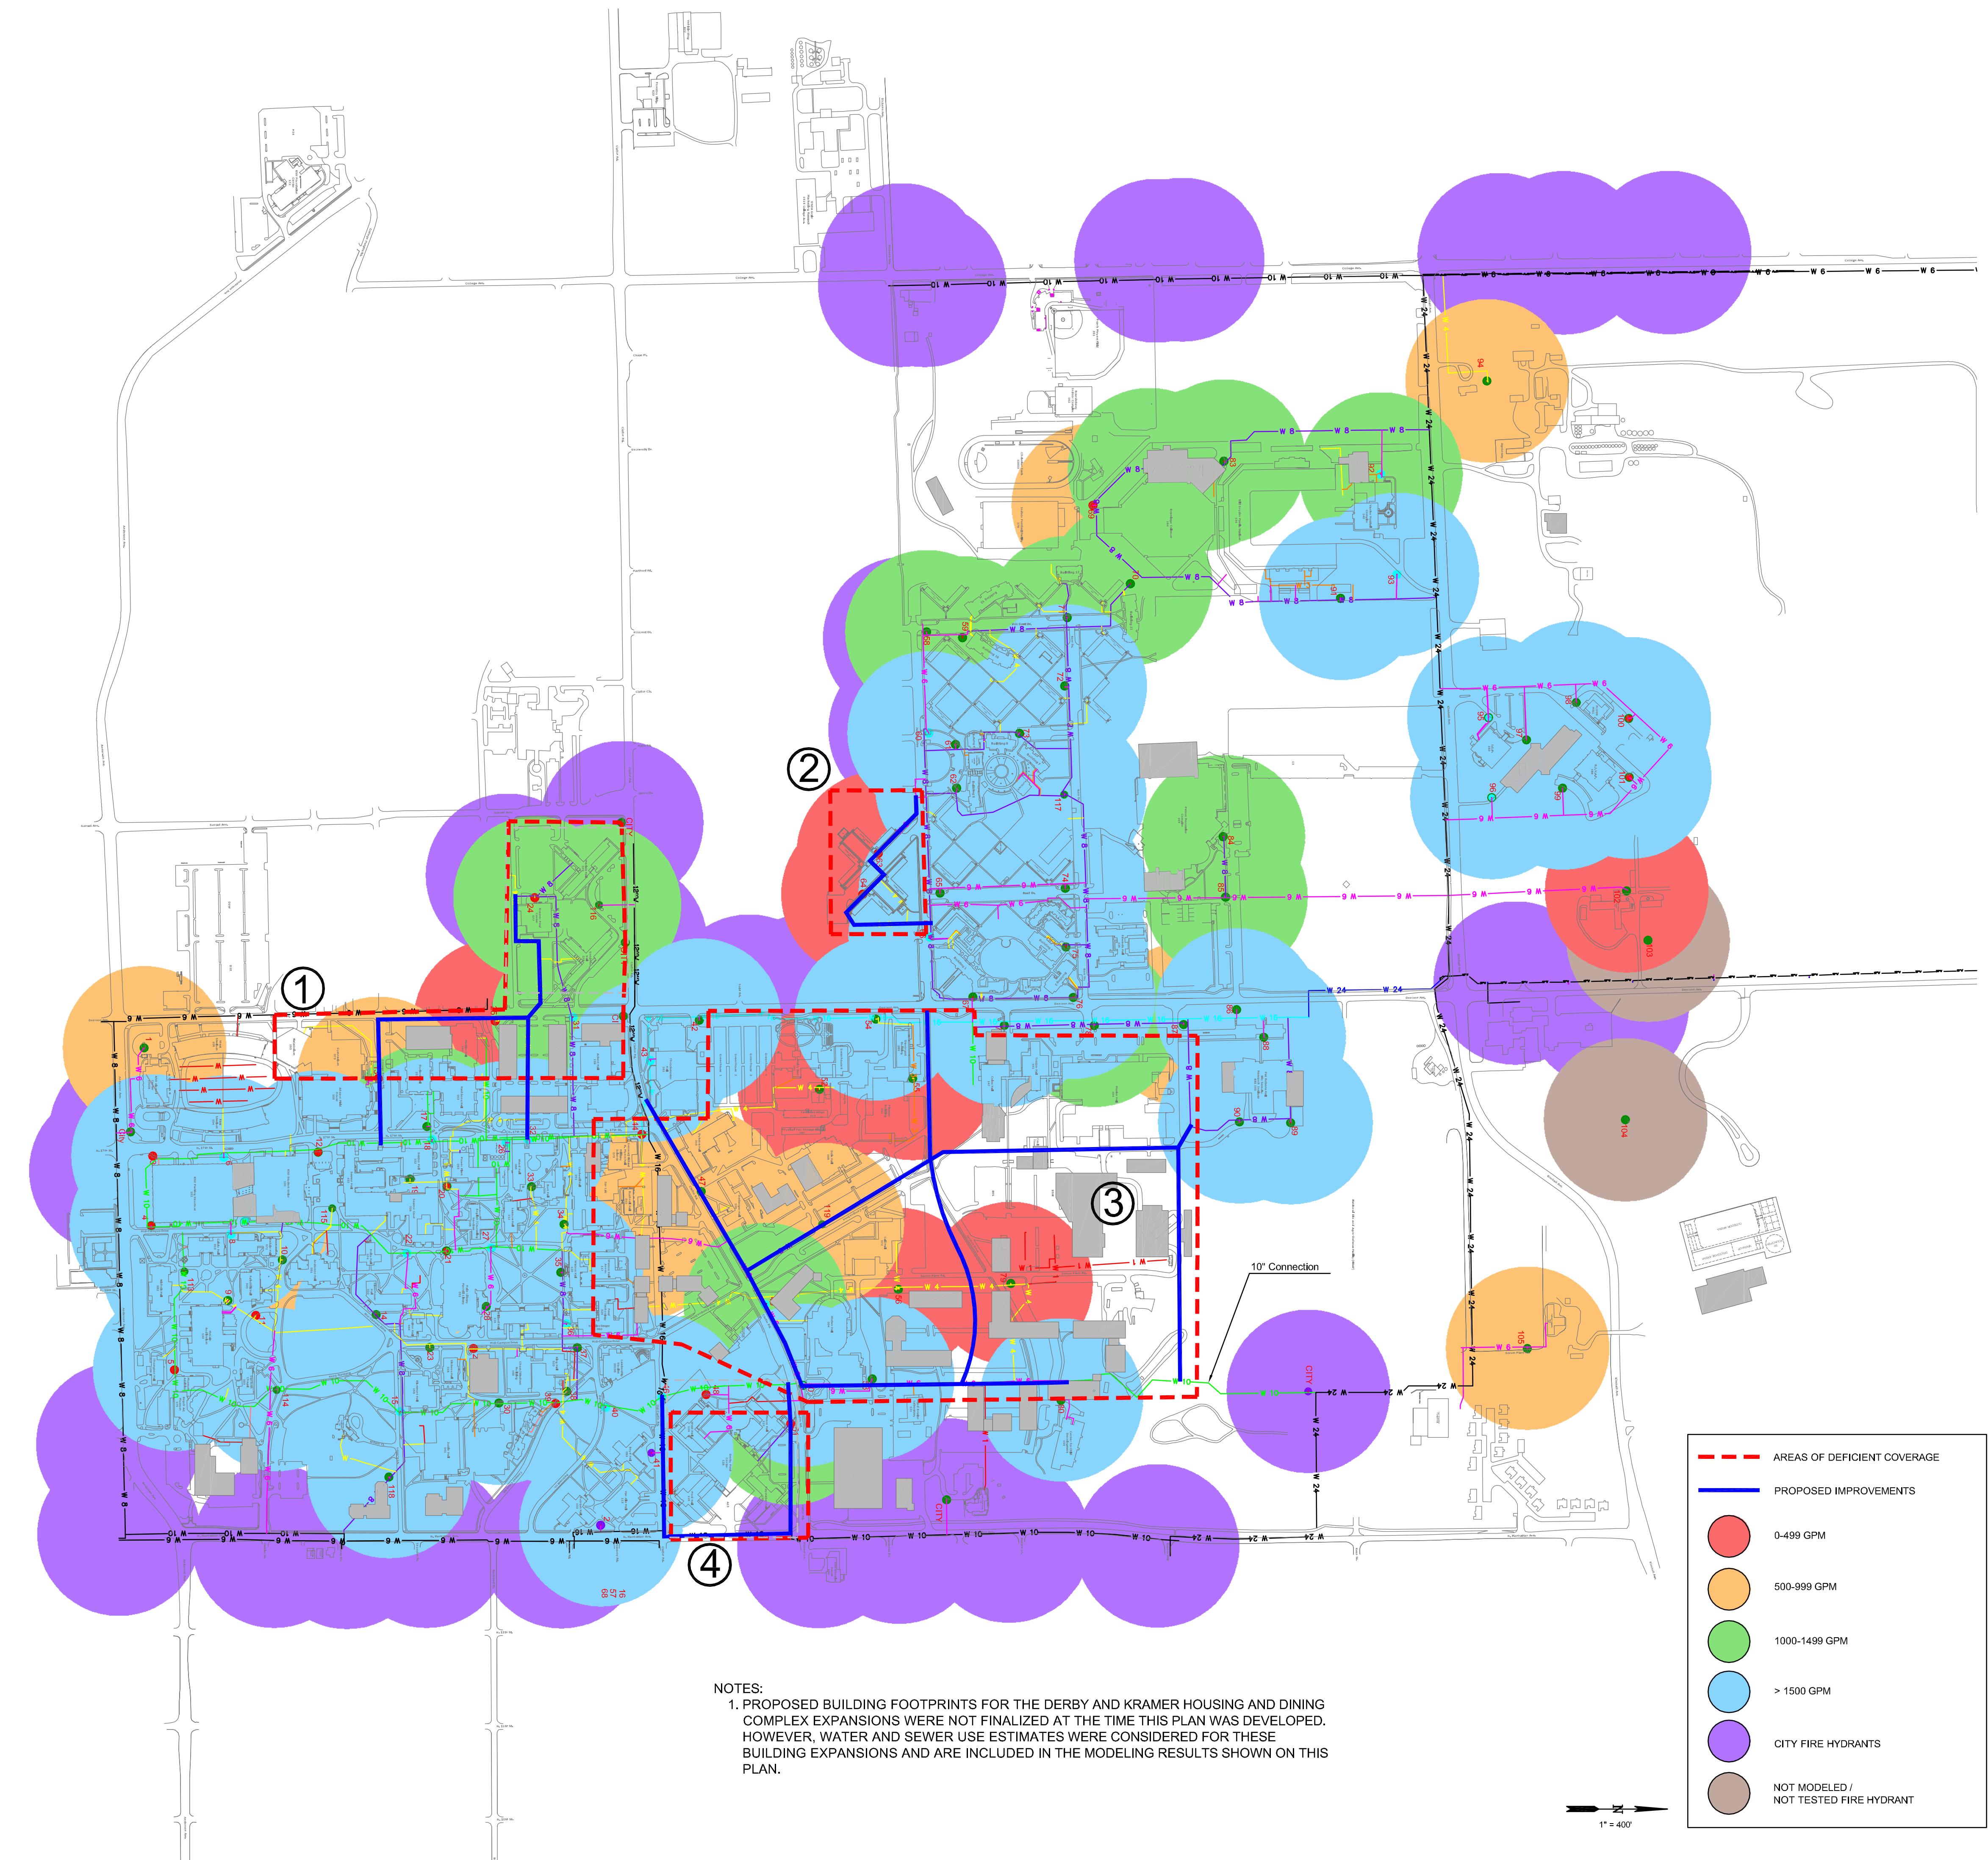
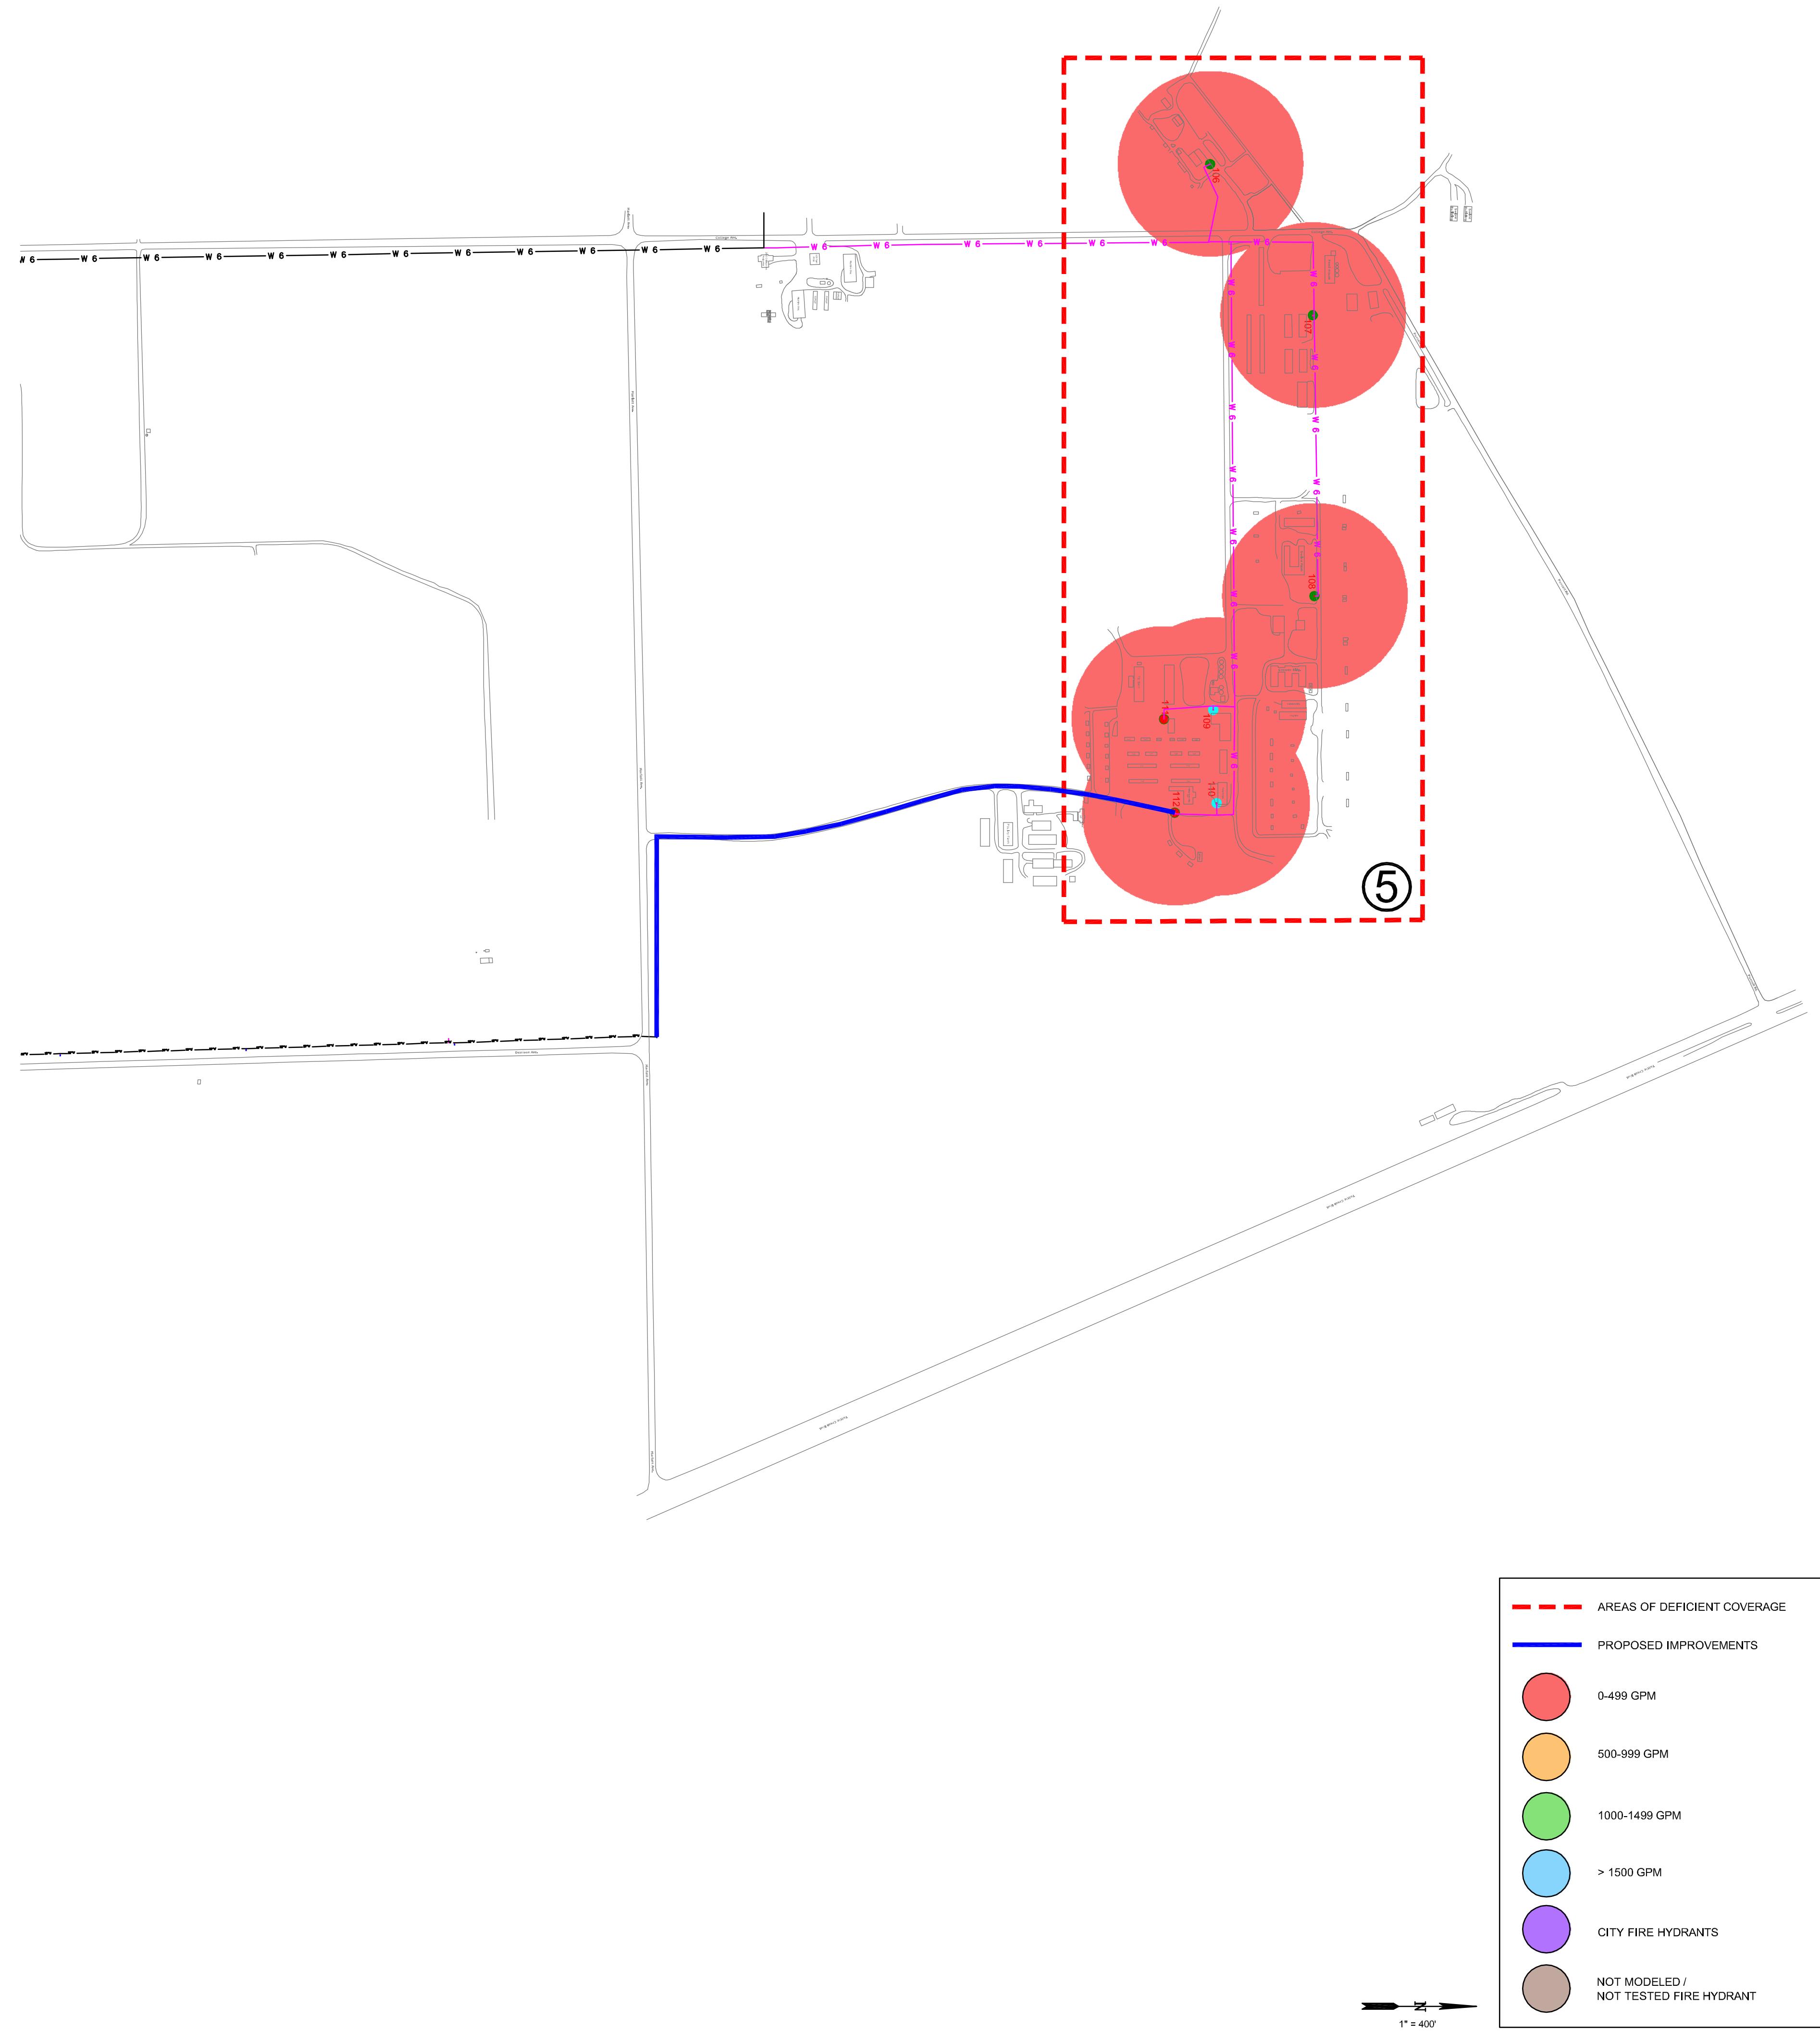
FIGURE 6A
AREAS OF DEFICIENT FIRE HYDRANT COVERAGE

The existing Kansas State University Potable Water Distribution has a few deficiencies, most of the deficiencies result from areas of campus that are not covered by fire hydrants that can produce the recommended flow rate of 1500 gpm at 20 psi. As illustrated in Figure 6, located at the end of this section, there are five main areas of concern.

There are 5 areas of the K-State Campus that are considered to be major deficiencies. They include area #1, the Engineering complex/Kramer Complex, Area #2, the South Jardine Apartments, Area #3, Umberger/Call Hall/Dole Hall/Mosier Hall, Area #4, the Derby Complex, and Area #5, the North Farm. Each of these areas is described below and is illustrated in Figure 6. The recommended improvements that are aimed at addressing the noted deficiencies are also illustrated in Figure 6. A detailed EOPC of each recommendation is included below.
