Session Number 5R

Semi-arid Green Roof Research 2009-2014: Resilience of Native Species

*Kansas State University, ¹Landscape Architecture and Regional & Community Planning;
²Horticulture, Forestry & Recreation Resources*

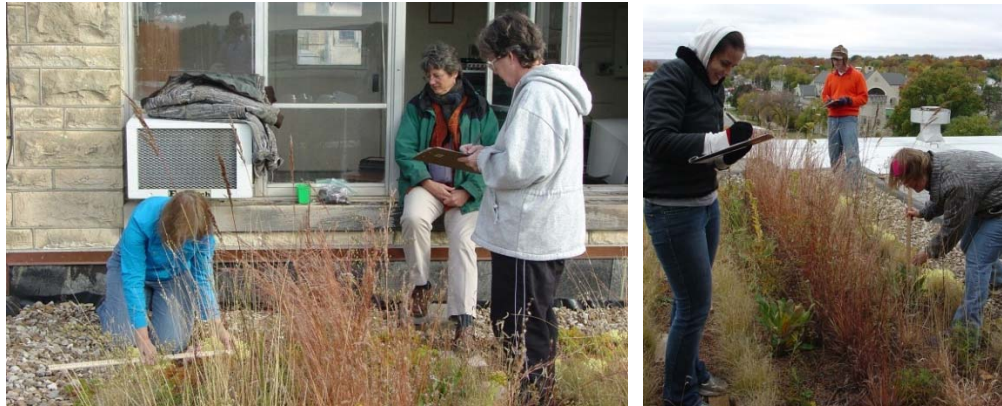
Figure 3. First-Year Monitoring Activities on UGR (Oct. 2009). Photos by Lee R. Skabelund

All measurements were taken at the end of the growing season but before complete senescence each year of the study (see Figure 3). To determine survival, plants were visually assessed for any greenness in the above-ground part of the plant. Plants with no visible evidence of green or any above-ground living parts were recorded as dead. A meter stick was used to measure plant height and diameter and a measuring tape was used to obtain the basal circumference of grasses. The number of flowering stalks were counted and recorded. Refer to Appendix A for an example of preliminary blue grama findings and analysis.

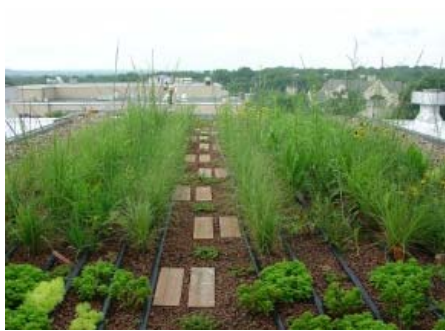
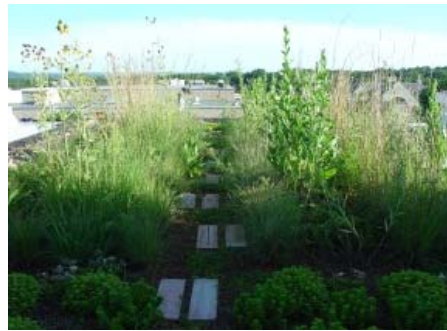
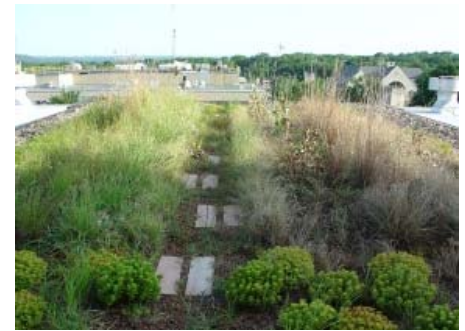
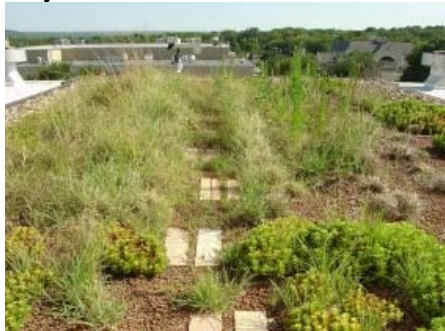
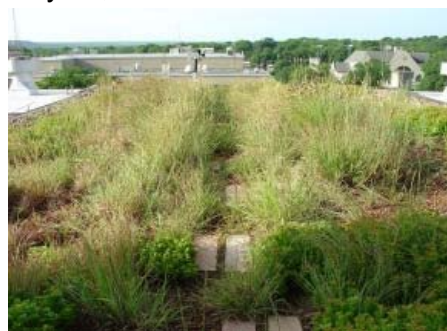
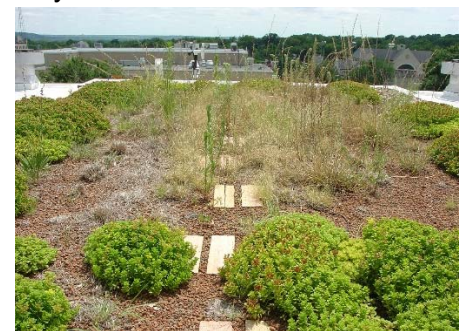
Figure 4. Time sequence photos (looking south) of mid-season growth. Photos by Lee R. Skabelund

UGR observations have been assisted by frequent photographs taken by the lead author (Figure 4). Photographic monitoring (with images taken from the same location month-to-month) provide a visual record of changes season-to-season and year-to-year. Following a four-week dry period in July 2014 (part of the sixth growing season), native grasses in substrates closest to sedums (typically in the 3-5 inch range) showed the highest rates of growth and survival on the UGR. This is likely due to the tempering of severe microclimatic conditions; average daily temperatures 5 cm below the surface between July 1 and Aug 31 during 2013 and 2014 were 2.36 to 3.51 C lower where sedums covered sensors S5-S7 (versus S1-S4). For an earlier period, Figure 5 shows high and low air temperatures July 1 to September 30, 2011 while Figure 6 reveals the influence of irrigation and non-irrigation on the UGR (leading to brownout on the west side).

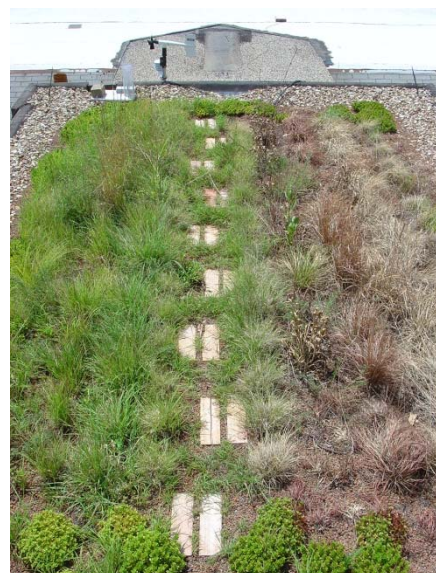
Figure 6. Effect of irrigation on green roof vegetation, Aug. 2011.
Photo by Lee R. Skabelund.
Note that the west (right) side of the UGR did not receive irrigation in 2011.

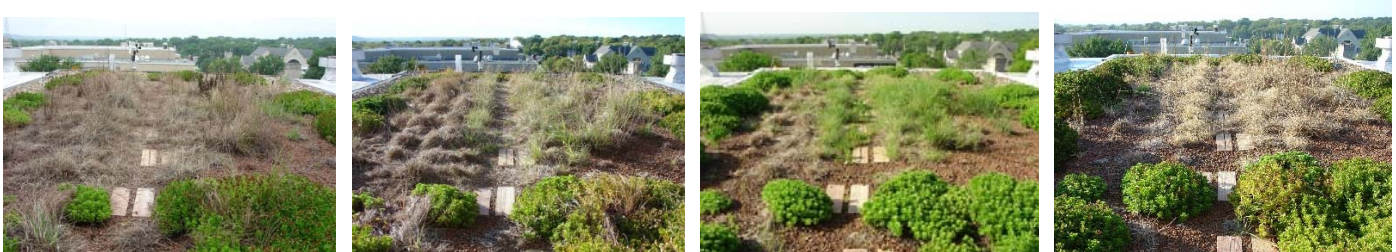
Figure 7. Green roof without Supplemental Irrigation (Aug. 5, 2013; Oct. 21, 2013; May 14, 2014; and Sep. 29, 2014). Despite high temperatures and extended periods without rain (including the three-week dry spell in July 2013), native vegetation survived without any supplemental irrigation. However, following the nearly four-week dry-spell in July and August 2014, minimal regeneration has occurred (as of Oct. 15, 2014).

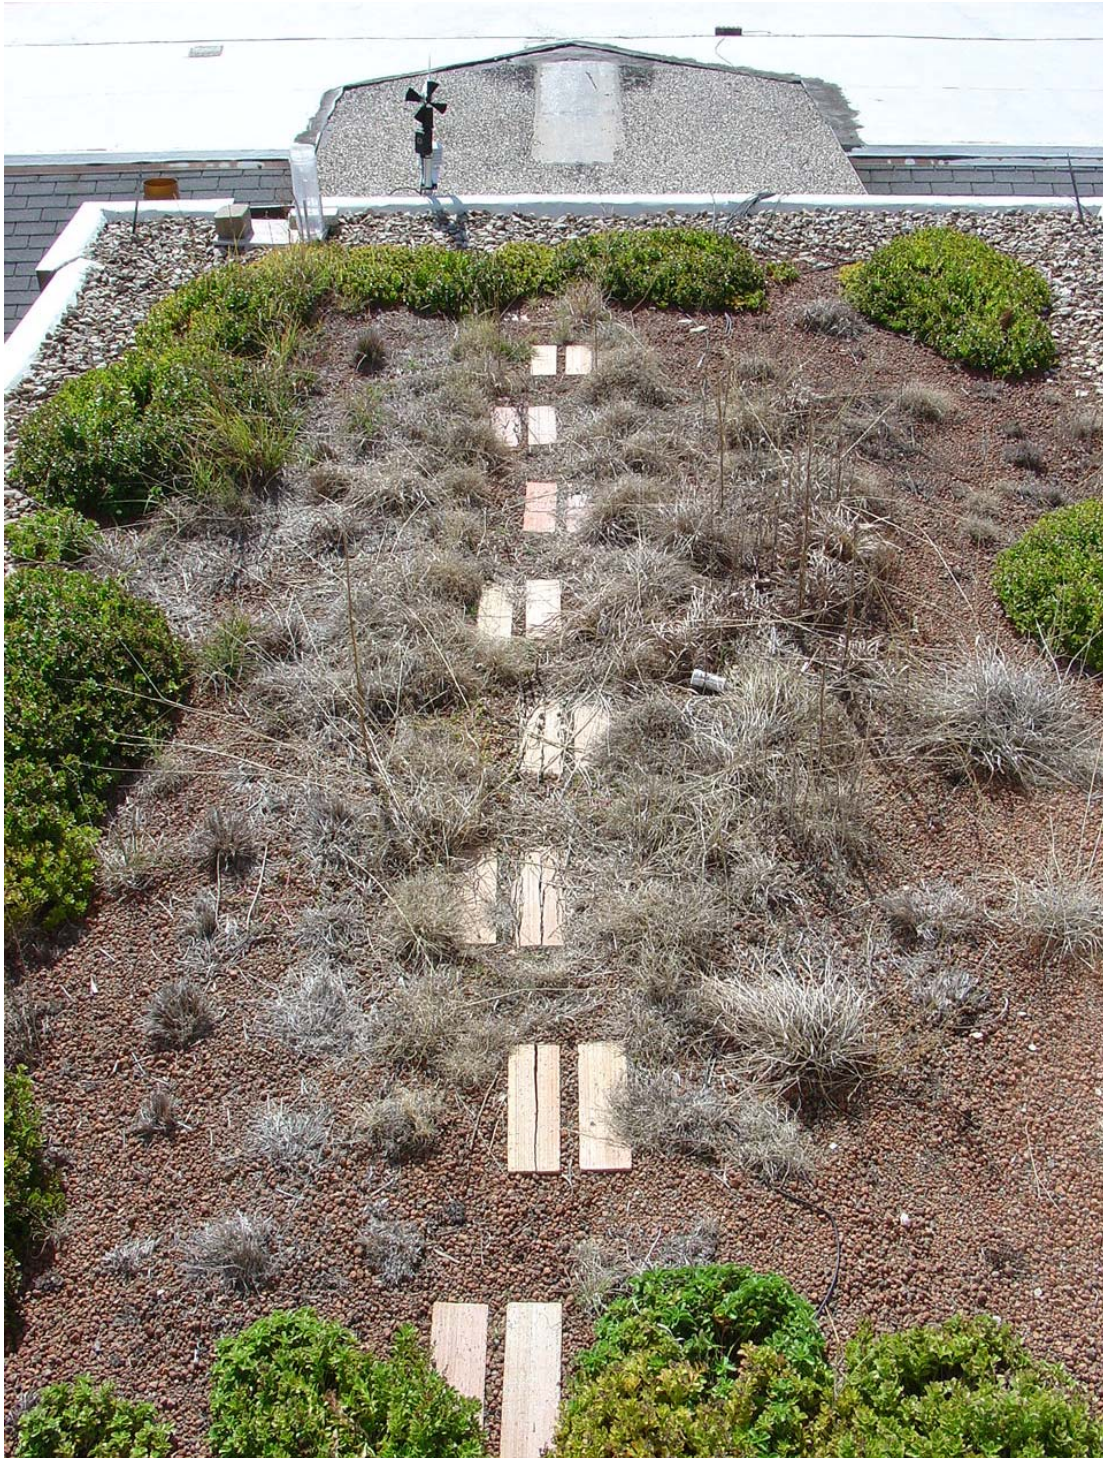
Appendix C1: KSU Seaton Hall Upper Green Roof - October 17, 2014 Photograph – L.R. Skabelund

Two surface sensors are visible in this photograph, two other surface sensors are buried: one by sedums on the southwest corner (upper right of the photo), the other by prairie grass biomass in the center east.

Between 2010 and 2011 the number of plants from the original plantings decreased from 130 to 98 for grasses and from 98 to 39 for forbs. At the end of 2012, grasses with visibly-green above-ground biomass remained at 98 while forbs increased to 54. By November 2013, original grasses numbered 68 and forbs 21. In May 2014, original grasses numbered 65 and forbs 25. However, many second-generation plants from seed were present (especially blue grama, side-oats grama, and little bluestem). Species such as common spiderwort and prairie dropseed continued to survive on the Upper Seaton Hall Green Roof through the end of 2013 and into early July 2014. Despite no irrigation on the 10 to 18 cm substrate since mid-August 2012, more than 80 native plants were still alive in mid-October 2014 (refer to Appendix C1 & C2 for photos).
