MBACI Monitoring Set-Up for Tallgrass Prairie Restoration on Kansas State University Campus

Department of Geography and Geospatial Sciences

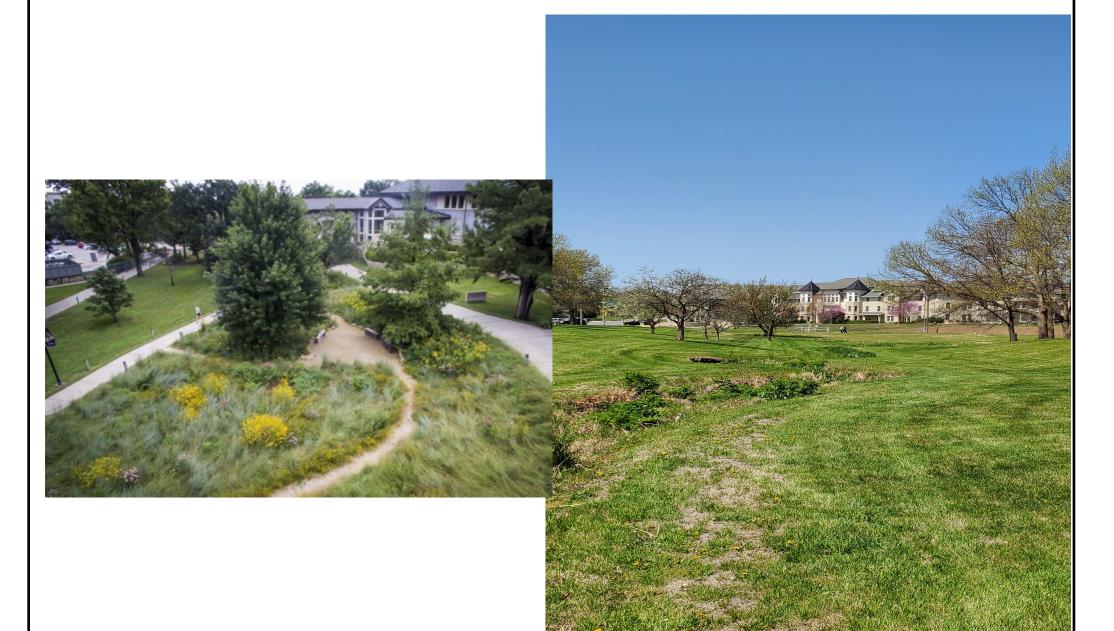
Figure 2. On left restored tallgrass prairie on the KSU campus called The Meadow. On right, the proposed location of tallgrass prairies restoration south of Coles Hall on the KSU campus.

location is The Meadow near the Beach Art Museum (Fig. 2, left), which was completed in 2013. The Sustainability Coalition is currently investigating

converting Coles Hall lawn (Fig. 2, right) to tallgrass prairie. Coles Hall lawn is situated near the headwaters of Campus Creek, south of Coles Hall, and if restored, could help with improving water quality and reducing flooding.

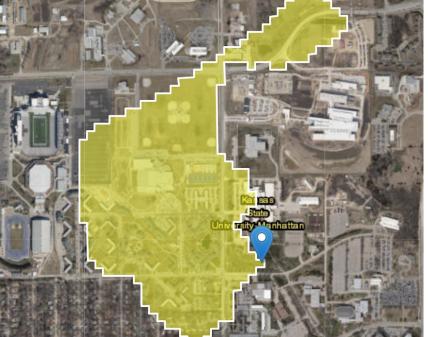
Figure 3. Coles Hall StreamStats watershed area (0.25sg/mi).

The comparison between Coles Hall impact site and the Konza prairie control site watershed area and soil types are depicted below in Figures 3 and 4, and Table 2.

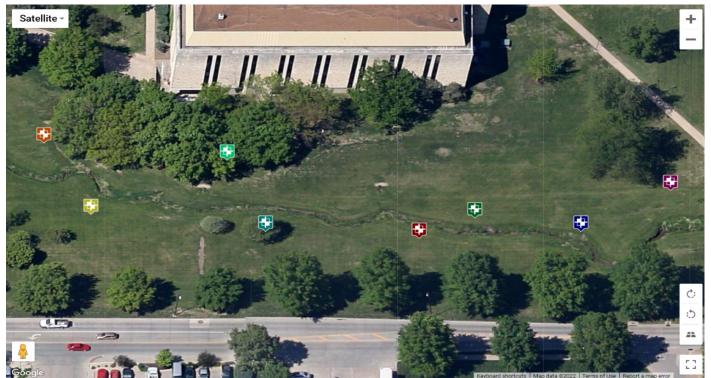
Figure 5. Locations of where the soil samples were taken from Coles Hall and tested for Bulk Density and Soil Texture.

Soil samples were taken from eight different locations on the Coles Hall lawn (Fig 5.). The goal was to collect data on each side of the stream, as well as both near and far from areas with trees. To analyze the soil properties, a 1-cm diameter soil sampling probe was used to obtain samples to a depth of 15-cm. Soil properties obtained from this sample included bulk density, soil moisture, and soil texture.

• Bulk density ranged from 1.029g/cm³ to 1.396g/cm³ (avg. $1.23g/cm^{3}$)

Gravimetric water content ranged from 17.37% to 32.51% • The texture classification of the soil samples taken at Coles Hall were both silty clay loam using the hydrometer method, which differs slightly from Web Soil Survey.
