# Compromised Water Quality at Milford Lake and Potential Remediation Strategies

Ashton Pickering, Brady Wolken, Makayla Oeding, Dawn Ledeboer, and Sydney  
Tumberger

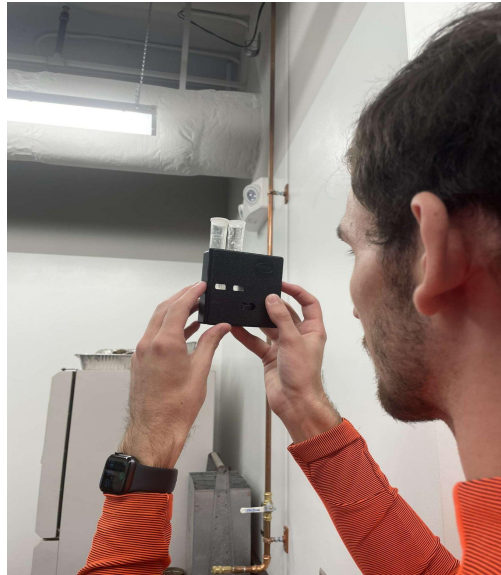
**Figure 2**

To test for nitrate, phosphate, and ammonium, we used a water quality chemical testing kit with a color disc. Each test required the addition of specific chemicals that would detect the concentrations of certain ions, so each test needed to be done separately. Figure 2 shows the testing procedure that the group conducted for nitrate, phosphate, and ammonium.

*Nitrate, phosphate, and ammonium testing*

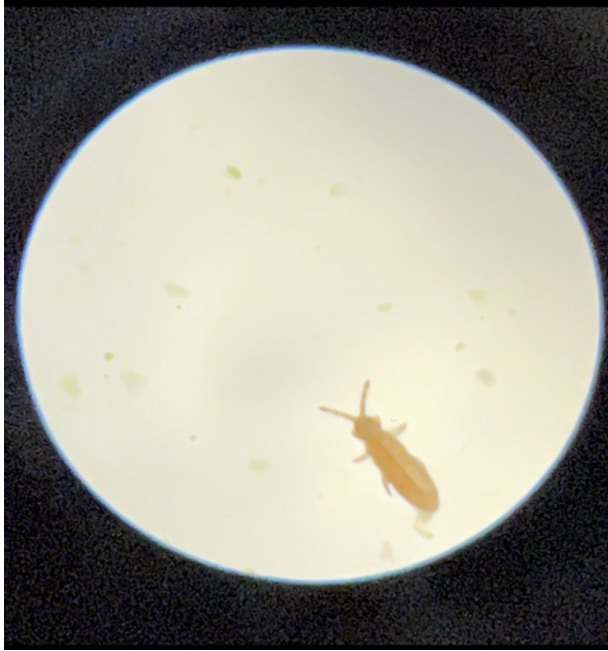
Scud (*Diporeia*)

Our research group did an aquatic macroinvertebrate survey at two different points and found there to be similar insects at both points. The two points we surveyed were South Milford State park and Milford Dam. We found *Diporeia* which is a tiny shrimp-like organism also known as Scud. We also identified Tadpole shrimp (*Notostraca*), springtail (*Collembola*), Flatworm (*Planaria*), Riffle Beetle (*Elmidae*), Darner dragonfly larvae (Aeshnidae), Mayfly larvae (*Ephemeroptera*), snails (*Gastropod*), Zebra mussel (*Dreissena polymorpha*), Water boatman (*Corixidae*), and mosquito larvae (*Culicidae*). Pictures of our samples can be found in Figure 4.

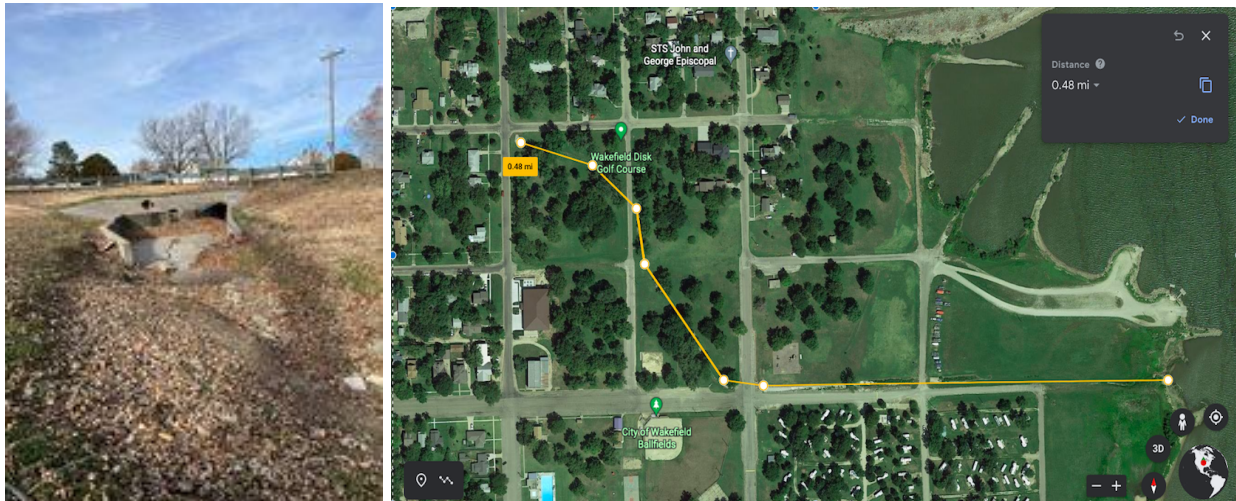
**Figure 13.**

Surface runoff carries debris, fertilizers, herbicides, and pesticides into water sources (Pearson et al., 2018). These pollutants are a contributor to the degradation of water quality in lakes, wetlands, estuaries, and groundwater. The local community's infrastructure in the town of Wakefield and Milford both contribute to water pollution through surface runoff that ends up in the lake. Road debris can include a collection of soil, plant matter, and waste materials that accumulate along the edge of roadways and eventually find their way into waterways. If road debris or other pollutants like fertilizers that nitrogen (N) and phosphorus (P) are able to leach into water reservoirs, water quality degradation would likely occur and create an ideal environment for eutrophication (Pearson et al., 2018). A solution to reduce the amounts of pollutants entering the lake that come directly from Wakefield and Milford would be to create rain gardens. Water From Wakefield's sewer drains, shown on the left in Figure 13, runs into the lake along this route. The image on the right in Figure 13 shows where a rain garden could actually be installed to reduce their local contributions.

*Sewer drains in Wakefield, Kansas on the left and possible rain garden system on the right*

gardens can be designed and installed along the sewage systems of Wakefield and Milford. Not only will these rain gardens absorb pollutants in water runoff from storms, but it will also bring more jobs to these small communities through rain garden construction and ongoing maintenance. Installing floating wetlands to Milford Lake can bring about more jobs as well as another source of profits through tourism. Many lakes do not have floating wetlands, so this tactic will bring tourists of all types while it also cleans and filters the lake water. Finally, annual or semi-annual sediment release can benefit plants and wildlife at Milford Lake. Sediments will not be trapped and can travel downstream, bringing nutrients from the Republican River into the Kansas River and preventing the buildup of excess nutrients in Milford Lake that in turn cause toxic algal blooms.

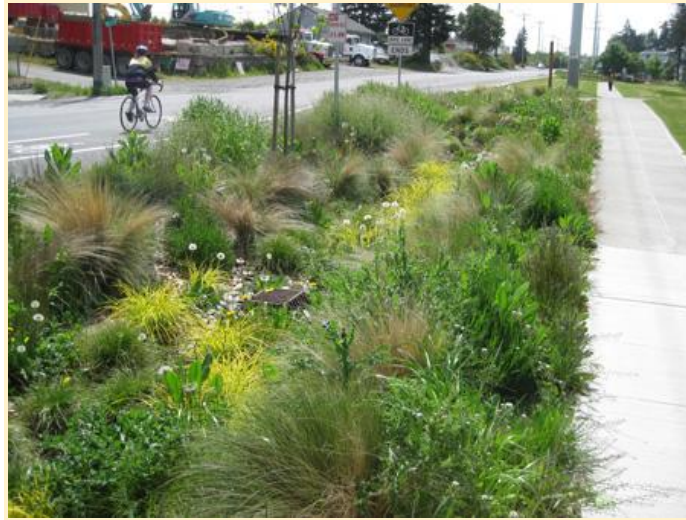
**Figure 14.**

The use of native plants and wildflowers can help animals and insects like pollinators survive and thrive in urban environments. Additionally, the use of native plants and wildflowers in towns is aesthetically pleasing due to their natural beauty. A rain garden was installed along a roadside in Seattle and is shown in Figure 14.

*Rain garden found in Seattle, Washington*

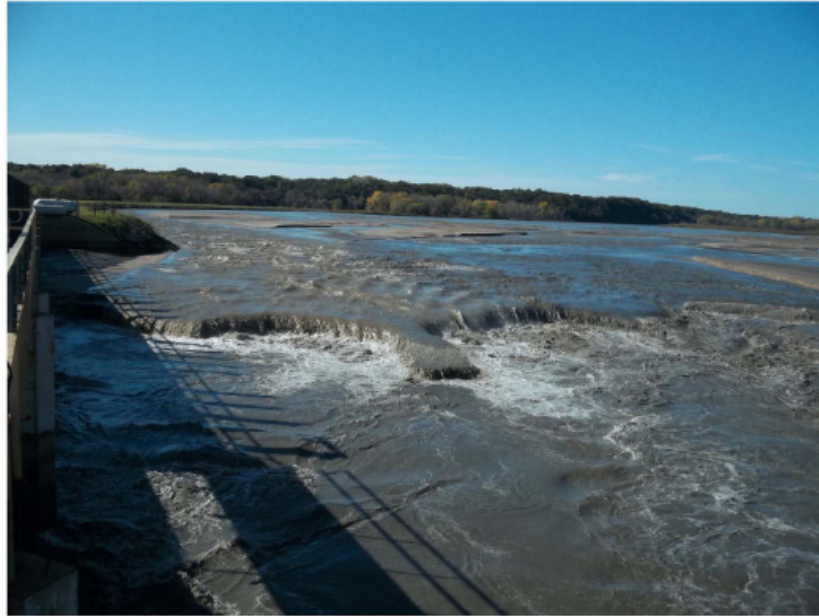
**Figure 15.**

Because sediment plays a major role in nutrient absorption and release, it is necessary to develop a system or process to improve sediment flow and release in reservoirs. Too much sediment accumulation in reservoirs can lead to a multitude of issues including a decrease in reservoir benefits, environmental damage, and an increase in cost of maintenance and management (Shelley, Hotchkiss, Boyd, & Gibson, 2022). Authors Shelley, Hotchkiss, Boyd, and Gibson conducted research on different sediment release methods that have worked successfully at different reservoirs in the United States. The study conducted closest to Milford Lake takes place at Spencer Dam located in northeast Nebraska (Shelley et al., 2022). While the dam failed in 2019 due to issues with ice, observations and studies were done prior to this event (Shelley et al., 2022). This reservoir had high levels of fine sand sediment that flowed from the Niobrara River through the Sandhills region of Nebraska (Shelley et al., 2022). Issues began once the reservoir started filling with this sandy sediment, similar to Milford Lake sediments, as discussed above. Engineers and project managers developed a plan to release sediments by performing a semiannual, two-week drawdown flush (Shelley et al., 2022). This process allowed sediments and water overflow from the reservoir to flow downstream freely for two weeks straight. It created sandbars downstream that naturally eroded away by the time the next flush was due (Shelley et al., 2022). While profit loss is a negative effect of this procedure, since no hydropower can be produced during this two-week process, it would cost a great deal more to have to hire professionals to clean out the sandy sediments that would eventually block important valves and piping systems. Another concern that authors in this article found was fish killing due to a rapid release of stagnant water with low levels of dissolved oxygen (Shelley et al., 2022). Fortunately, this problem can be solved. Engineers of the Spencer Dam resolved the conflict by slowing down the initial drawdown to decrease the impacts of water with low dissolved oxygen levels (Shelley et al., 2022). In conclusion, sediment release is an important process to keep stagnant water and sediment fluxes constant so that there is not an excess buildup of these sediments and the nutrients that they absorb and release. Figure 15 shows sediments traveling from Spencer Reservoir during a flush.

*Sediments traveling from the lake during a flush (Shelley et al., 2022)*

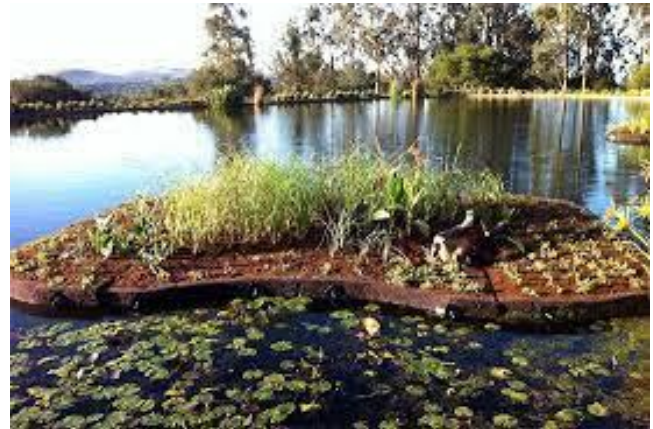
**Figure 16.**

Much like rain gardens, floating wetlands are a good solution to remove nitrogen, phosphorus, and other pollutants from water sources. Floating wetlands can be used in areas where water is too deep for plants to grow and thrive. These wetlands can be installed on top of any water surface, and then anchored down. Since they are anchored they can be moved if necessary. The International Institute for sustainable development conducted research on using floating wetlands to treat eutrophic freshwater lakes. In this study they used cattail plants to treat the water and remove excess nutrients. In order to remove the nutrients from the water fully, management action would be necessary to remove plant materials at the end of the growing season. The removal of these plants from the floating wetlands would ensure that the plant matter and the nutrients stored within them would not be cycled back into the water. The results of this research and previous research found that the removal of plant matter should occur in August or September, in order for the plants to survive the cold winter months (Grosshans 2014; Grosshans 2019). Floating wetlands may also help reduce algae blooms by reducing the water temperature. Since the wetland will float on the surface of the water, this will create a barrier in between the sun and the water's surface. The Minnesota Pollution Control agency states that "Blue-green algae prefer warm, calm, sunny weather and water temperatures higher than 75°F" (*Blue-green algae and harmful algal blooms, 2022*). Reducing the amount of available nutrients is going to be the biggest factor in controlling algae blooms but lowering the water temperatures still will also be helpful. A picture of a floating wetland is shown in Figure 16.

When considering where to install floating wetlands at Milford lake, it may be necessary to install them where water enters the lake. Additionally, wetlands should be placed in areas of

the lake that are more shallow as identified in Figure 16. Placing them in areas that are more shallow will have the biggest effect on lowering the water temperature.

*Floating wetland found in a lake ( Kansas department of Health and Environment)*
