***Sediment Surge: Predicting the Downstream  
Effects of Water Injection Dredging at Tuttle  
Creek on the Big Blue River***

Research Report

DAS/DEN/GENAG 582

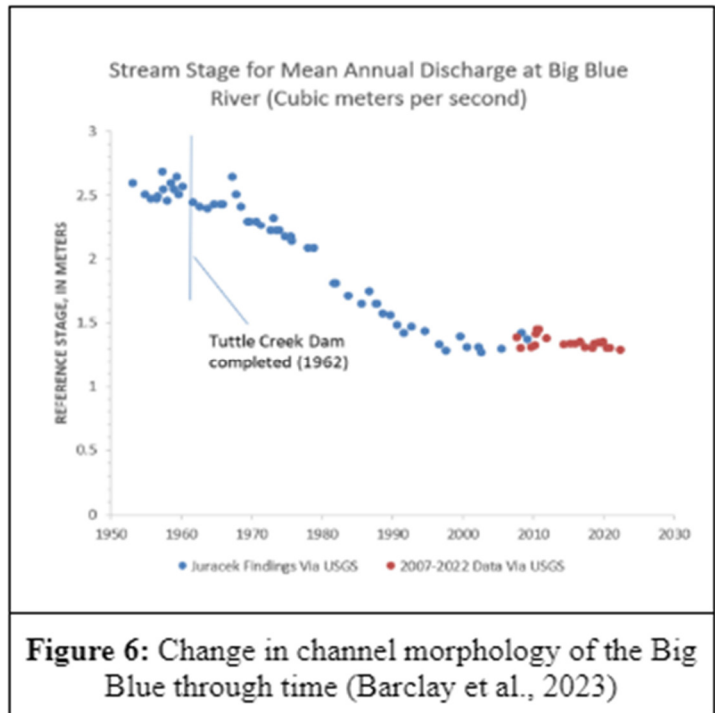
The Big Blue River has seen many changes to its channel in the past hundred years. The event that brought the most change to the channel was the flood of 1951 which shortened the river channel length and greatly reduced the sinuosity (Weatherly, 1994). Shortly after, and as a result of the constant flooding, in 1962 the Big Blue River became Tuttle Creek dam and reservoir, halting the steady flow of the river into its downstream counterpart. Barclay and his team worked to analyze the results of installing the Tuttle Creek dam, they looked at daily discharge, pulse count, pulse duration, hydrography rise rate, peak flow date, peak discharge, and return interval which are all summarized pre-dam construction and post-dam construction in the

image. Up until the late nineties the elevation of the Big Blue river was declining post dam construction (decreasing by a total of 1.6 meters). Soon after the bed stabilized and remained degrading at a steady rate, seen in Figure 6.(Barclay et al., 2023). Degrading is typical of a sediment starved river as there is less sediment to deposit which makes the bed unable to accumulate which makes the elevation raise.

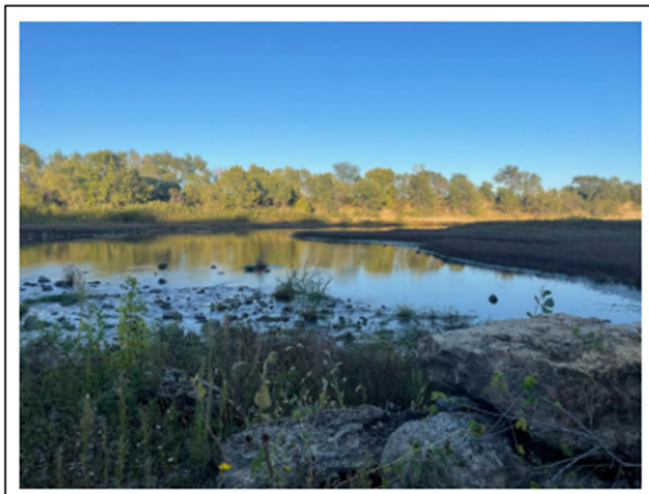
**Figure 9:** Rocky Ford Recreation Area downstream of Tuttle (Raja Brockenberry)

is also a dam, once used for milling and power as seen in Figure 9 (KDWP, 2023). Today, the milling foundation still stands and the area is largely used for fishing. At the time of our data collection the water was low and many sand bars were found throughout the area and vegetation and wildlife were abundant. Further downstream on the Big Blue, Dyer Road crosses overhead, this is where our second set of collections were taken. Water injection dredging poses unknown effects to the downstream area, therefore a year from now, the area may look starkly different. The geographic relationship of our study area can be seen in Figure 10.

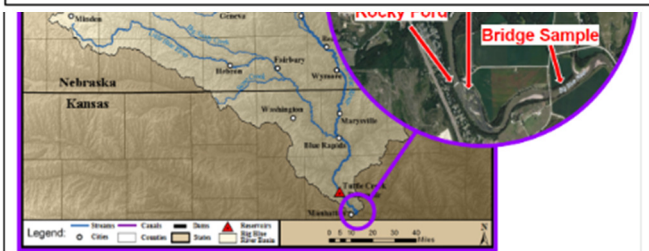
**Figure 10:** Our Study Site (Nebraska Dept. of Natural Resources, Palmer Bowles 2023)

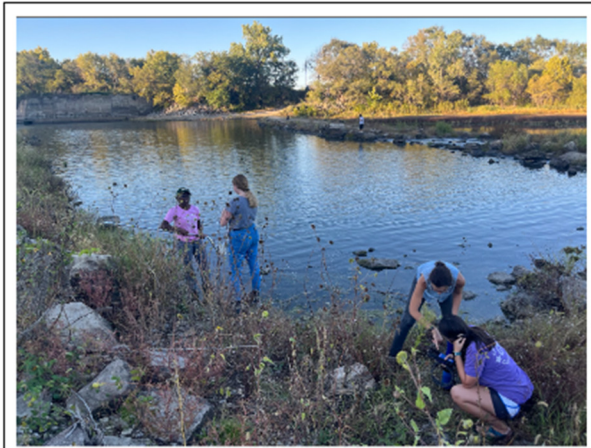
Figure 11: Group Sampling at a Small Pond adjacent to Rocky Ford (Palmer Bowles)

At our research sites, our groups conducted multiple water and sediment tests in order to establish baseline conditions (as seen in Figures 11 and 12). These tests were conducted on October 5th of 2023 at a discharge of 581 ft<sup>3</sup>/s. It is worth noting that this was an extremely low water year for the Blue River watershed and therefore it is predicted that these results would vary in a more precipitous year. Our data collection/river sampling equipment consisted of a YSI multi parameter sonde (EXO3) with sensors for dissolved oxygen, temperature, conductivity, pH, turbidity, chlorophyll-a and phycocyanin pigments. Additionally, we used a soil corer in order to gather reliable and consistent soil samples. These samples were then sorted and

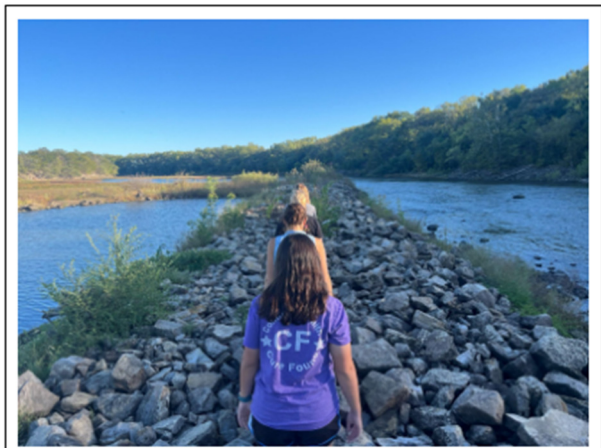
Figure 12: Sample Collection below Rocky Ford (Palmer Bowles)

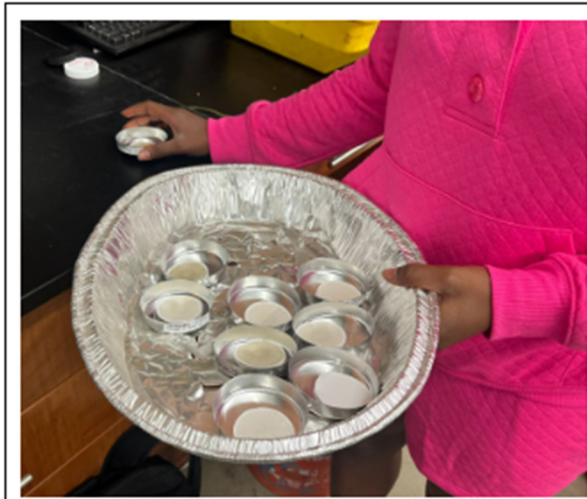
**Figure 13:** The Eight Samples on the Micron Filters (Palmer Bowles)

unused filters on a vacuum pump attached to a filter bottle with a 0.45 micron filter mesh to separate the solids from liquids. From there, we poured the 100 mL sample over the 0.45 micron filter. After distributing the water sample on the filter, we then removed it from the vacuum pump and placed it on a tin plate to be dried at 105 degrees Celcius for 24 hours before re-weighing it (as seen in Figure 13). We then repeated this for all 8 samples in addition to a “Blank” sample to serve as a control variable. After thoroughly

drying the samples, we then reweighed the dry filters and subtracted the weight from the initial weight/control variable weight in order to determine the sediment weight.
