# Influence of Waterfowl on Water Quality at Marion County Lake

Jessica Jurczak<sup>1</sup>, Kristen Kimbrell<sup>2</sup>, Kirsten Prindle<sup>1</sup>, Nathan Ryan<sup>2</sup>

<sup>1</sup> Department of Biological and Agricultural Engineering, Kansas State University  
<sup>2</sup> Department of Agronomy, Kansas State University

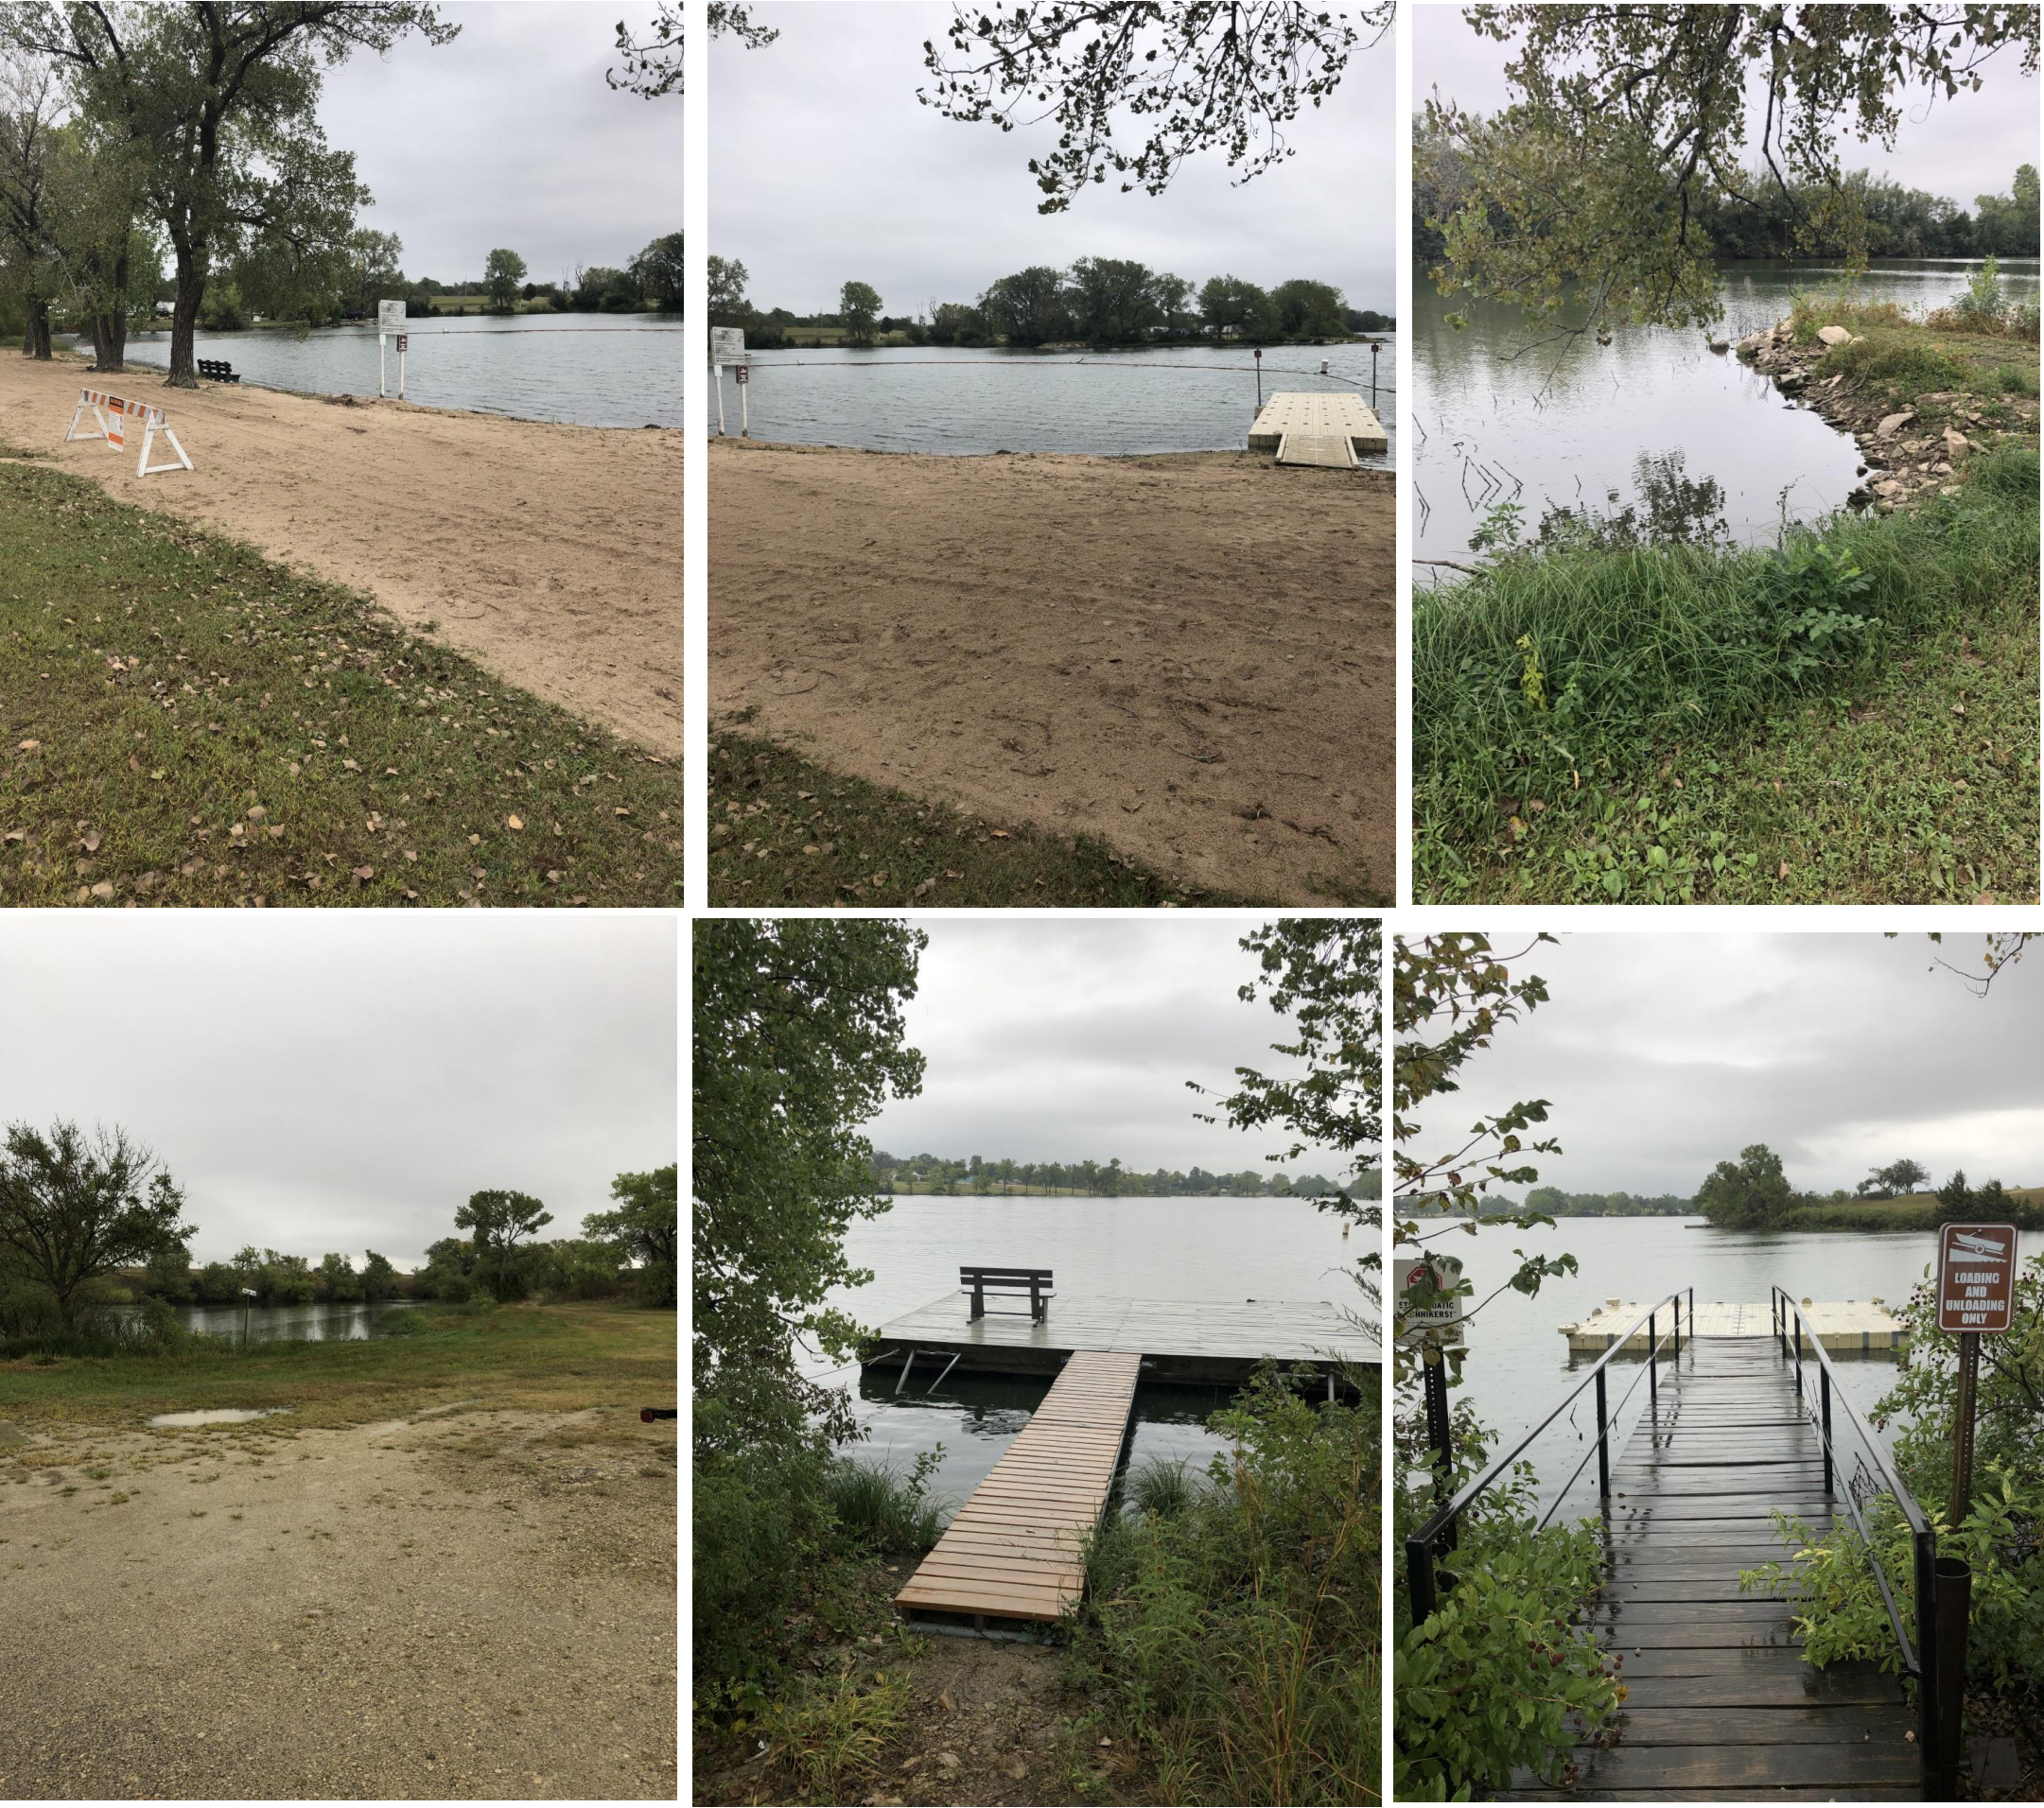
Fig 1: Water and fecal sampling locations around the perimeter of the lake.

Two different experiments were performed using samples acquired from Marion County Lake. Water samples taken from four locations around the lake's perimeter were used to run water quality tests, while goose excrement gathered at one of the sites was used to test the nutrient leaching. The procedures of both experiments are detailed below.

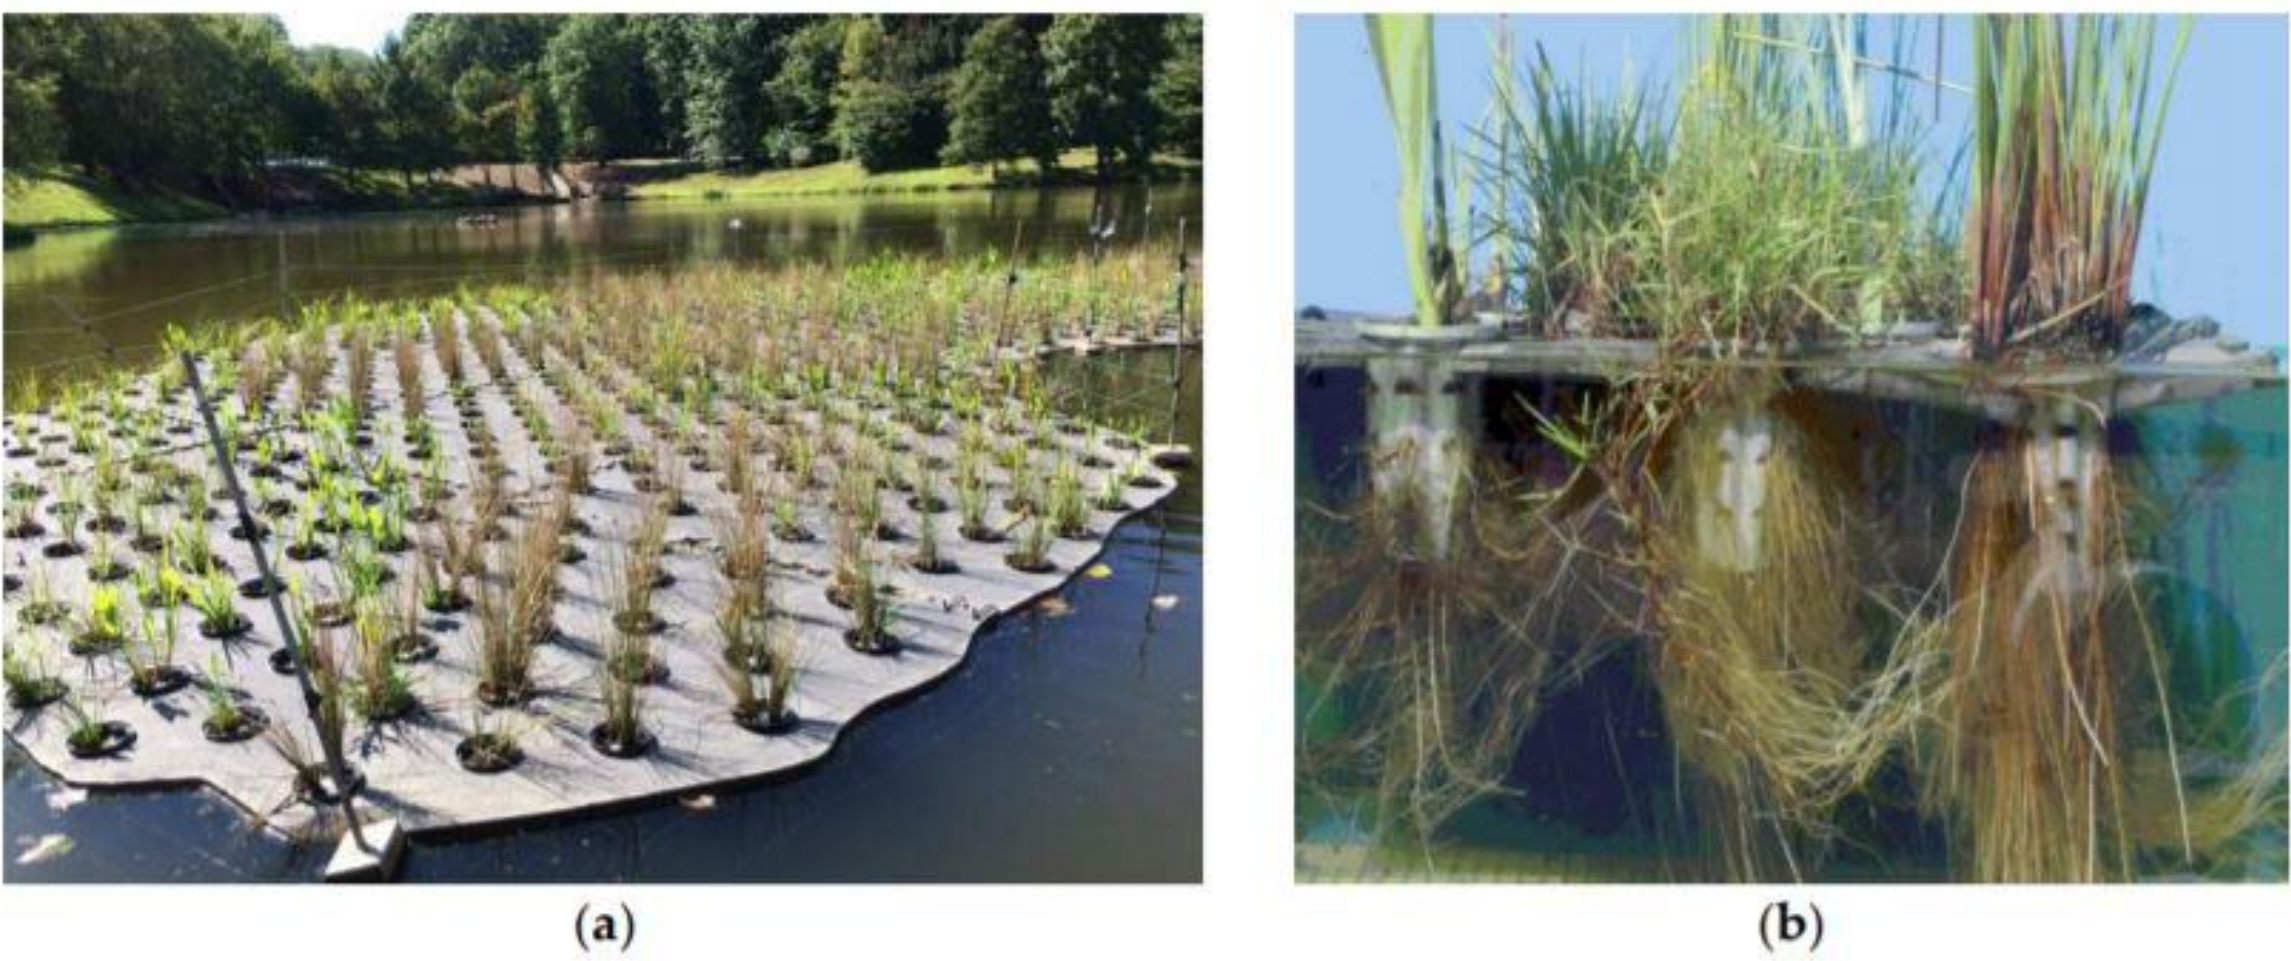
Figure 4: A surface view (a) and a cross-sectional view (b) of the "Beemat," a floating waterbed treatment system (McAndrew et al., 2016).

Floating waterbed treatment would be the most viable solution to implement on the lake. Floating waterbeds are foam mats constructed to hold submerged vegetation. They have been proven to have high nutrient removal efficiencies using native vegetation. The "Beemat" floating waterbed shown in Figure 4 has a nitrogen removal rate of 0.01 g/m<sup>2</sup> of matt/day (McAndrew et al., 2016). Floating waterbeds are also cost effective and can be easily self-assembled. Floating waterbeds are meant to be in waters equal to or less than five feet deep.

For Marion County Lake, these waterbeds can be tethered in place at shallow coves away from boating, fishing, and swimming areas. Based on the research conducted, approximately 1 acre of the 300 acres of the lake water surface area would need to be covered by floating waterbeds. However, a smaller initial amount of floating waterbed matts can be implemented, and the matts can be added or removed as needed. To keep any waterfowl from walking on the waterbed or consuming the vegetation, small wire or net fencing can be placed around the perimeter of the floating waterbed. The only maintenance required for the floating waterbeds is cleaning debris that accumulates on the matts and harvesting the biomass.
