# Sylvan Grove Farmer's Elevator Company

## Corrective Action Study

5/7/2012

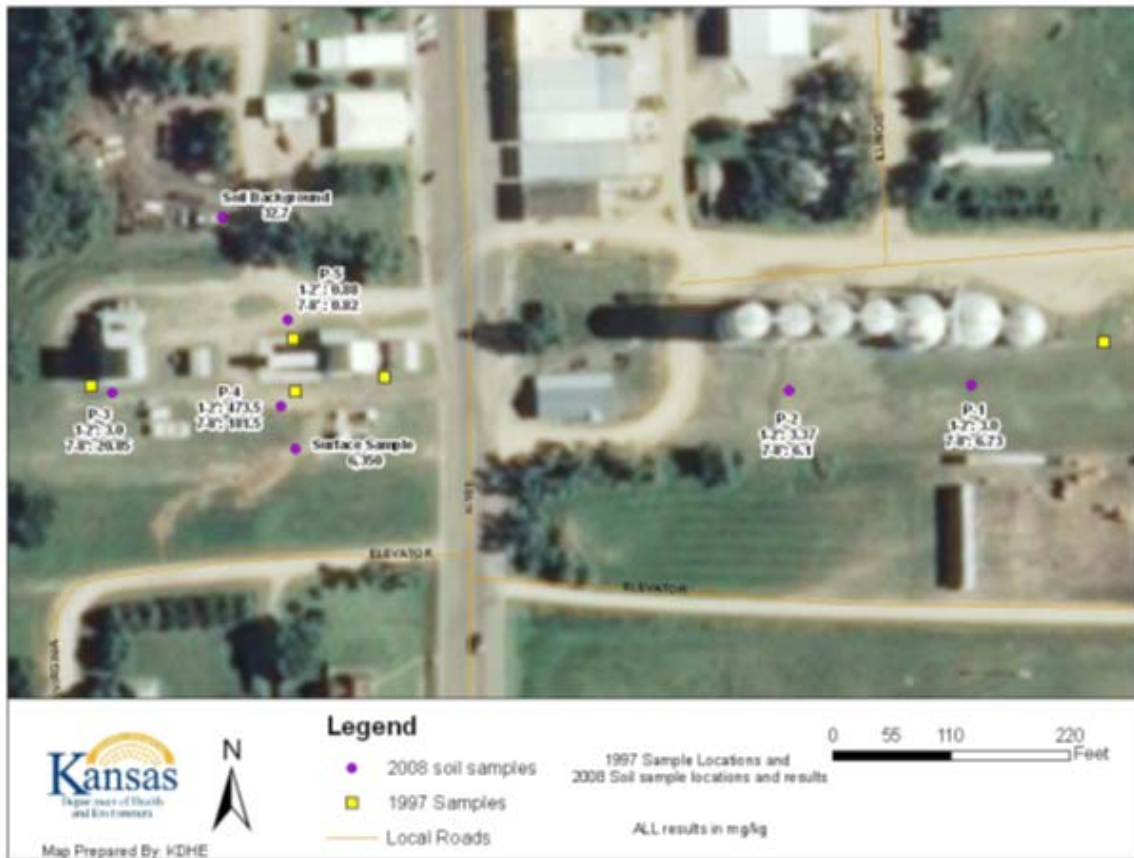
**Figure 1: Location of May 2008 Soil Samples**

This investigation's focus is the area south of the elevator and west of the sump. This general area revealed the highest nitrate contamination in the 2008 KDHE report and appears to have "scarring" typical of a synthetic nitrogen fertilizer spill. To determine the extent to which the nitrogen contamination is dispersed, a sampling plan has been devised as follows:

Google Earth Images show the large scar seen in Figure 1 appearing between the 2006 and 2008 photo. There was nitrate contamination before, but this is when the spot where no plants can grow any more appeared.

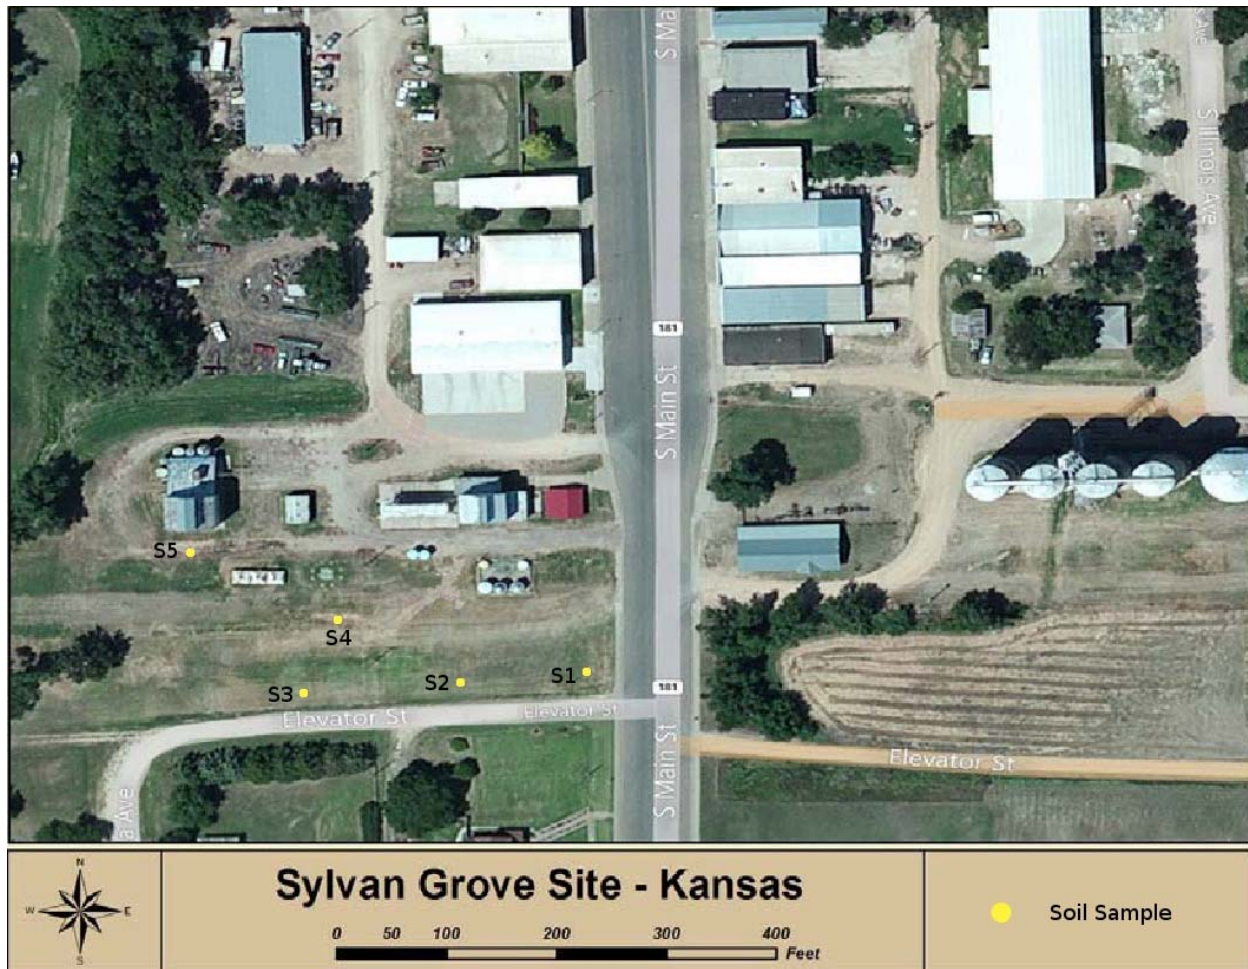
**Figure 2: Location of April 1, 2012 Soil Samples**

Additional soil samples were collected on April 1, 2012. Hand driven soil probes were used to extract soil at locations S1 through S5 (Figure 2). Three samples at 0-8" and 12-24" depths were taken in a 1 meter radius around each location and were given values of A, B, and C. Each sample represents a single core. Thomas Grund, Albert Maurin, and Jack Sparks were in attendance. Samples were collected with hand soil corers at depths of 0 to 8 inches and 12 to 24

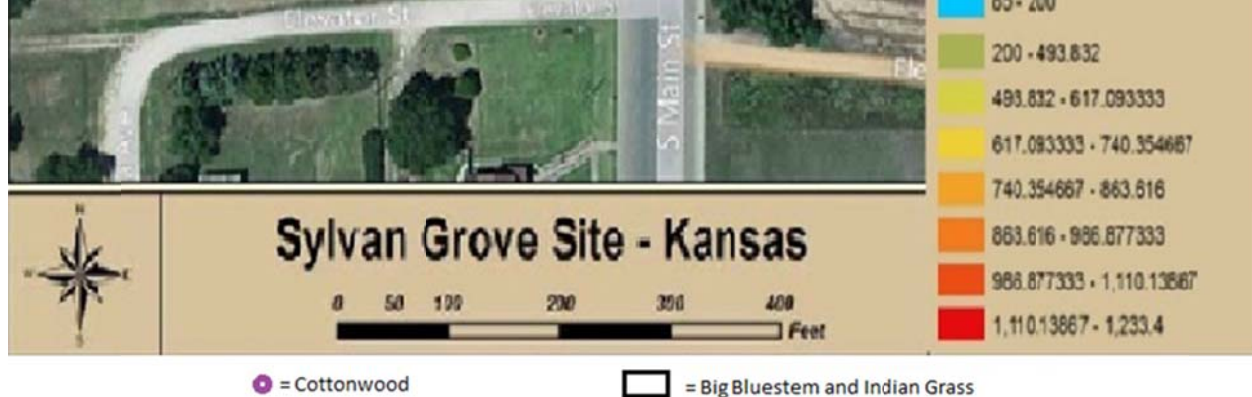
implementability. The plan would also provide: the desired ET rates needed to phytohydraulically contain nitrates onsite slowing nitrate movement throughout the soil profile, an extensive root systems with adequate ability to reach and filter mobile nitrates that have already leached in groundwater, as well as adding vegetative protection to the currently barren area of soil from any farther significant surface erosion. Several factors have been considered for the final plant selection and design including but not limited to; climate, weather, required tools, ET rates of many plant species, Nutrient up take rates of varying species, Soil quality factors, contaminant location/depth, plant growth requirements and limitations, Root/contamination depths/area, legal restrictions, physical restrictions such as utilities/facilities/. /. Our sketch of where the plants will be planted in this remediation option is shown below. An analysis of the plant types is presented next.

Figure 1: Placement of Cottonwood trees and Big Bluestem and Indian Grass for phytoremediation option

This alternative still uses the same plant design as presented in the phytoremediation section. The grasses will grow much better in the new replaced soil over the heavily nitrate contaminated soil before. The cottonwood growth should be unaffected except due to some unintended soil compaction from the heavy excavation equipment. The grasses will be established with proper maintenance after 2-3 years, and the cottonwood should be established after 10 years. The cottonwoods have lives of around 100 years, so once they are established, the flow of the nitrate in the groundwater should be contained.
