Identification of Sediment Sources in the Tributaries of Marion County Park & Lake to Develop Future Erosion Management Plan

Chuck Balkenbusch, Lucas Linder, Tessa Zee

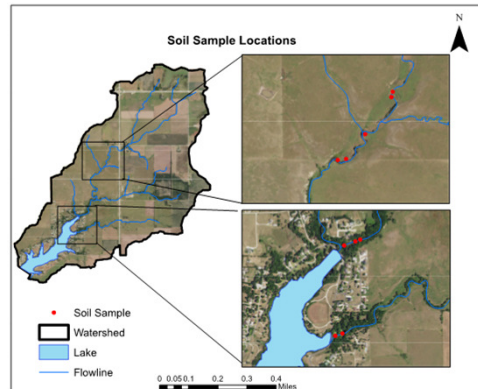
Figure 1: Map of site and soil sample locations along the two tributaries of Marion County Lake. The top right figure is Northern Stream Site A. The bottom right figure shows Northern Stream Site B north of the lake and the Northeast Stream Site towards the bottom of the figure.

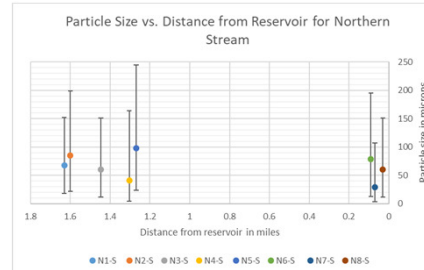
Figure 2: Particle Size Data for all Northern Stream samples in relation to distance from reservoir. The bottom tick mark in each box represents the Dx10 size, the dot in the middle represents the Dx50 size and the top tick mark represents the Dx90 size.
